Technical Bulletin 07/03 Dated: 28.02.07

Quality Complaint Log No 20070157

Subject: Potential for electric shock from live LED casing on Victor Excalibur Emergency luminaire (battery management version).

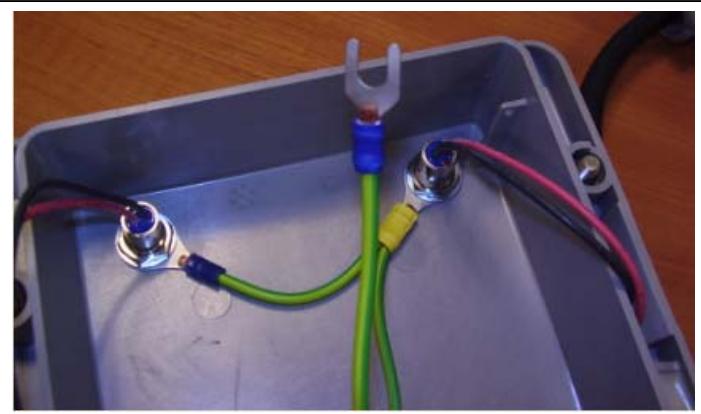
Having identified the possibility of incoming supply cables being located within the area that the Exm certified LED's are positioned, the LED casing may cause damage to the cable insulation, therefore causing the LED case to come into contact with the bare wire.

Victor have investigated and are now fitting an earth between the two LED's, using M12 ring terminals and 2.5mm² stranded earth wire, which is then connected to the gland plate earth connection. (See attached Picture)
