# Marine Safety Forum – Safety Flash 12-10

**Issued:** 1<sup>st</sup> March 2012

**Subject:** Cargo Hose Related Incidents

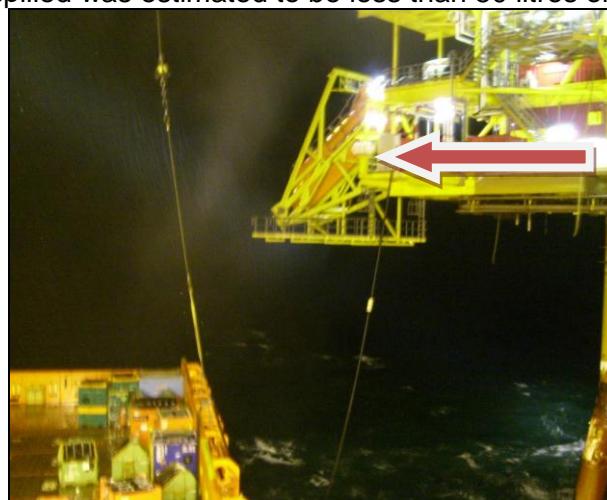
Position of Manifold

Vessel was near finishing the discharge of FO to an offshore platform, when the vessel's 2<sup>nd</sup> Mate noticed that there was a person standing at the platform manifold, and this person appeared to be closing the FO manifold valve. As this valve was operated the fuel hose burst just below the coupling on the platform side, causing a small spray of diesel.

The Mate stopped the FO discharge immediately using the emergency stop, and informed the installation. The amount spilled was estimated to be less than 50 litres of MGO fuel.

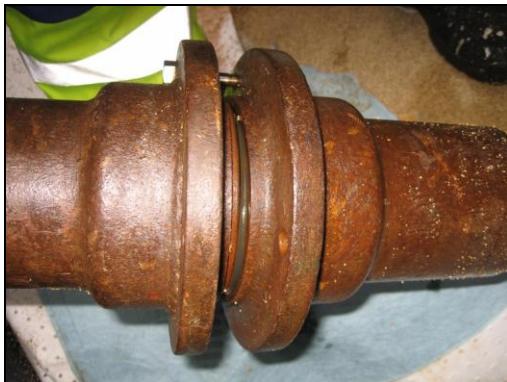
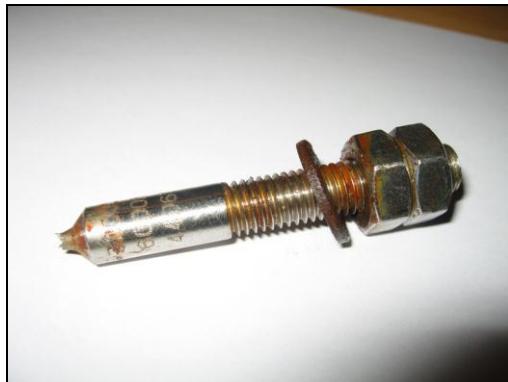
Whilst connecting a fuel hose from an offshore installation, the clean break fitting approximately 5m from the Avery-Hardoll, failed spraying diesel onto the 2<sup>nd</sup> Mate's face with some pressure. No injury was sustained as he was wearing Safety Glasses. The vessel's spill response equipment was deployed and the spillage was entirely contained on deck. The quantity spill was estimated at 20 litres.
