HSSE & Integrity ALERT

Subject: Incorrect Fittings on Portable Air Receivers

Platform/Site: Andrew

Date: June 2012

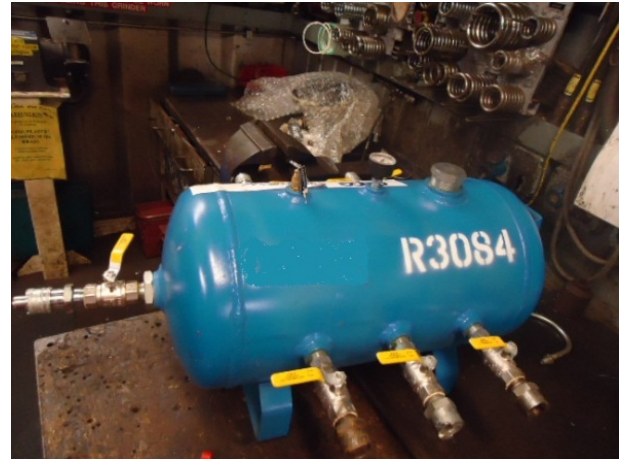
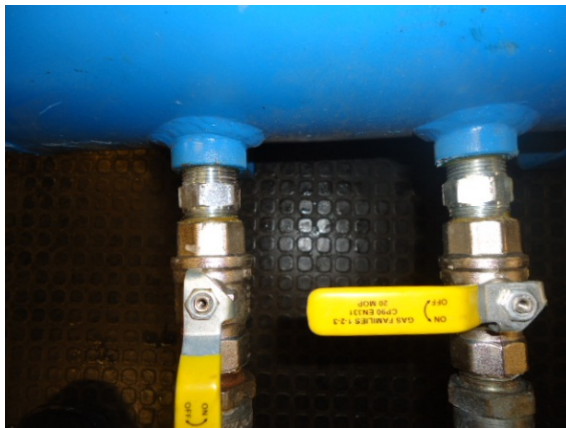
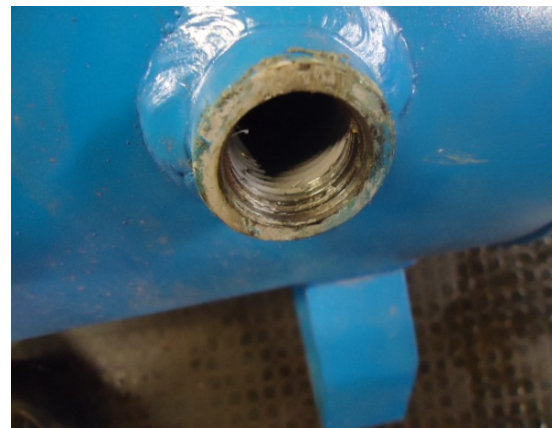
Whilst carrying out a check on a recently installed portable air receiver (commonly referred to as a "pig"), a mechanical technician noticed that the fittings screwed into the pig did not look correct. On further investigation it was found that male National Pipe Thread (NPT) fittings had been screwed into the female British Standard Pipe (BSP) threads of the pig.

The NPT standard is a tapered thread, whereas BSP is a parallel thread. There were therefore only 2 threads of each NPT fitting holding the assembly attached in place.

Whip checks were in place but would have provided no protection in the event of a failure, as they were attached to the screwed fitting. The fitting would therefore have detached under pressure.
