Step Change Safety Alert Template

Failure of LP Separator Inlet Isolation Valve Stem Packing resulting in hydrocarbon leak through actuator 'tell tale' ports

13th August 2013

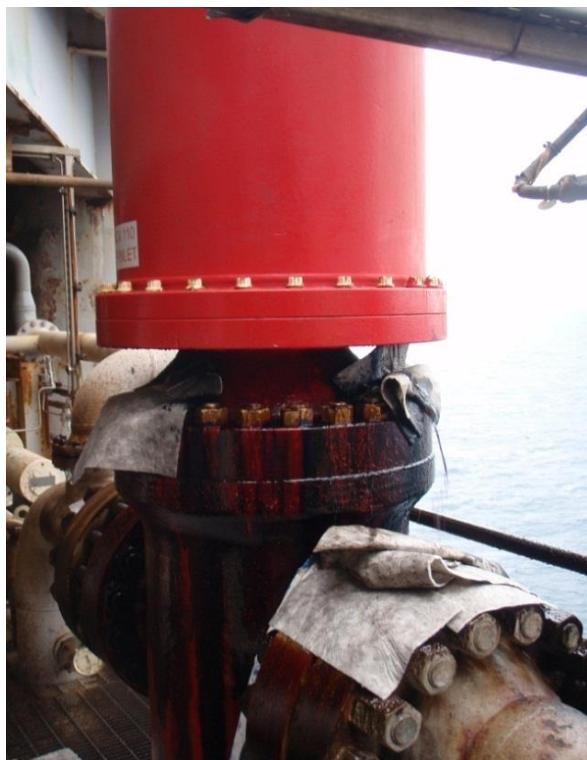
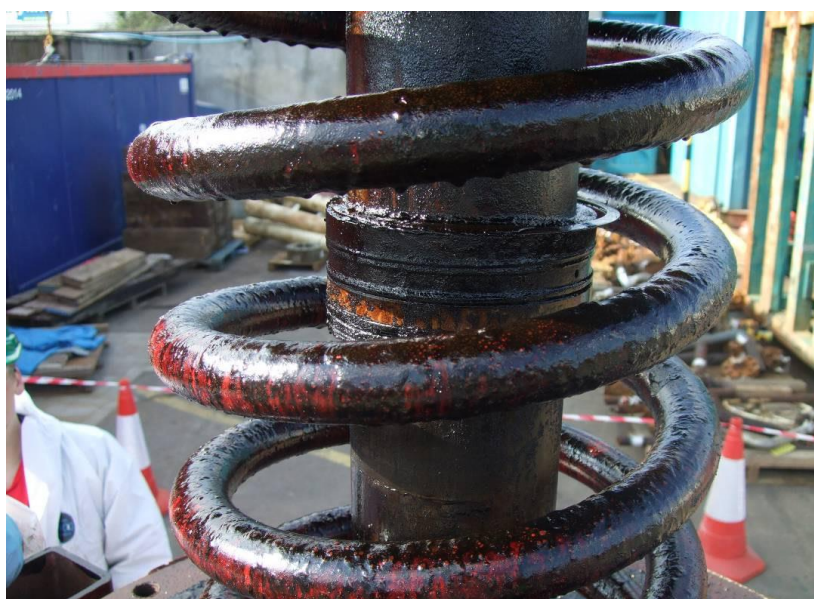
Inspection identified leakage through the stem seal area. The cause of the valve failure was ejection of the valve stem packing during actuator operation resulting in a lack of active seal when the valve is in the open position.

Upon inspection, the spiral spring clip which retains the stem packing had also been ejected and could be clearly seen above the stem packing. This spiral spring clip had been forced out of its retaining groove by the operation of the actuator.

Valves of similar design have been identified and are being assessed for repair. Modifications to stem packing retention mechanism will be carried out on all similar valves irrespective of their condition upon inspection. Any valves with potential to leak in a similar fashion should be considered for isolation and removal for repair at the earliest opportunity
