SAFETY BULLETIN

MAJOR ACCIDENT CAUSED BY PIPE HANDLING SYSTEM FAILURE EIGHT PERSONS INJURED, FOUR FATALLY

Equipment involved: Saipem 7000 J-Lay Tower

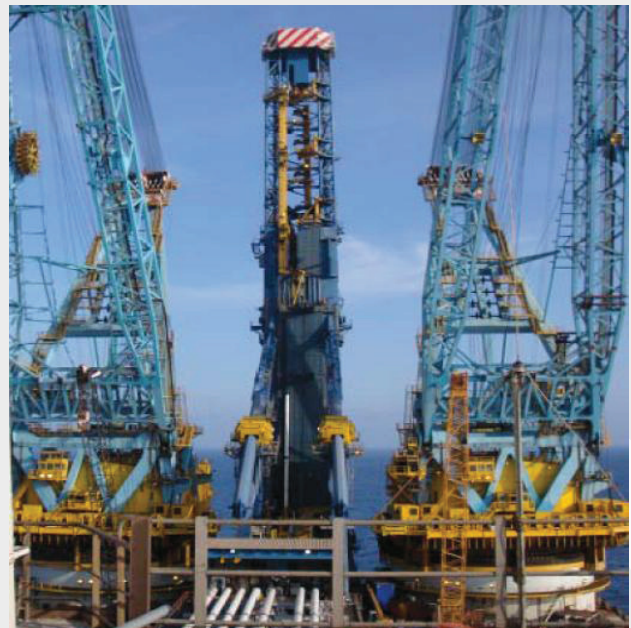
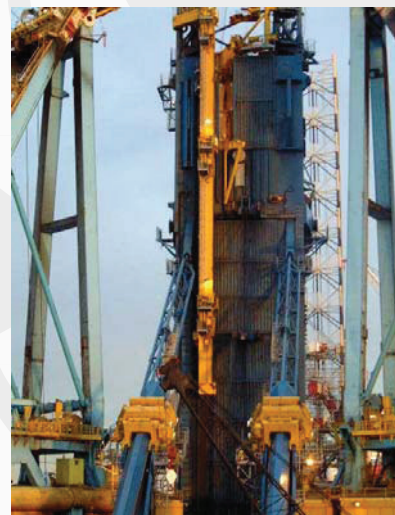
The accident occurred on Saipem 7000 during pipe lay operations. A system failure in the hydraulic pipe handling system of the J-Lay Tower (JLT) caused two quadruple joints (QJ) being handled contemporarily in two different areas of the Tower, to suddenly drop. Each QJ pipe was a 24" x 50mts long, weighting approximately 20tons.

One of the two quadruple joints dropped from the pipe transfer system inside the tower landing on the pipe alignment area (upper welding deck), falling approximately 1 meter causing neither injuries nor damages.

The second quadruple joint was retained by the pipe elevator stationing at the top of the J-Lay Tower and was in the process of being handed over to the pipe transfer system. The pipe fell outside the tower crashing through the walkway at the lower section of the tower. It stopped at the bottom structure of the JLT.

Several crewman were present on the walkway. Eight people were affected by the accident. Four were fatally injured, two seriously and two slightly injured.

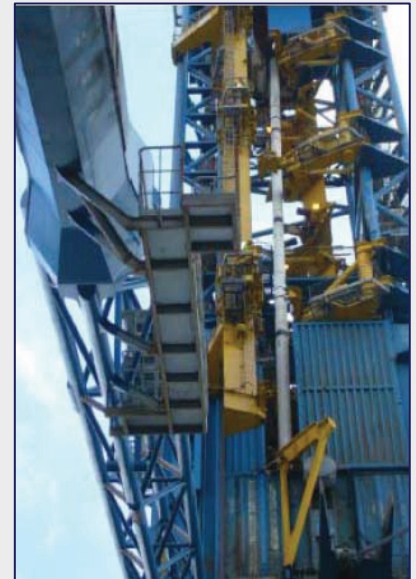
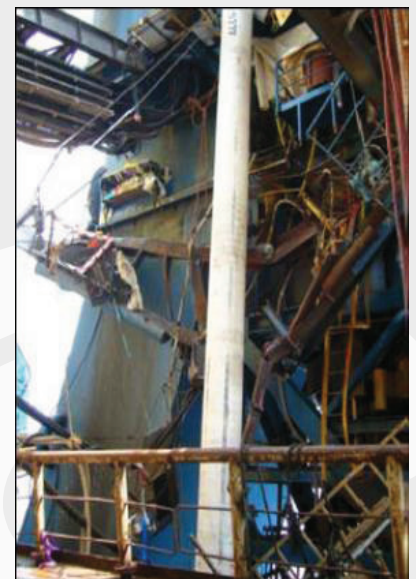
As soon as the power packs were started a loud bang together with hydraulic noises were heard. One quadruple joint within the J-Lay tower, held by the transfer system was released and fell down about 1 meter down to the upper welding deck. At the same time, the quadruple joint held by the pipe elevator at the top of the pipe laying tower was also released by its clamps and the hydraulic safety stop swung away, allowing the pipe section to fall down the full height of the tower smashing through the access platform located outside the non destructive test/coating station to the lower deck below.

All the injured people were on the access platform. The force of impact caused some of crew members to fall down onto the lower deck at the base of the pipe laying tower and some to be projected into the open sea.

The sudden release of the 2 quadruple joints was caused by a failure in conceptual design of the control system software. In fact the program relevant to the JLT initializing instruction was pre-loaded in the EPROM memory of the PLC4 with the instruction to open all clamps.

The unnecessary presence and uncontrolled access of working personnel onto the access platform destroyed by the falling pipe have exposed the injured people to suspended load hazard and to this catastrophic event.

The 1st Primary Cause has been resolved with the definitive removal of the EPROM memories from the system.

The 2nd Primary Cause has been addressed by a revision of the vessel and JLT working methodologies. The pipe handling activities have been reconsidered through a dropped object philosophy in order to identify mechanical and electrical barriers, additional controls, and new set of operational procedures.
