March 2009: Electrical Shock to individual whilst carrying out routine maintenance work on lighting systems.

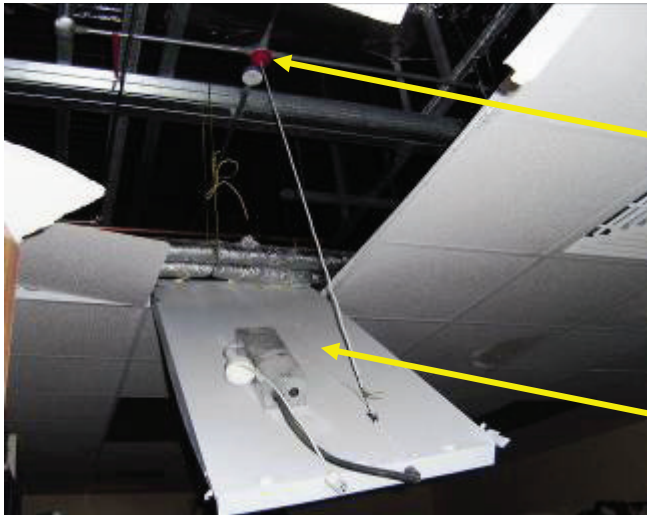
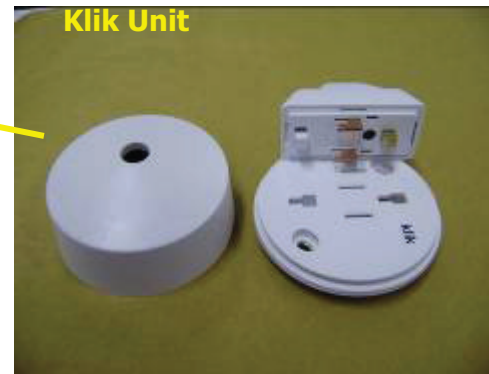
Back-up Battery Pack

Photographs showing the lighting set up with the klik unit and the battery pack on the back of the light fitting

Local Tests were carried out to find what caused this incident and initial indications are that A fault on the inverter could have caused a possible back feed from the emergency feed (permanent live) through the light fitting and through in to the klik unit.

When working on lighting circuits on site, isolate the MCB feeding the circuit then prove the light fitting to be worked on is dead, only then remove the klix unit/units, work can then be carried out on a dead fitting.
