# Songa Mercur

## King Post Failure

**Mike Ferguson**  
**Mercur Rig Manager**

**DrillSafe Forum**  
**Brisbane**  
**3 Dec 2009**

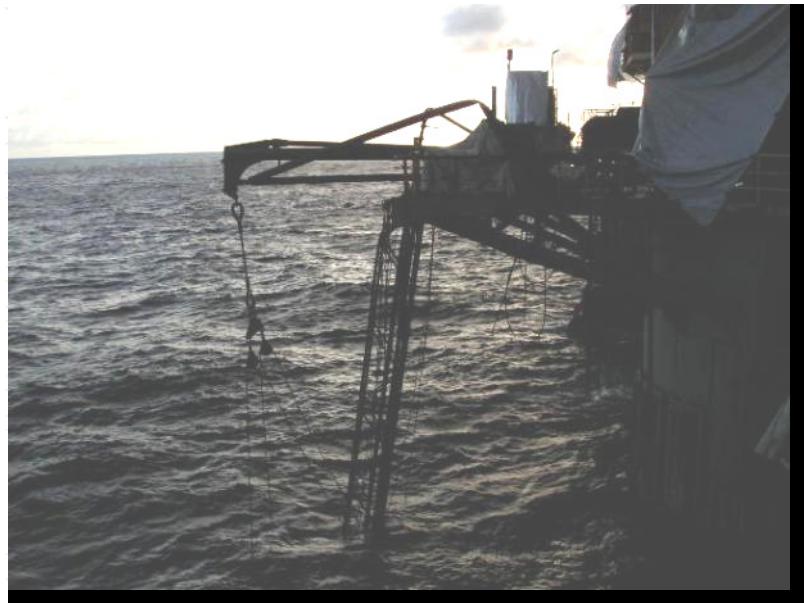
**Starboard Flare Boom**

The Starboard King Post Rear Stay Base Plate separated from the wing deck

This caused the King Post to fall forward and outboard under the weight of the Flare Boom

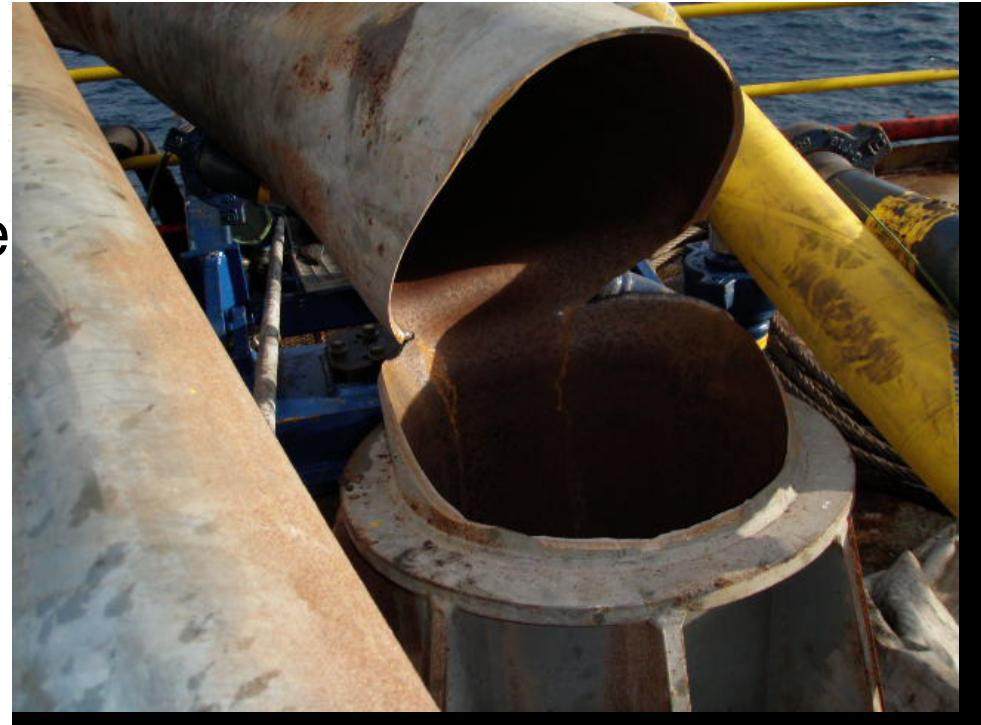
The Starboard King Post failed causing the Flare Boom to fall into the sea

Failed Starboard King Post

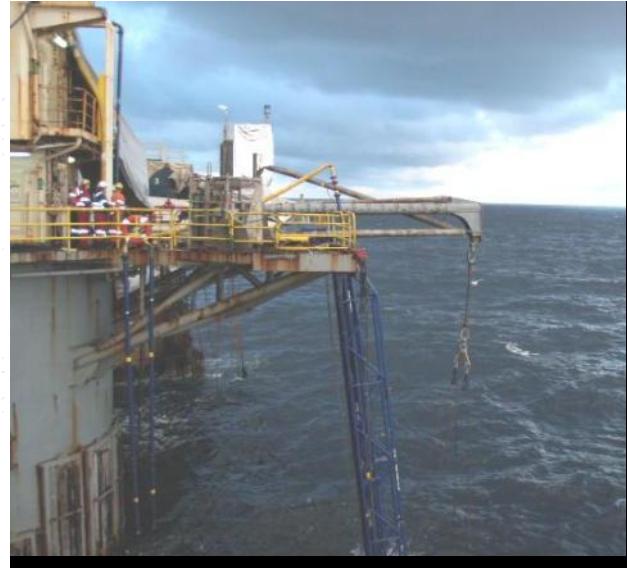
Significant damage to flare boom

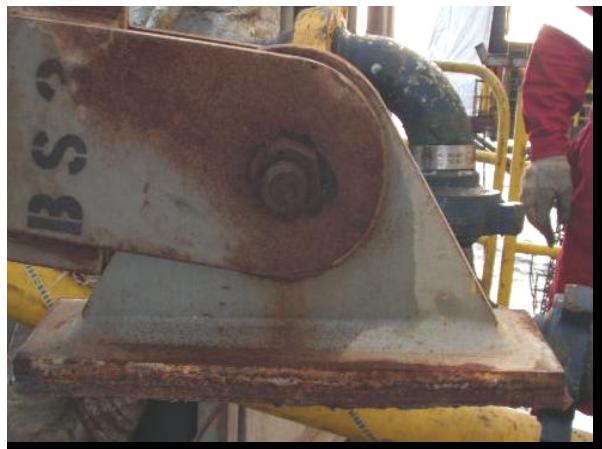
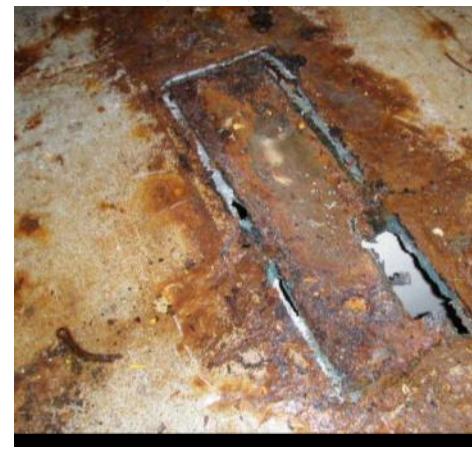
**The original design did not anticipate that the weld to the rear stay base plate was not uniformly loaded**

This was due to the pad eye being located over the caisson wall and deck stiffener creating hard points to weld, resulting in only a fraction of the weld being effective

1.	Redesign the starboard and port king post bracing using the American Institute of Steel Stress Design – 1989 AISC principles
2.	Ensure that future design scopes for engineering projects ( <i>rated as high risk</i> ) include in the design submission an independent review of methodology and calculations
3.	Ensure all MoC submissions include a project risk assessment
4.	Circulate a Technical Safety Alert re incident
5.	Audit all previous MoC documentation
6.	Recommend findings promulgated to industry

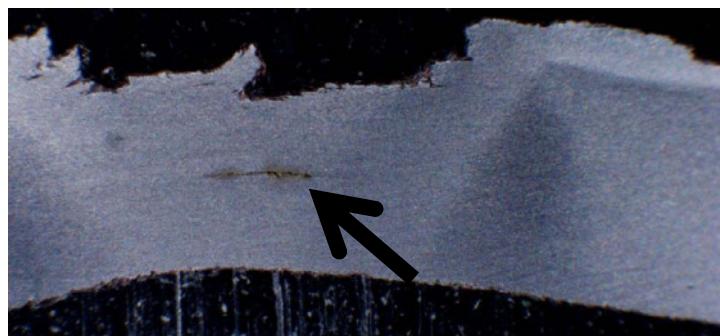
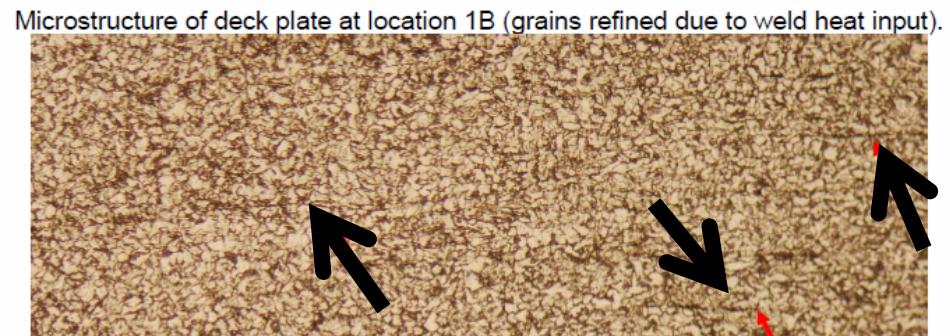
- Weld design caused lamellar cracking in the welding zone
- Extra load was added to the flare boom without a MOC
- Weld design assumed a deck thickness of 8 mm not 6 mm
- Project management responsibilities changed without adequate handover process
- Formal updates were held with NOPSA throughout the investigation
