SAFETY ALERT NO. 216: IMPACT OF SEA-STATE ON LIFTING OPERATIONS

Type of Activity: *Lifting, crane, rigging, deck operations*

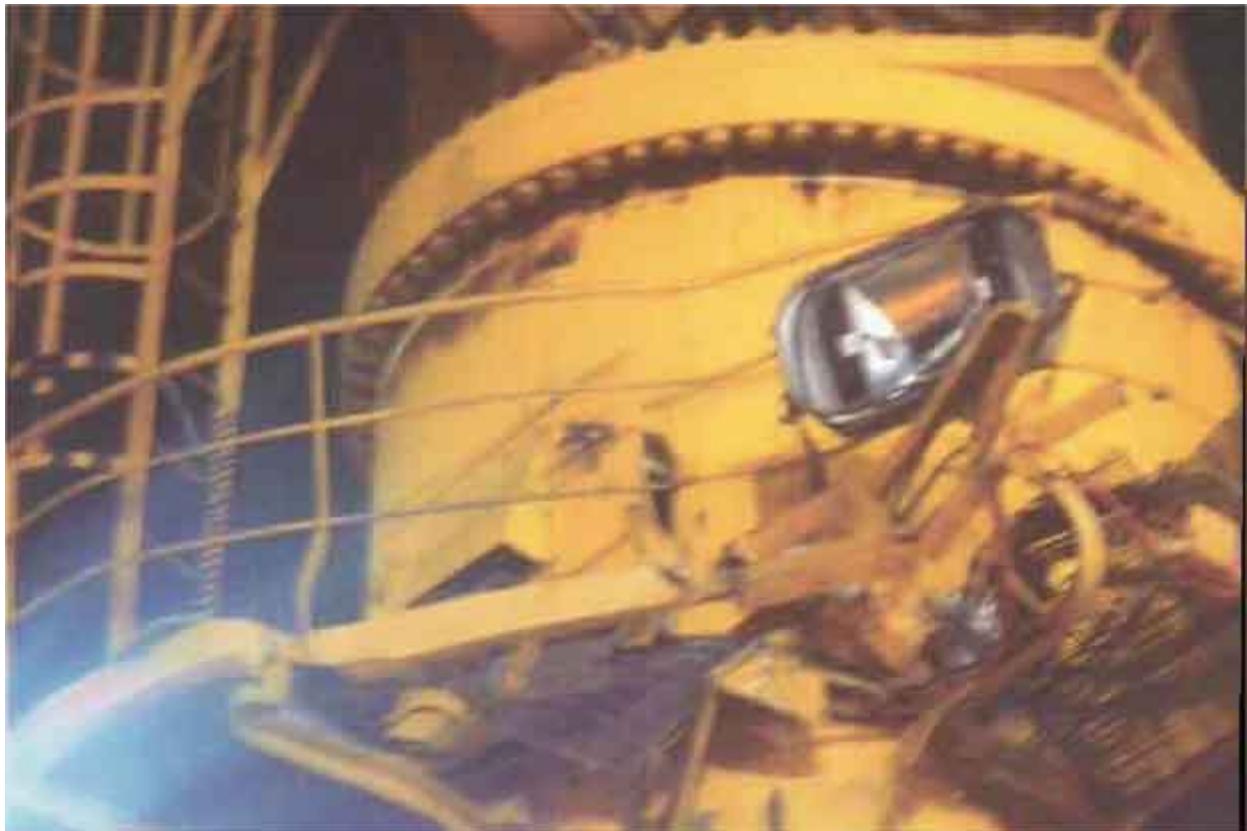
Case 1: The first incident (in Australian waters) occurred during lifting operations on a construction support vessel. While lowering a crane block to the deck, a large swell hit the vessel inducing a rolling motion and causing the block to swing. Despite efforts of the crane operator to control the swing, the block collided with an empty product reel (dislodging its sea fastenings), an air-conditioning unit and the walkway of another crane before it could be recovered to a safe height. Personnel in the vicinity of the lifting operation had earlier moved clear of the lifting area and nobody was injured, however the incident resulted in minor damage to the equipment struck by the block.

Damage to crane walkway and light caused by impact of swinging block

Both of these incidents resulted from a combination of poor planning of lifting operations and lack of suitable risk assessment to identify potential hazards and implement appropriate risk control measures. In particular, both lifting operations were conducted in congested areas where there was potential for vessel movement to result in lifted equipment impacting with surrounding structures, and while safer options had been identified, they had not been used.

Lifting operations are one of the most hazardous operations conducted on offshore facilities and require careful planning, identification of the hazards, assessment of risks and implementation of appropriate controls. It is important that any changes in circumstances, such as congested lifting areas and potential changes in sea-state which could lead to unpredicted movement of a suspended load, are given appropriate consideration in the task safety analysis.

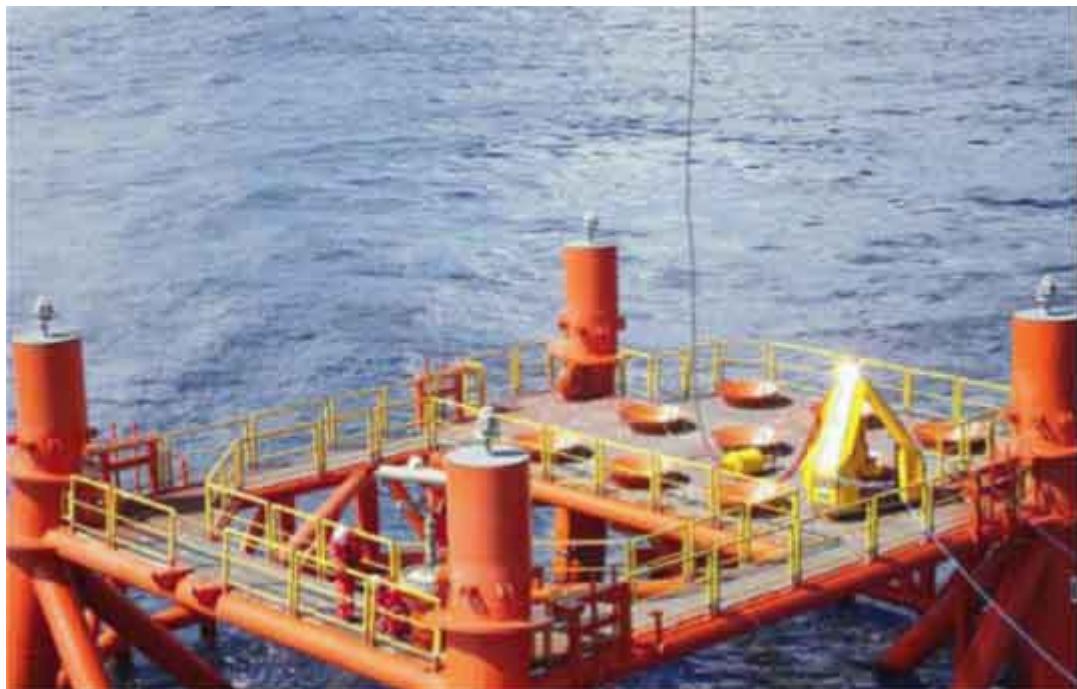
recently installed platform jacket and a vessel. Three people, who were involved in the commissioning activities for the recently installed jacket, were preparing to transfer back to the vessel and entered the personnel lifting device. Prior to the actual lift, a swing developed in the crane's headache ball due to a worsening sea swell. Despite efforts of the crane operator to control the swing, the swing gathered momentum until it eventually hit one of the platform legs and ricocheted into the frame of the personnel lifting device, striking one of the occupants. The injured person was taken to hospital but released later that day.

Platform jacket showing personnel lifting device and crane wire.
