Marine Safety Forum – Safety Flash 10/13

Subject: Damaged Wire Strop

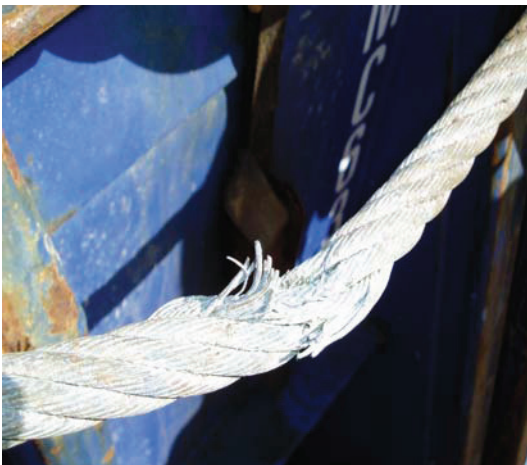
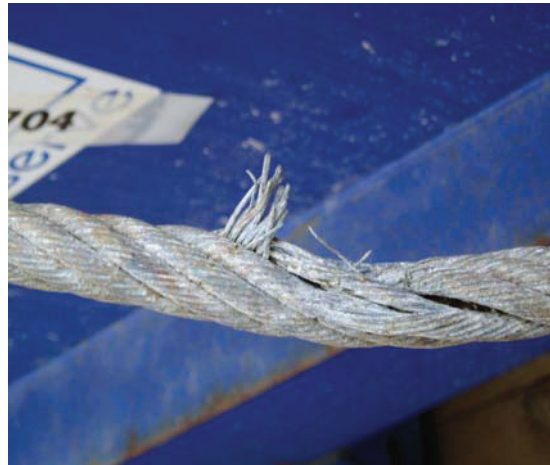
The damage was very close to the master link and the strop had obviously been crushed / pinched at some point. Unfortunately it could not be determined when & where the damage occurred.

If it wasn't for the awareness of the AB this damage, if undetected could have easily caused injury to others'.

This flash is to highlight / raise awareness for Installation personnel and vessel crews to ensure that all lifts are checked / inspected at each stage of the journey.

If **WE** all took a little extra time to adhere to procedures **WE** may just prevent personal injury or damage. Don't transfer the potential hazards' onto someone else.
