Safety Alert

ALERT 10 – 34

FATALITY OCCURS DURING OFFLINE CEMENTING OPERATIONS

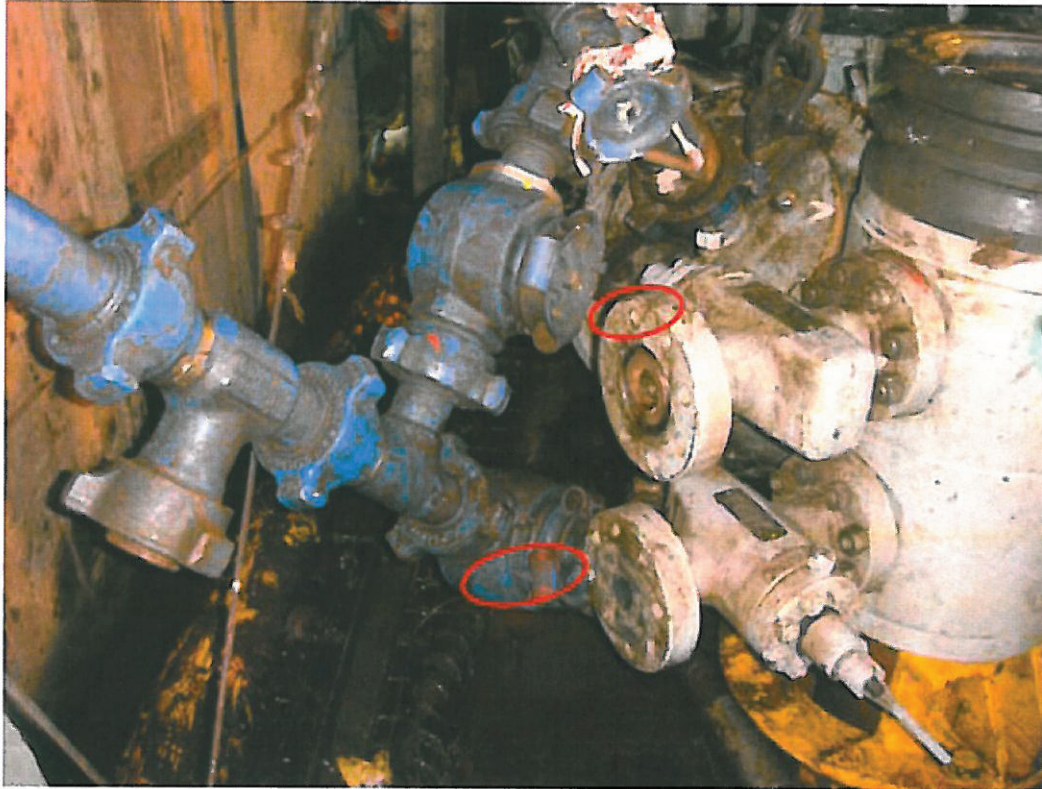
Photo 1 – approximate Crush points between annulus valve and valve (1) on cement head

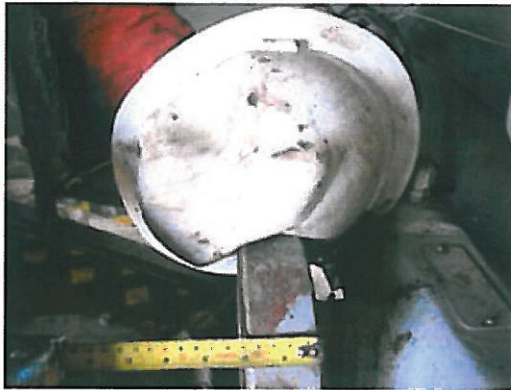
Photo 2 Position of head during impact

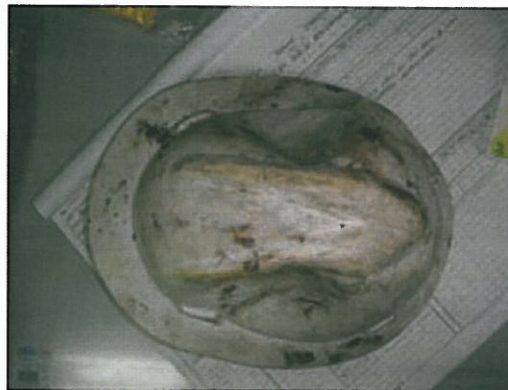
Photo 3 damage to Hard Hat
