## 421: Waste Food Disposal

## 422: Risk Assessment

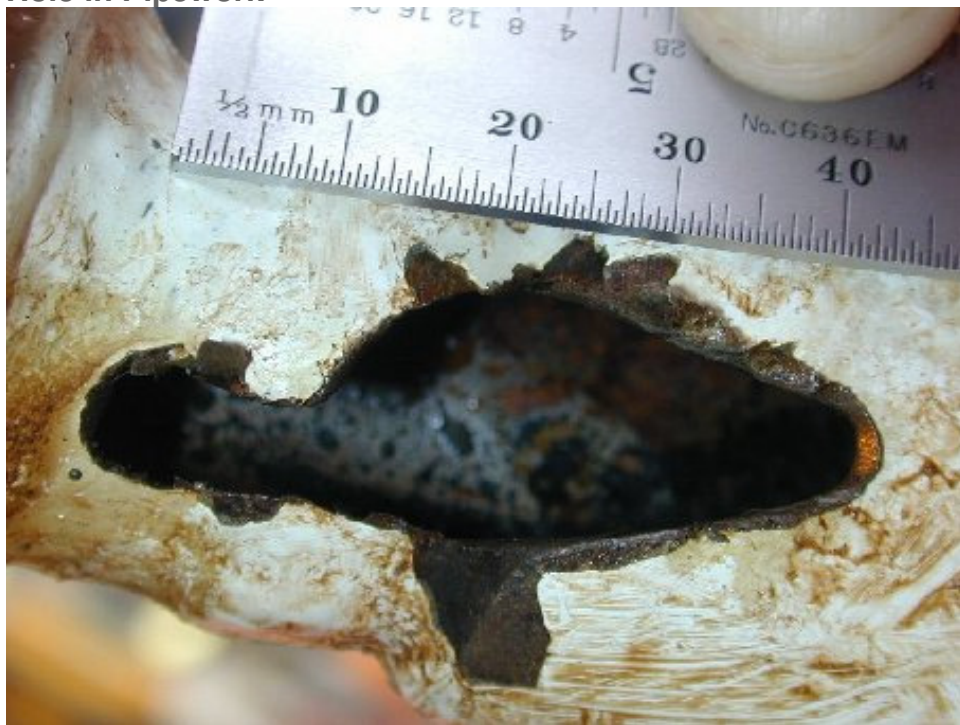
Description: A hydrocarbon release in a processing module was detected by the platform fixed gas detection system. An automatic ESD was initiated and the plant safely blown down from the Control Room. Initial investigations following the release confirmed that the cause of the leak was a pipe work rupture at a reducer downstream of the condensate outlet level valve, on a gas test separator (see Figure 1). This rupture was of some 40mm in length and 10mm across, (Figure 2) The condensate line was found to have a large quantity of proppant within it, proppant was also found in the area local to the pipe work rupture. Proppant is a pellet like material used for well frac jobs to fracture the formation and improve flow rates. The test separator had been used for a well clean up (Well 47) after the completion of a well frac in the days leading up to the release. Well 47 clean up and test was completed and a further well (Well 39) was on test at the time of the incident. The failure of the condensate pipework downstream of the level control valve was caused by rapid erosion of, initially, the level valve and, subsequently, the downstream pipework following gas blowby from the test separator with entrained proppant.

Lessons Learnt: Gas blowby occurred because the low condensate level trip to an ESV on the test separator had been inhibited and liquid level was lost. Proppant was present in the vessel because filters installed for the well frac clean up had collapsed, allowing significant quantities of proppant to pass into the gas test separator. These failures were not detected by the sand detectors or during the operation. It should be noted that the test separator was not designed to handle solids. The potential consequence of the release was increased by back-flow of a significant quantity of condensate from downstream pipework which routed to a higher level. The condensate flashed to atmosphere generating a second (larger) gas cloud than the initial release. There was a failure to identify that changes in operation had occurred since previous frac jobs. The original HAZOP and risk assessments should have been reviewed in the light of these. The risk assessments used for the task did not reflect the actual test separator used for the well clean-up. The final contributing factor was associated with the pipework design which included a severe reduction (6" to 2" to 1") over a short length adjacent to the level control valve (see Figure 1). This had the potential to induce turbulent flow and erosion, even without the presence of solids. The level control valve had been changed out on a frequent basis (every 18 months on average) but the significance of this had not been recognised.

Failure occurred  
at this point – 6  
o' clock position

Hole in Pipework

Recommendations: 1. Prior to completing well cleans ups etc, ensure any filtration units are fit for purpose and adequate solids monitoring is in place. 2. Ensure a control of inhibits procedure is in place, communicated to all, and effectively monitored. 3. Review pipework system design on long lengths of pipework where reverse flow could create a

hazard. 4. Review pipework design to ensure severe pipework reductions cannot cause potential turbulent/erosive flow. 5. Ensure risk assessments reflect the actual task being undertaken and the equipment being used.

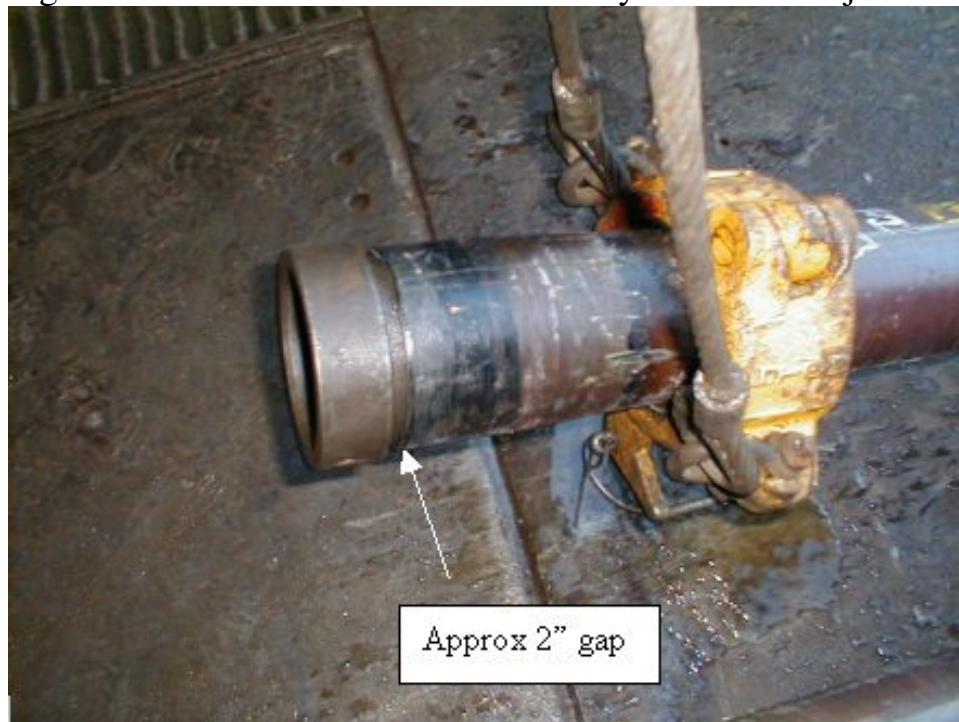
Figure A - Picture shows nubbin correctly screwed into joint

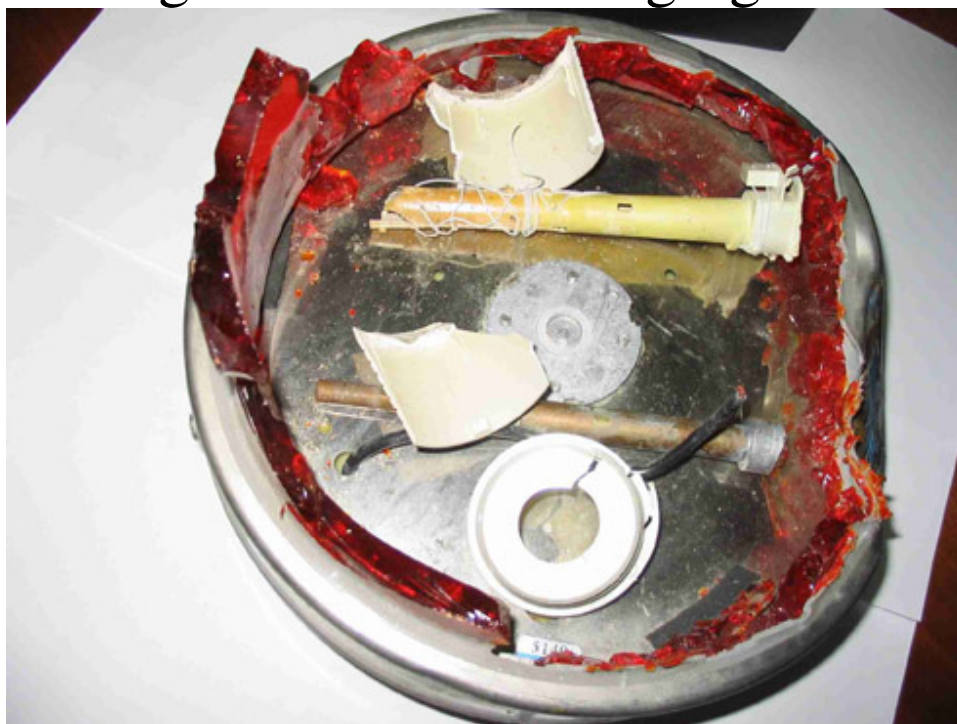
Damaged aircraft warning light

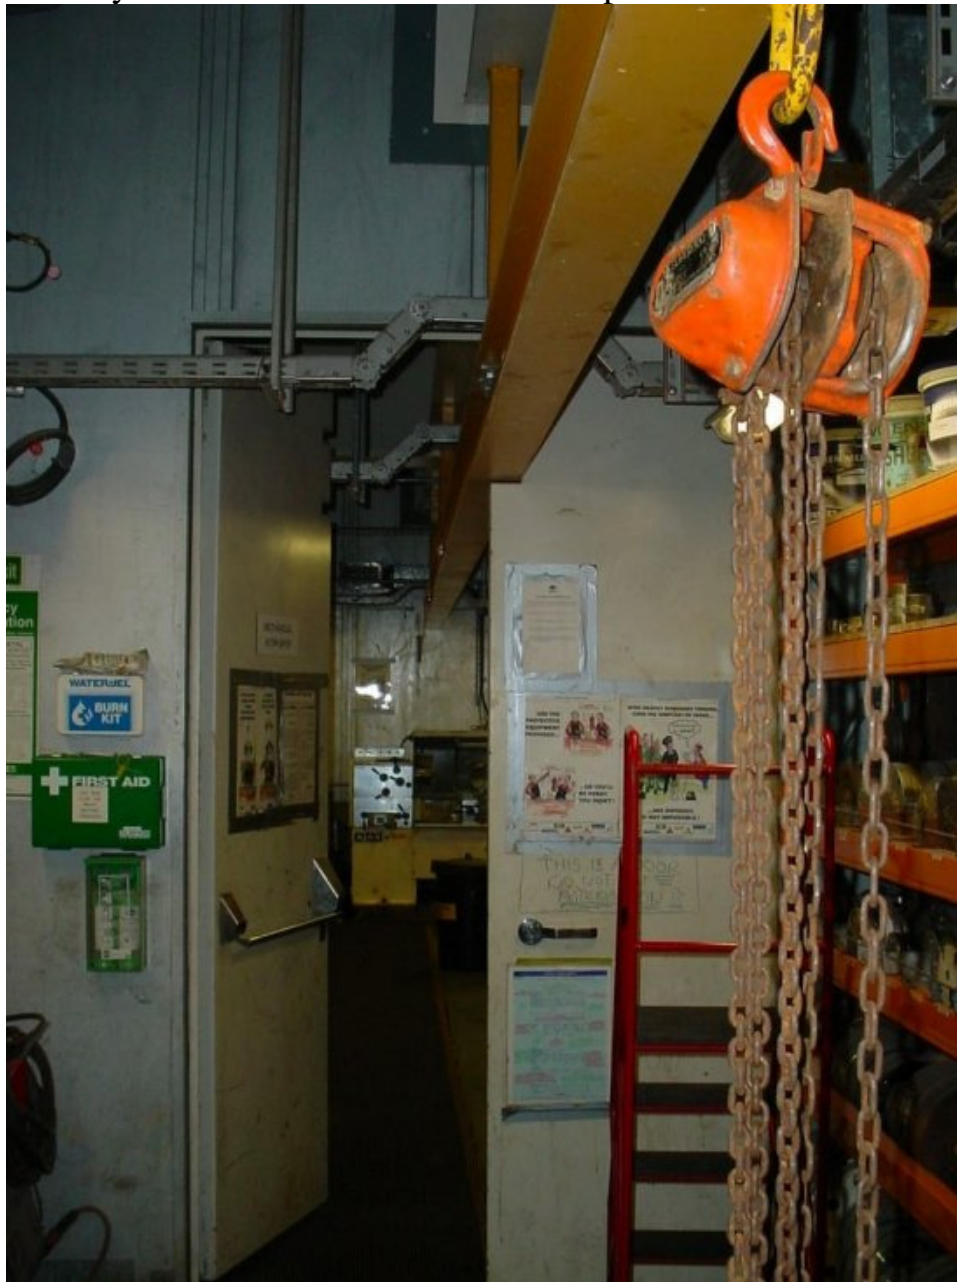
Runway beam from mechanical workshop into fabrication workshop

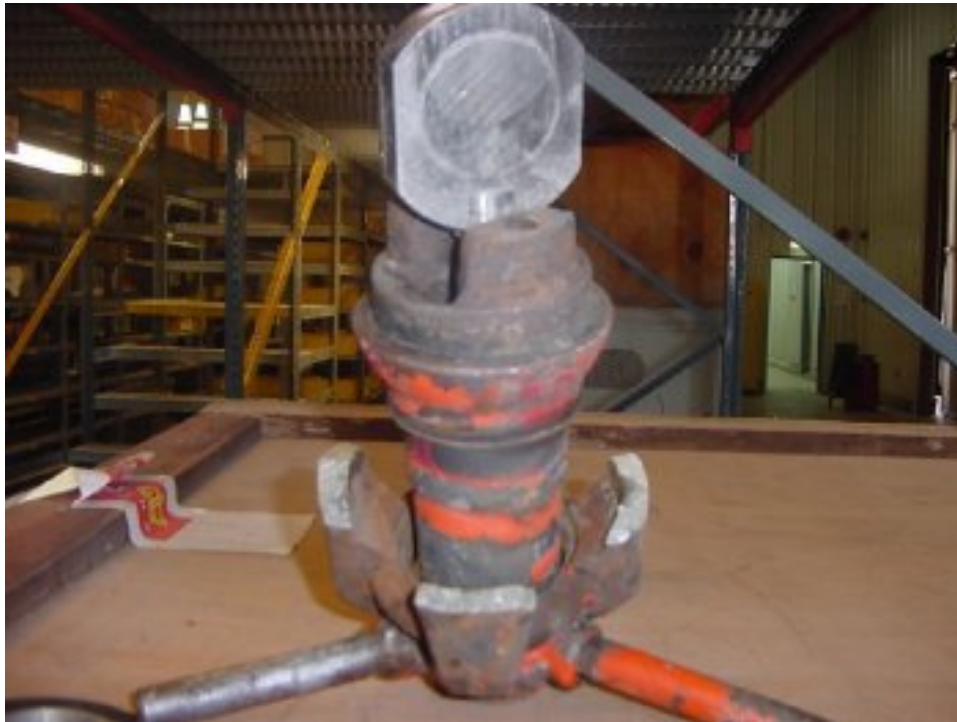
failed valve

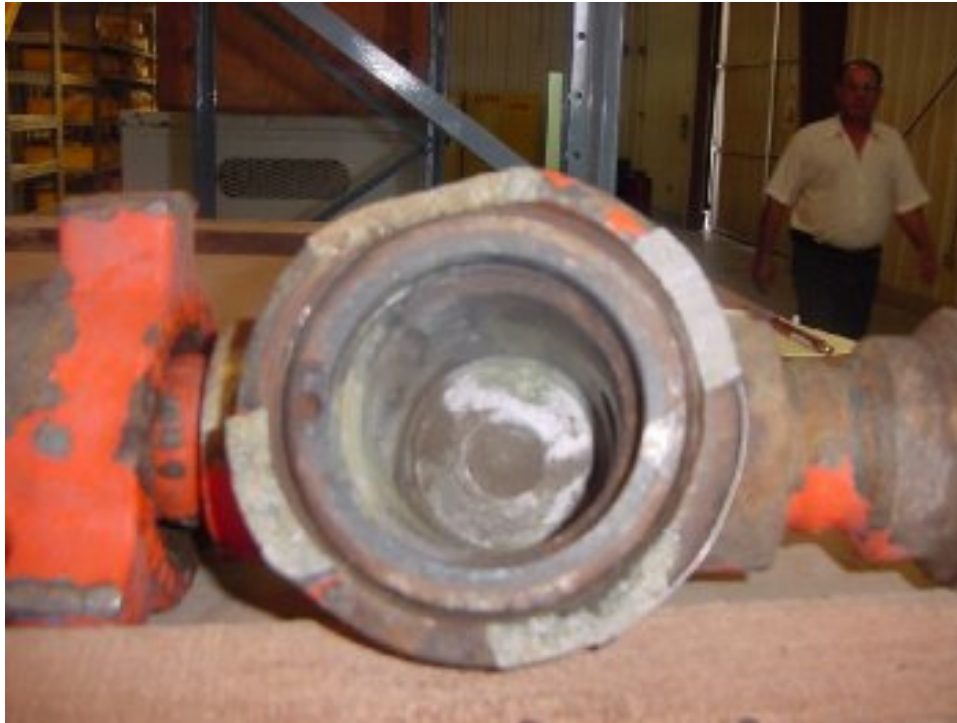
failed valve

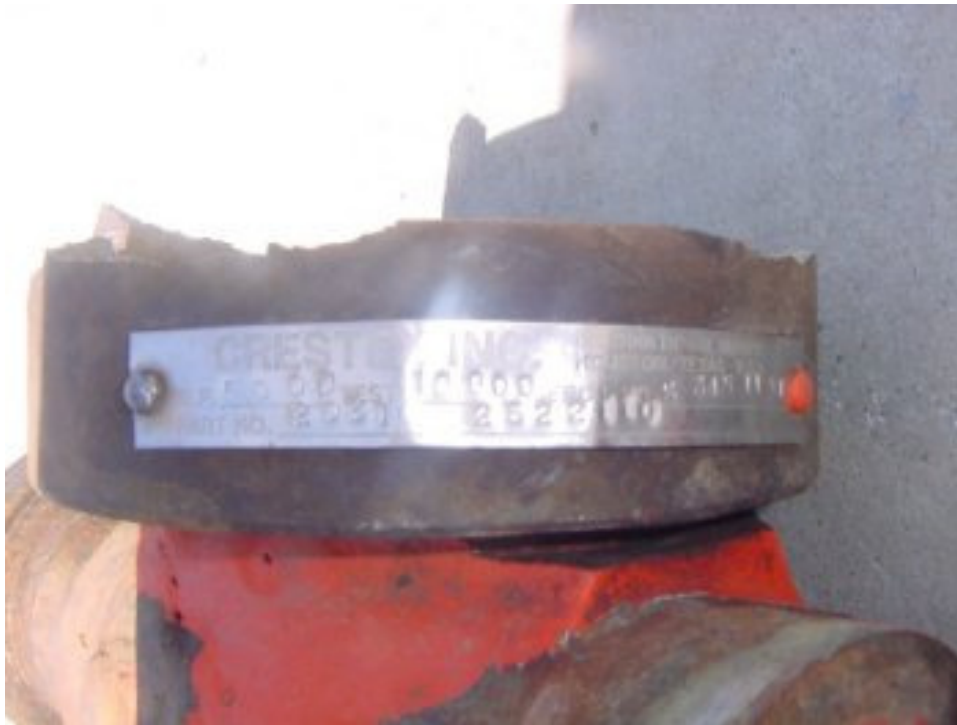
failed valve

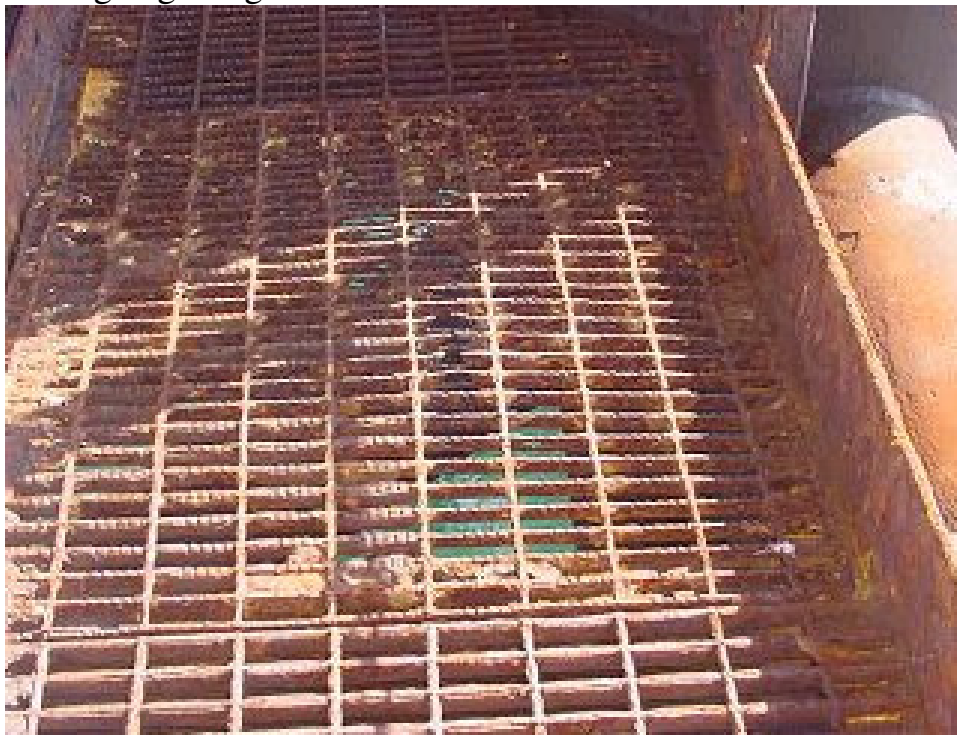
### **Damaged grating**

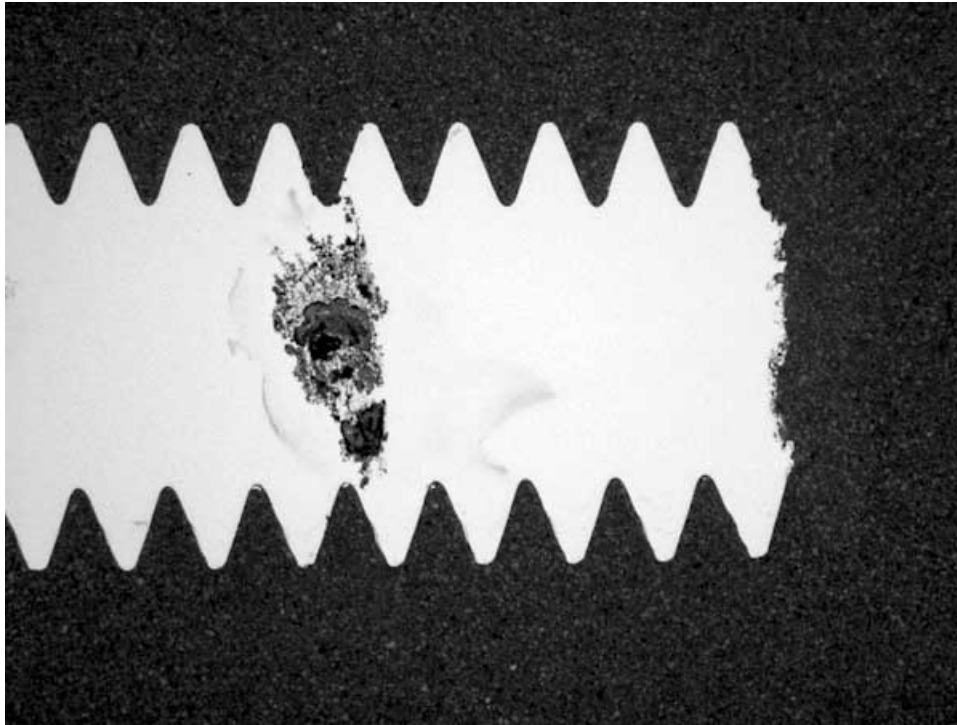
F1 Threads Macro

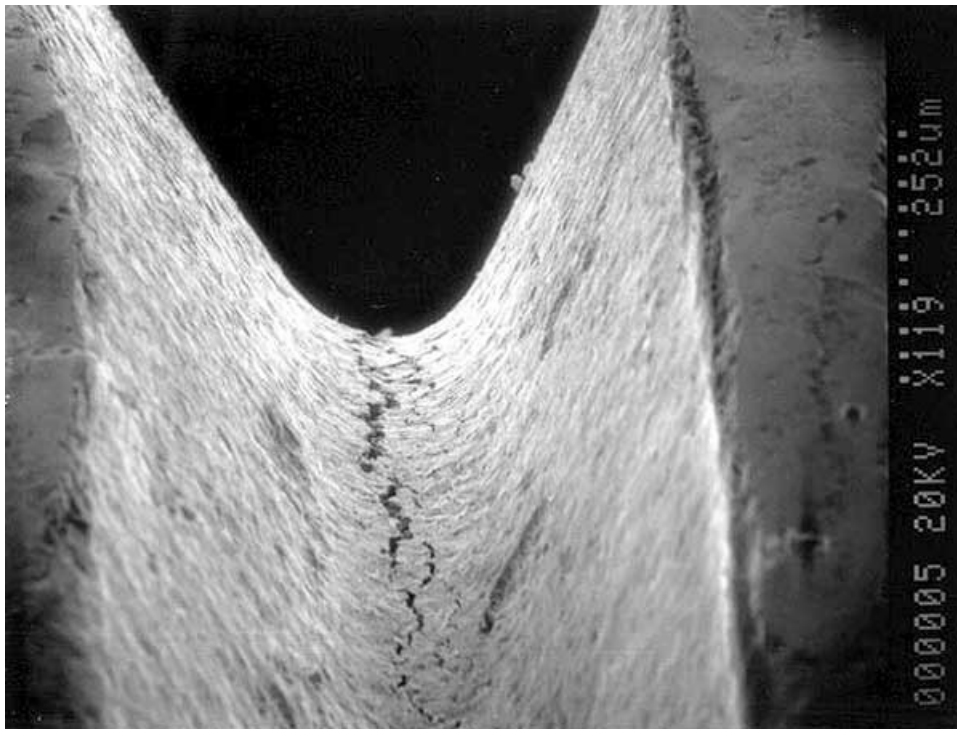
SEM Cracked Thread Root

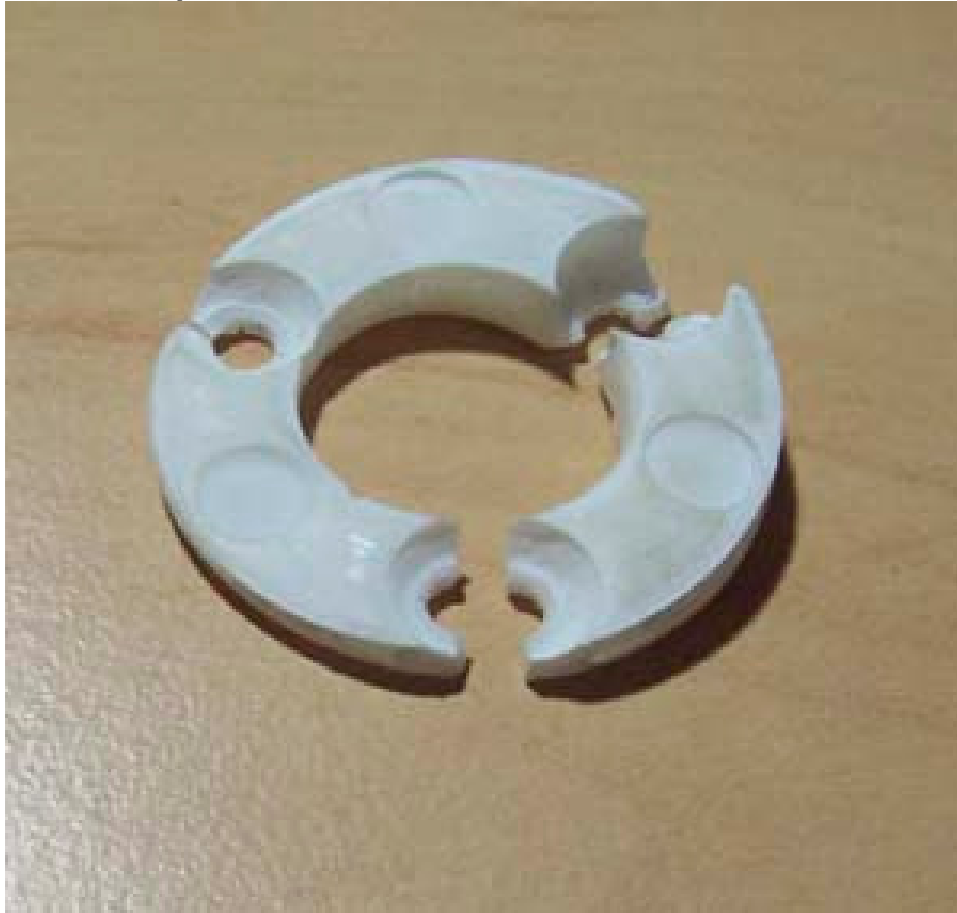
**Broken Stop Pad**

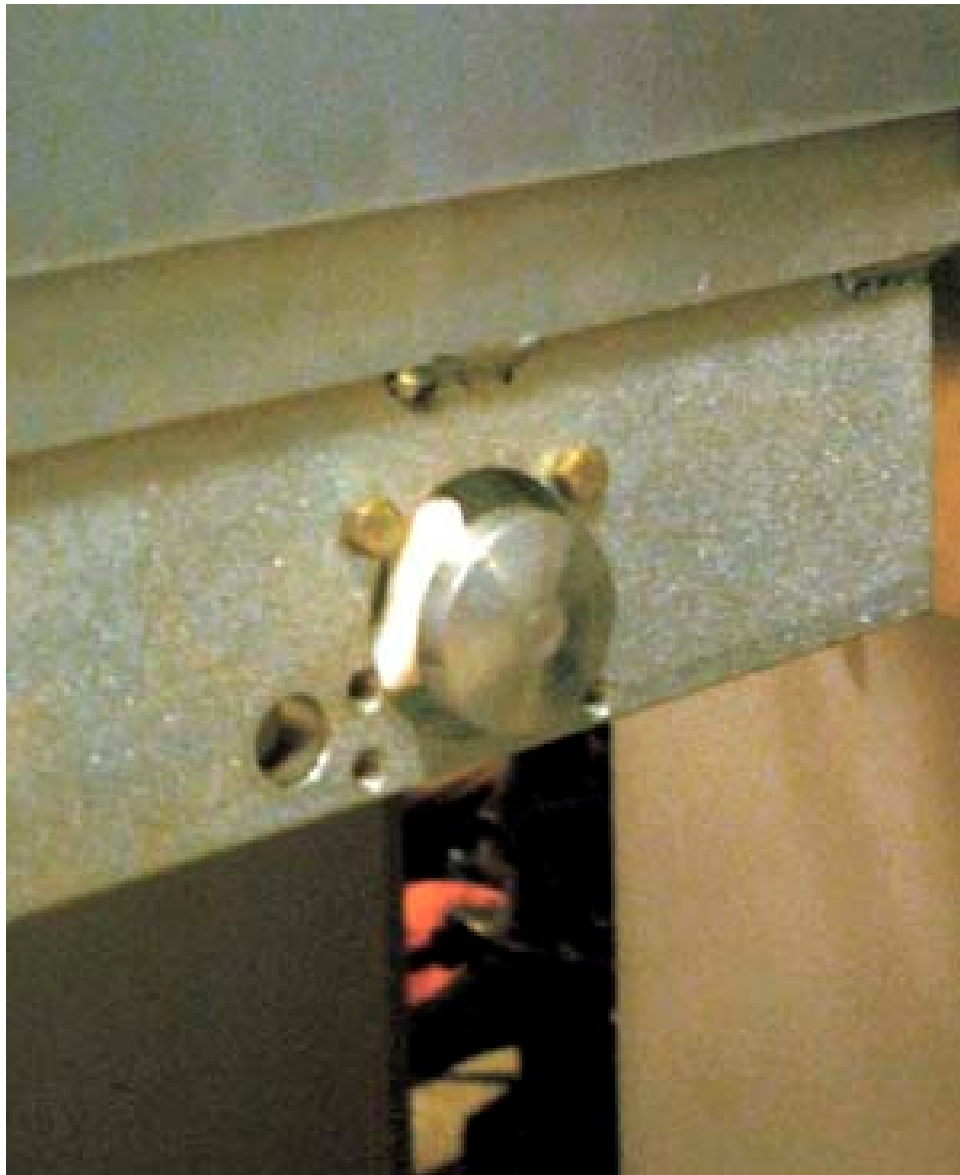
**Damaged Insulator**

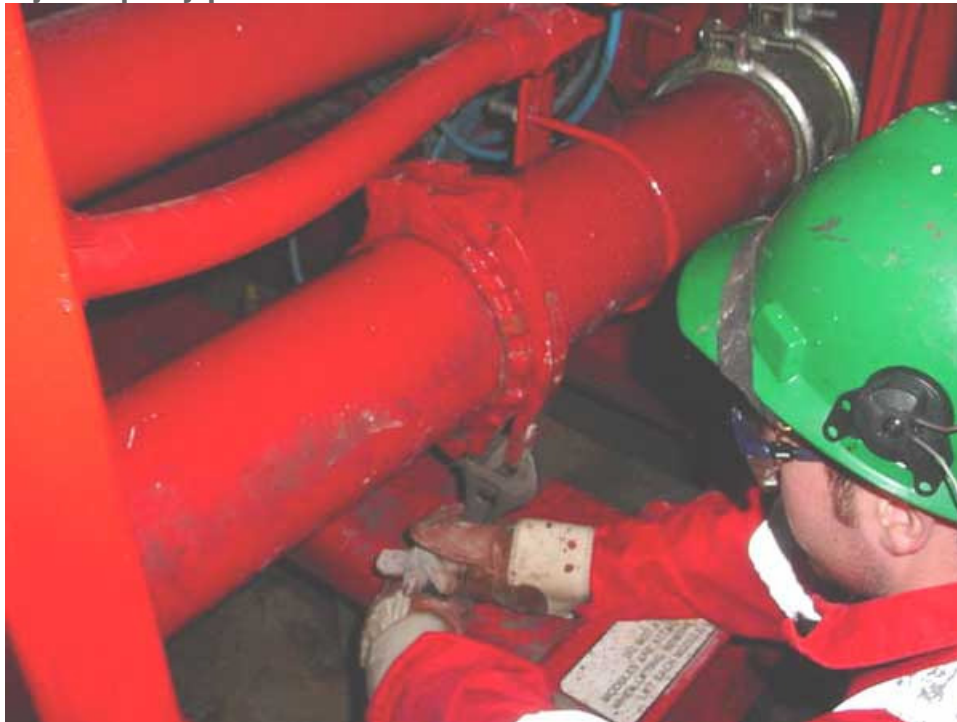
Injured party position re-enactment

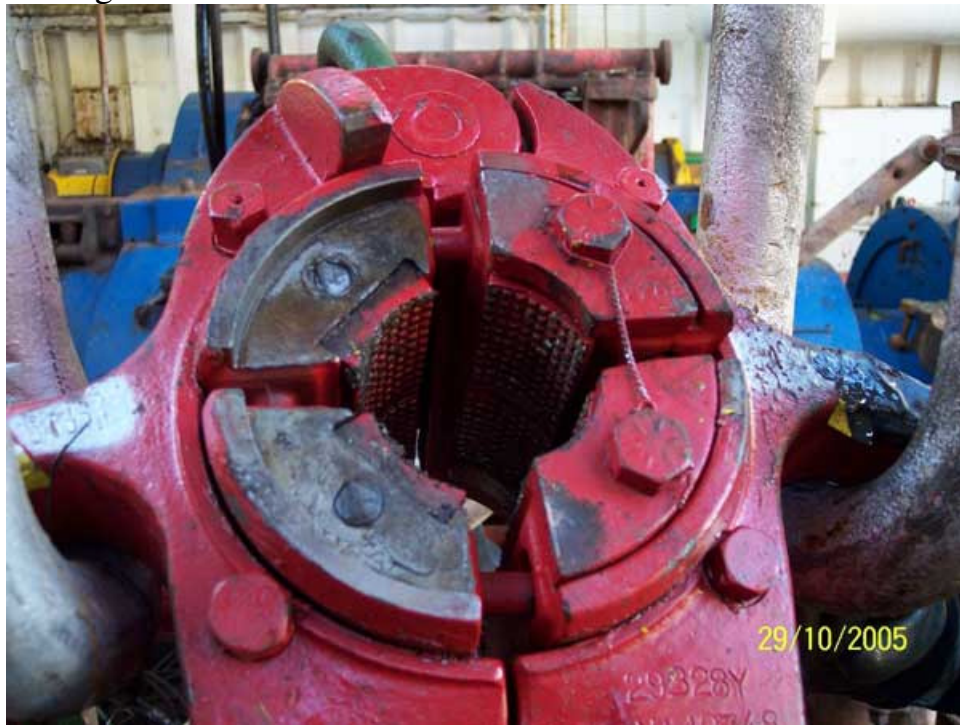
Damaged elevators

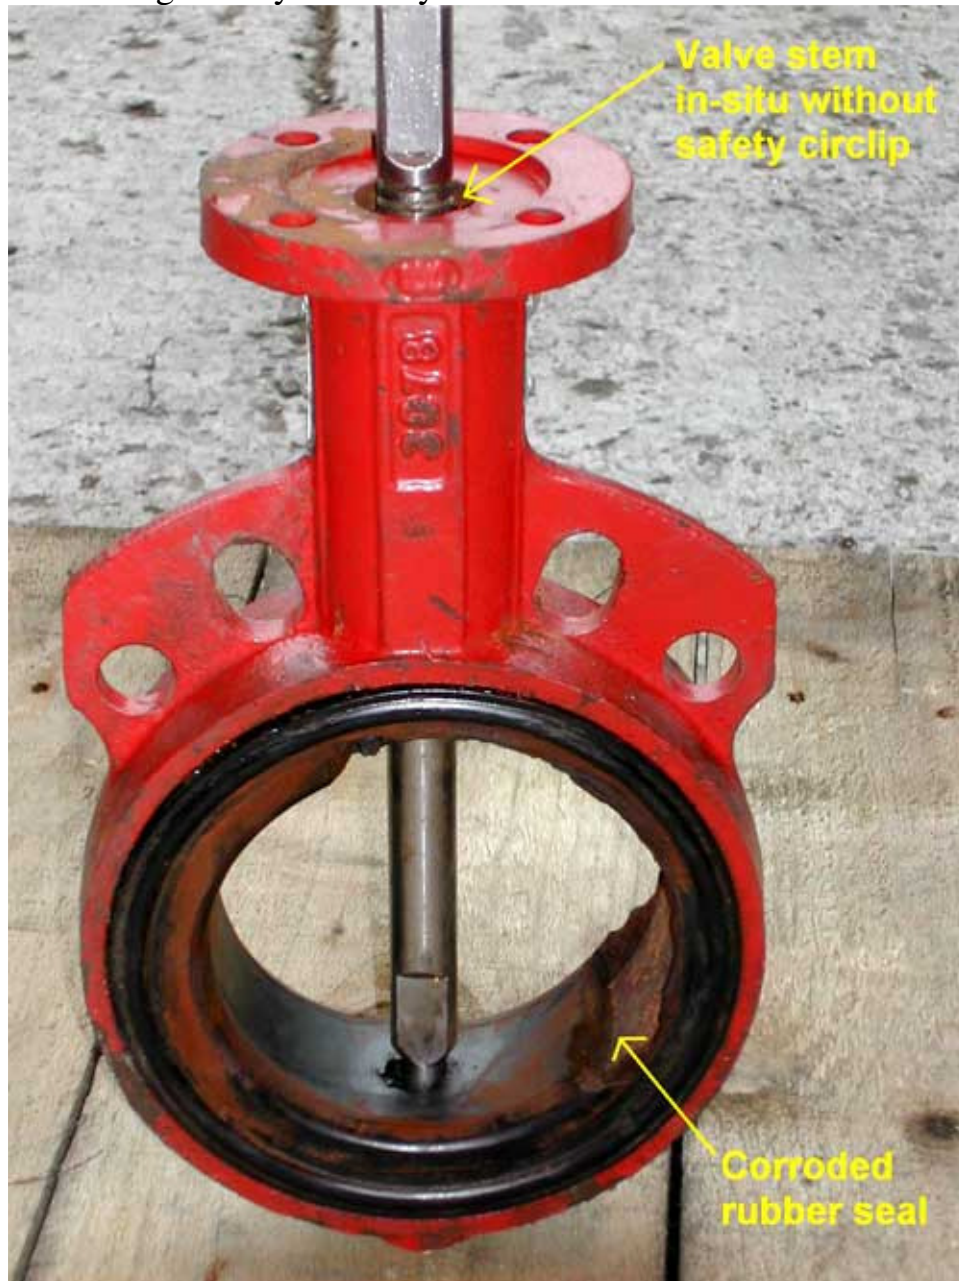
The damaged Bray Butterfly Valve

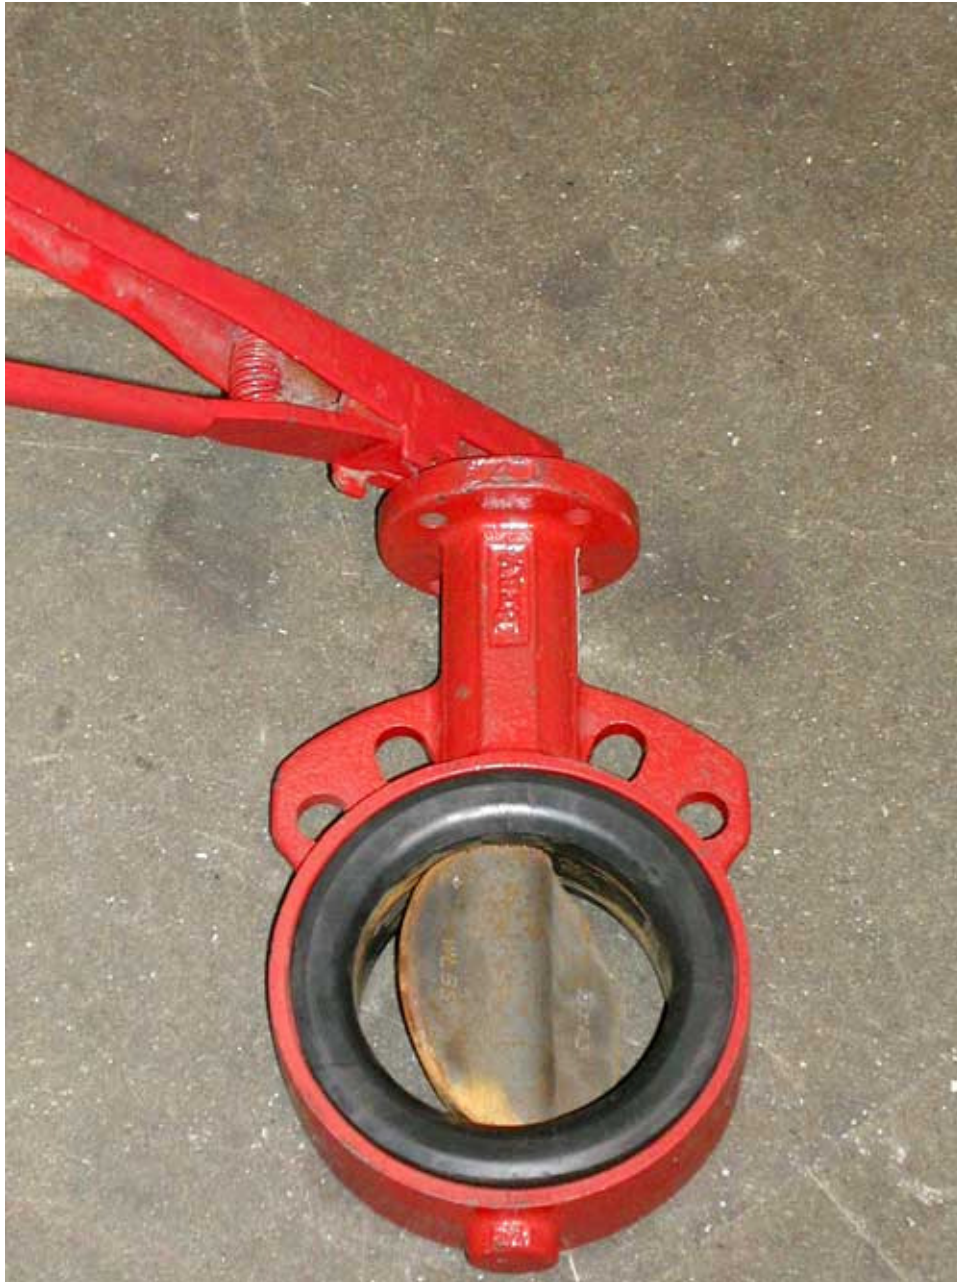
Intact Functional Valve

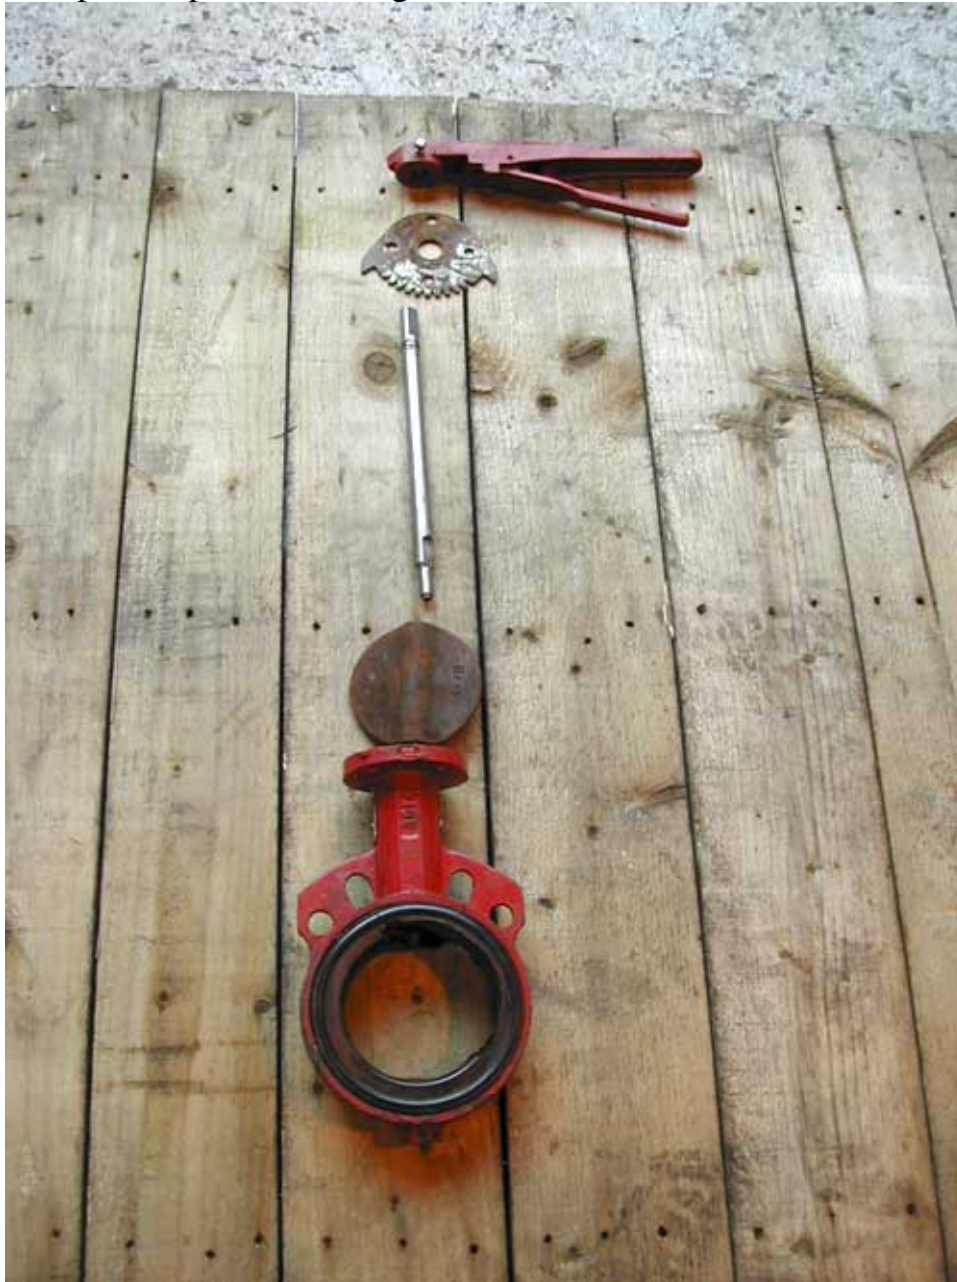
Component parts of damaged valve

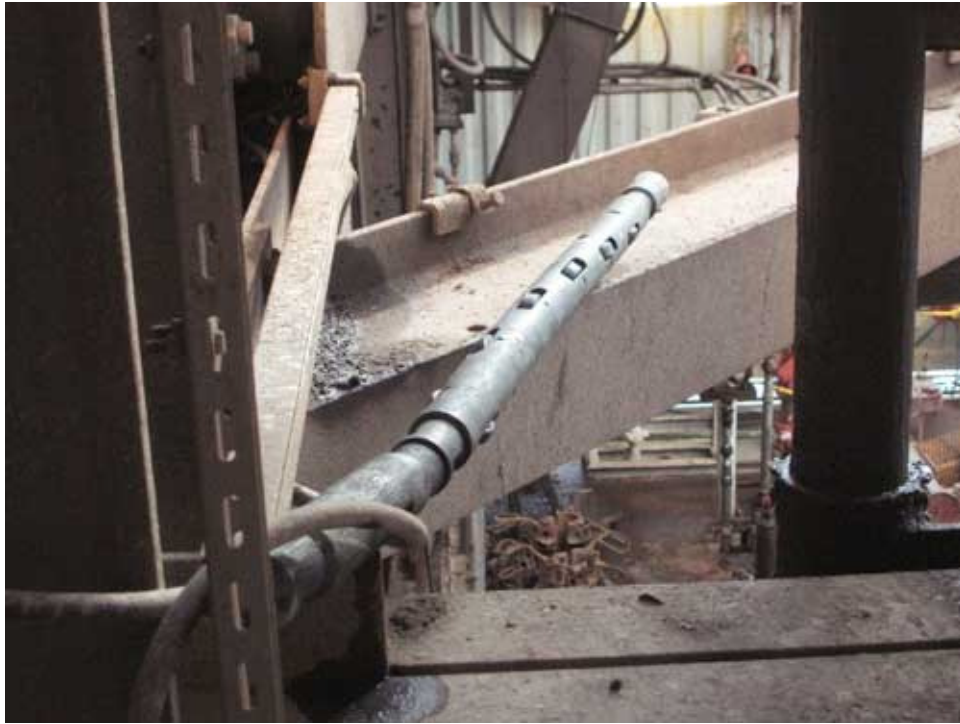
**Tool String lodged in Derrick**

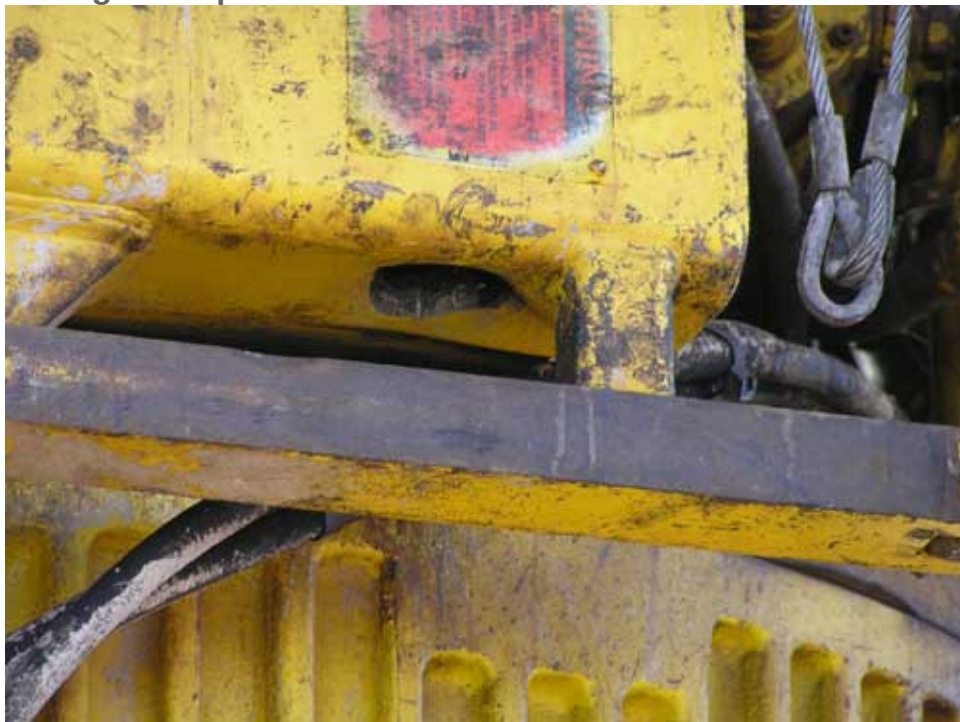
**Damage to Top Drive #1**

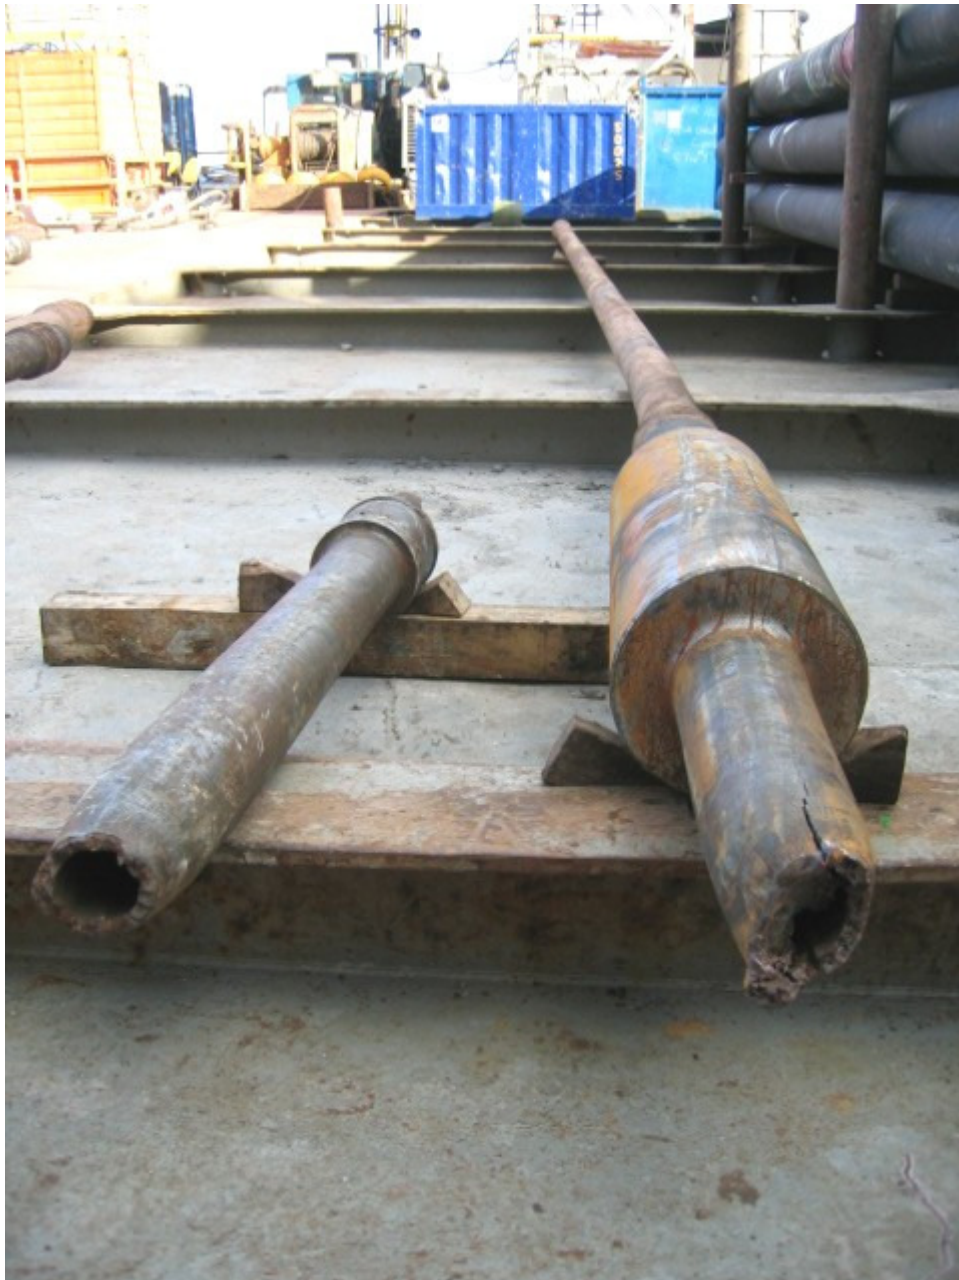
### Failed tool

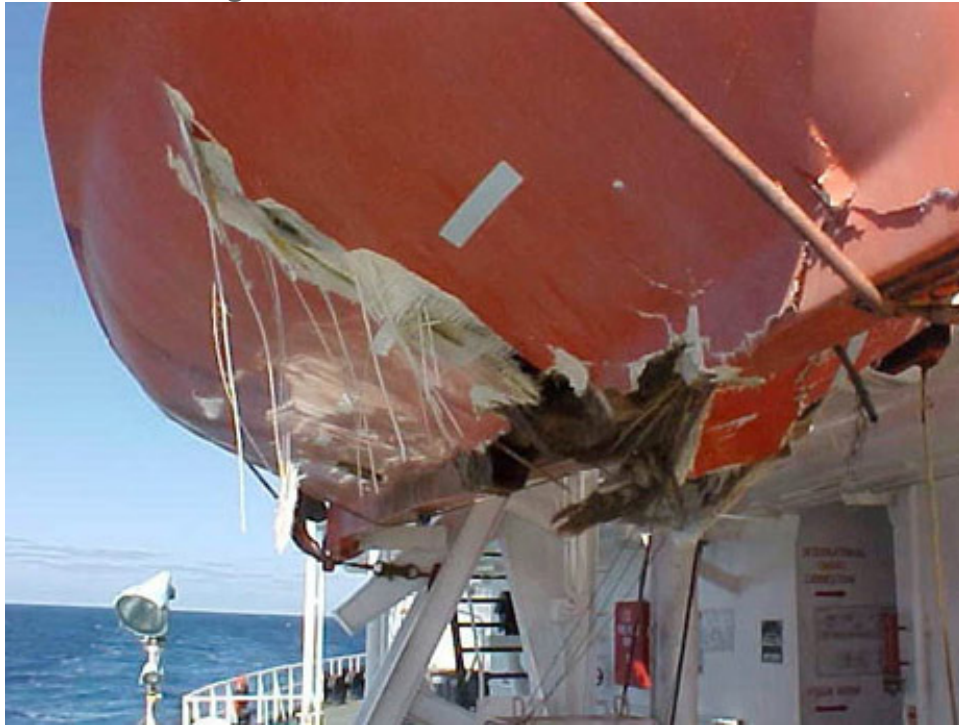
### **Lifeboat Damage**

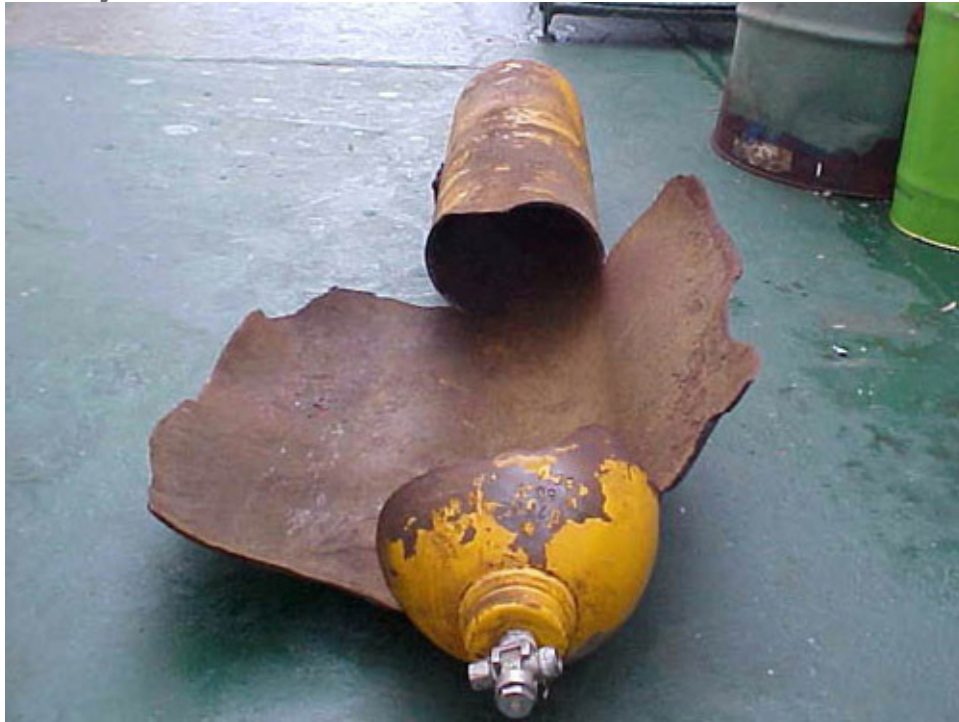
**Gas Cylinder Remains**
