Yoke Failure on Snubbing Unit

SAFETY ALERT

ISSUE #: 15-2011

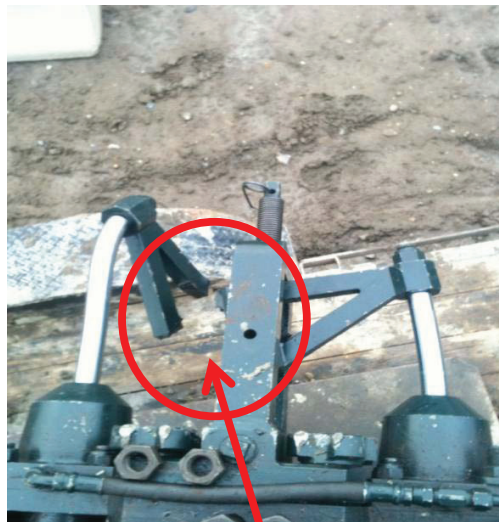
It was then noticed that the lower stripping QRC rams had malfunctioned and did not close properly due to a failure in the operating yoke of the QRC stripping ram breaking on the left side, making it impossible to apply the correct closing pressure to the QRC stripping pipe ram to achieve a seal on the tubing.

- The immediate cause of the incident was the failure of the operating yoke on the QRC.
- The original purchaser of the Rams had requested the manufacturer to modify the original equipment design to improve overall ease of handling, rigging in and rigging out of the BOP.
- The underlying causes of the failure included a faulty design from the manufacturer that did not account for the conditions the QRC was being used.
- A full management of change review was not conducted prior to the changes made to the equipment and assumptions were made about the strength and durability of the operating yoke and QRC.

- The snubbing company has 6 sets of the faulty QRCs and all were upgraded with new, heavier yokes. The yokes that were removed from service were sent for Non-Destructive Testing (NDT) and it was discovered that they were ALL cracked in the same spot.

Broken Yoke

- The manufacturer has been instructed to contact all customers who purchased the QRC's to inform them of the design flaw and remove all smaller faulty design yokes from service pending an engineering analysis on the new design.

- Snubbing operators are advised to add a visual inspection of BOP components to the supervisor's daily checklist.
- Snubbing operators are advised to utilize original equipment manufacturer (OEM) or an OEM approved vendor for BOP service and recertification.
