Safety Alert

From the International Association of Drilling Contractors

ALERT 11 – 14

HIGH POTENTIAL NEAR MISS - DROPPED OBJECT

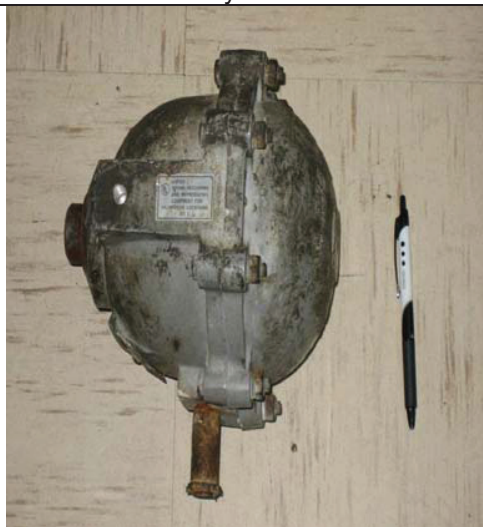
Speaker Assembly

- When speaker was installed in the new derrick it was not secured with secondary retention.
- The unsecured speaker had not been identified by third party derrick inspection as well as rig specific inspections.
- The speaker wire housing / mounting post thread was cracked ¾ of the circumference but could not be seen due to its location which was flush with the junction box.
- The vibrations and shaking of the derrick from the dropped stand retrieval caused the speaker to shear from the junction box.

- Immediately perform a full derrick inspection to ensure placement of secondary retention.
- Develop derrick inspection / secondary retention training to cover proper use of secondary retention, hands on / visual inspections, corrosion, hazard identification and temporary and permanent installations in the derrick.
- Conduct a full derrick inspection once derrick inspection / secondary retention training has been completed.
- Amend the “Derrick Access Log” to advise that all temporary or permanent equipment aloft is required to have secondary retention.

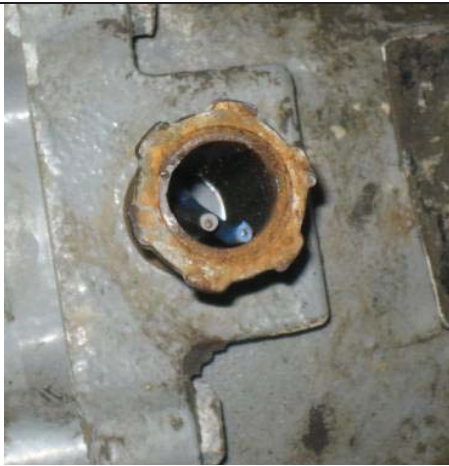
Clean area-no crack or sign of rust. This is what broke and was all that was holding the speaker in place.

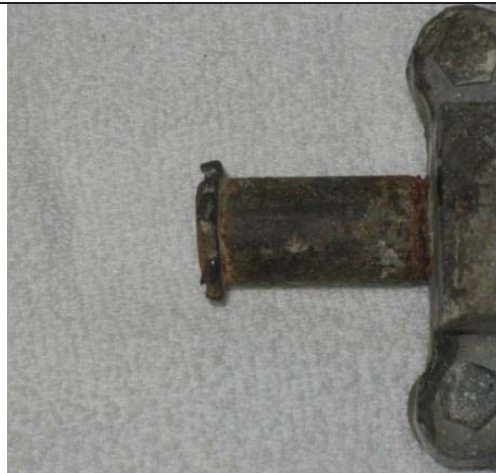
Speaker wire housing / mounting post. This point was flush with the junction box where it broke loose.
