Near Miss Incident Report	NMI/	75/	2011
		<i>(reference number to be filled in by AM)</i>	<i>(year to be filled in by AM)</i>

Date of the NMI:	October 4, 2011
Location:	UOTC (Yangon)
Time of the NMI:	11.30AM
Reported by:	Training Centre Supervisor: Aung Zaw Oo
Witnessed by:	----

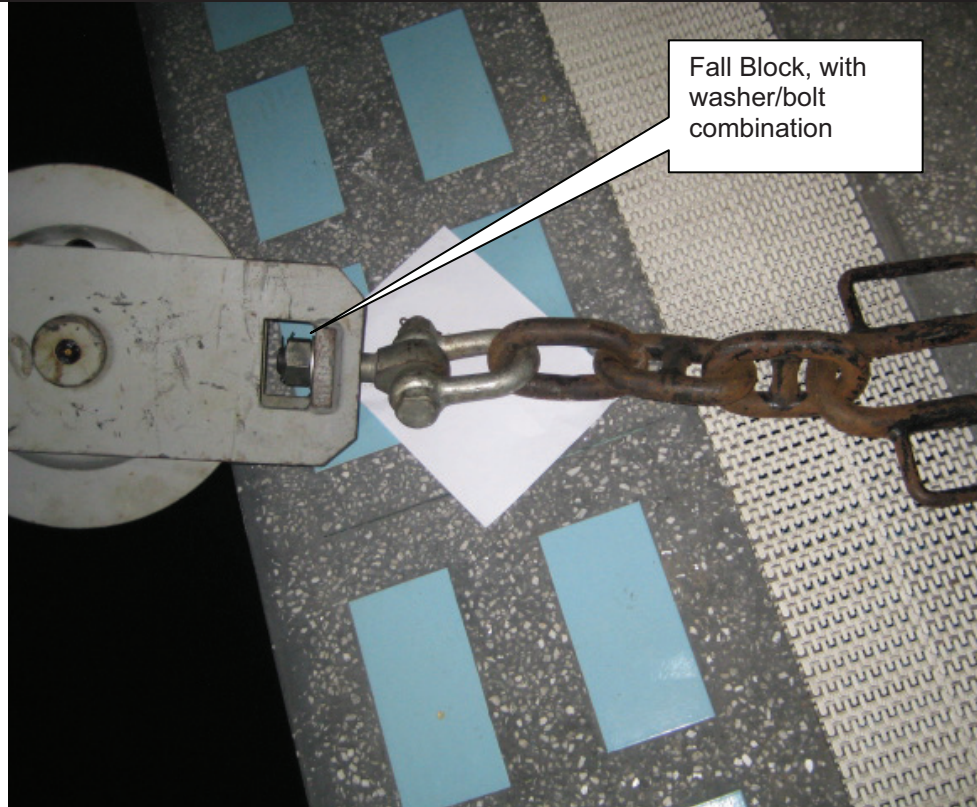
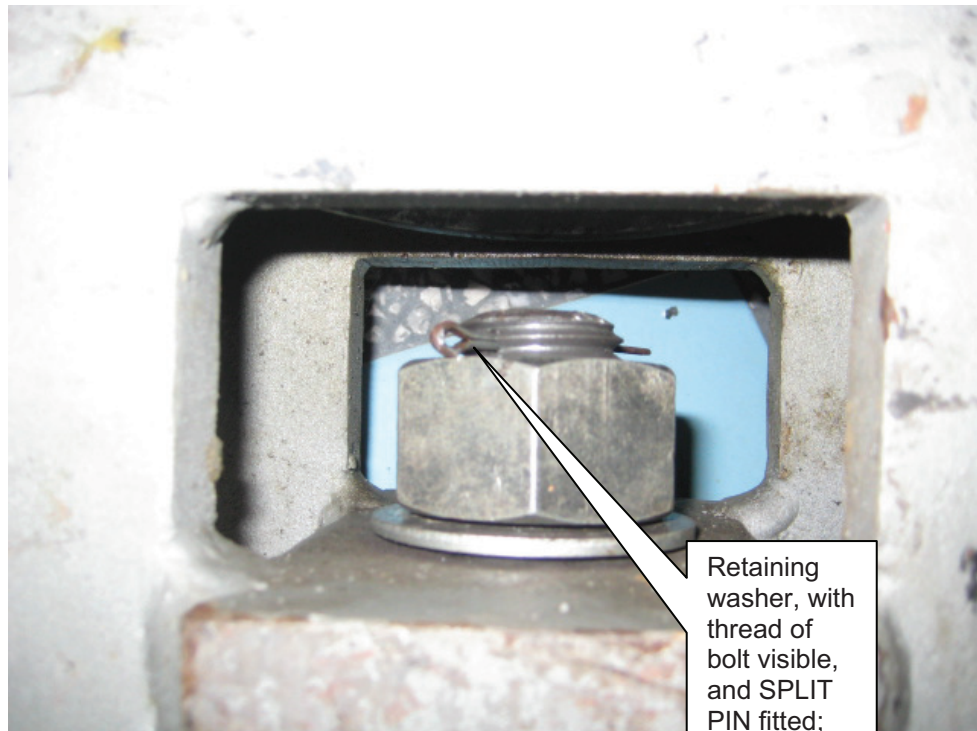
During launch of the TEMPSC during routine lifeboat training, Supervisor in attendance heard crackly intermittent noises. After lifeboat was launched, Supervisor stepped on the foredeck to investigate further. Upon closer inspection of the forward Fall Block, it was noticed that the split pin on the bolt was missing, and the bolt had nearly come out of the retaining washer.

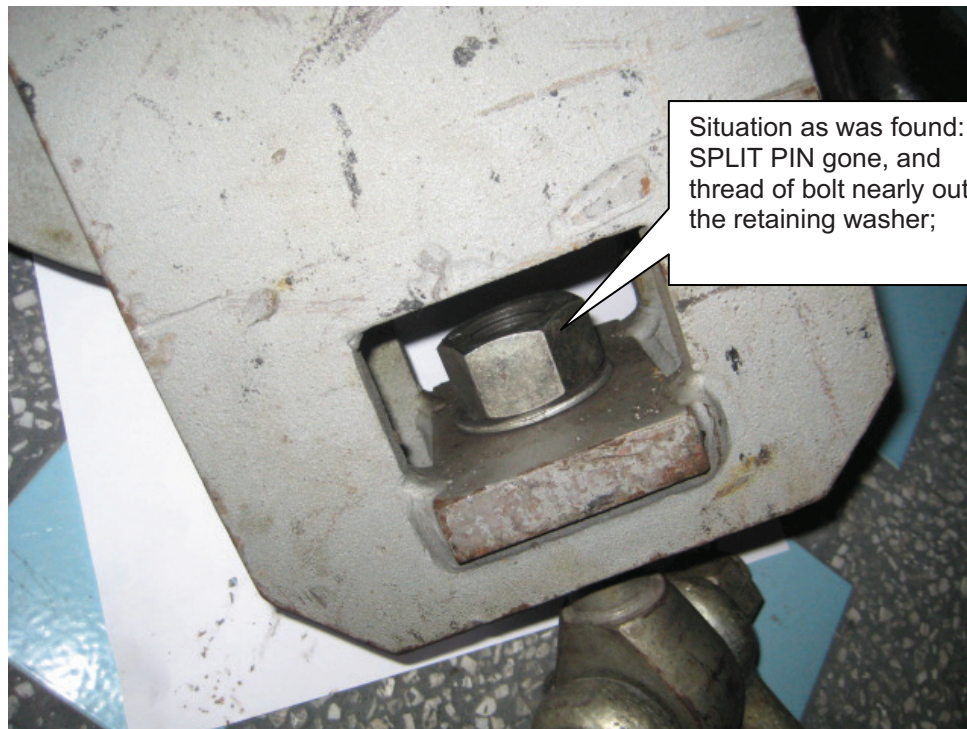
Situation as was found:
SPLIT PIN gone, and
thread of bolt nearly out of
the retaining washer;

Had the bolt come out of the retaining washer, it would have resulted in the TEMPSC dropping and falling down by the head (with the aft wire/fall block still connected), either on the pool deck or in the water. With passengers onboard, this could have resulted in significant (multiple) injury and/or fatality(s).

TEMPSC taken out of service, and barred from further use. Notified Director Offshore, and investigative assembled.

Sourcing new original split pin, and in the meantime temporary split pin installed.

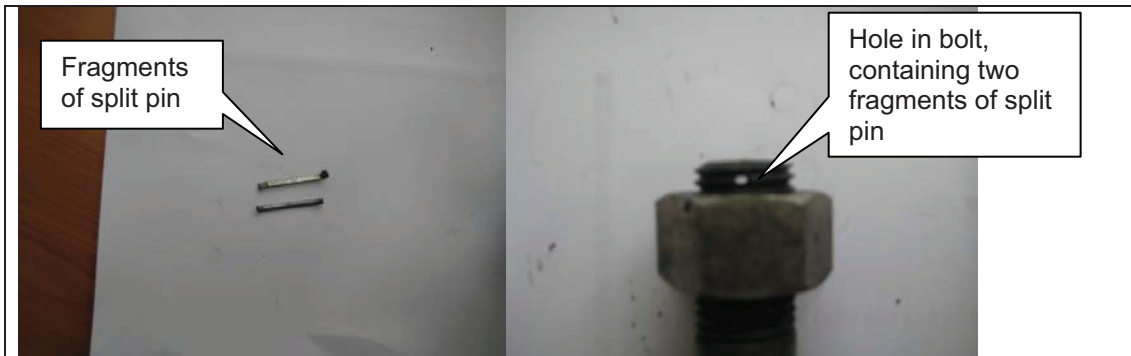
Upon dismantling of the block, two fragments of the broken split pin were found in the body of the bolt:

- 1 Cause of failure of SPLIT PIN cannot be established conclusively; it may be possible, though improbable, that during greasing operations on 22nd of September (quarterly maintenance routines) the split pin got damaged, and the bolt gradually came out during 6 launch/recovery operations of the TEMPSC.
- 2 A more likely cause is that the split pin got damaged during normal handling of the Fall Block (offload) when UOTC staff is recovering the TEMPSC. It has been noted that the Operators shake the Fall Block vigorously to check whether the lifeboat hook has closed properly.

Actions (to be entered in Status Report):				
	Action	Action Party	Close Out Date	Status
1	New SPLIT PIN (original) to be sourced, and installed;	Supervisor	1 st Dec 2011	OPEN
2	PRECOURSE CHECKLIST for lifeboat operations to be updated to include new routine: Check all split pins on TEMPSC and lifeboat davits, prior launch of TEMPSC is authorized;	DO	5 th Oct 2011	CLOSED
3	Consider rigging safety strops through Fall Block and Lifeboat Release Hook, to arrest fall of TEMPSC if washer/bolt combination fails. This is to be carefully considered, as the fitting of safety strop or shackle may cause damage to the SPLIT PIN;	DO/ Supervisor	5 th Oct 2011	OPEN
4	Near Miss Incident to be discussed during forthcoming Safety Meeting, and all UOTC personnel to be instructed to observe new PRE COURSE checklist routines, as well as be alert for unusual noises during routine operations.	Supervisor	15 th Oct	OPEN

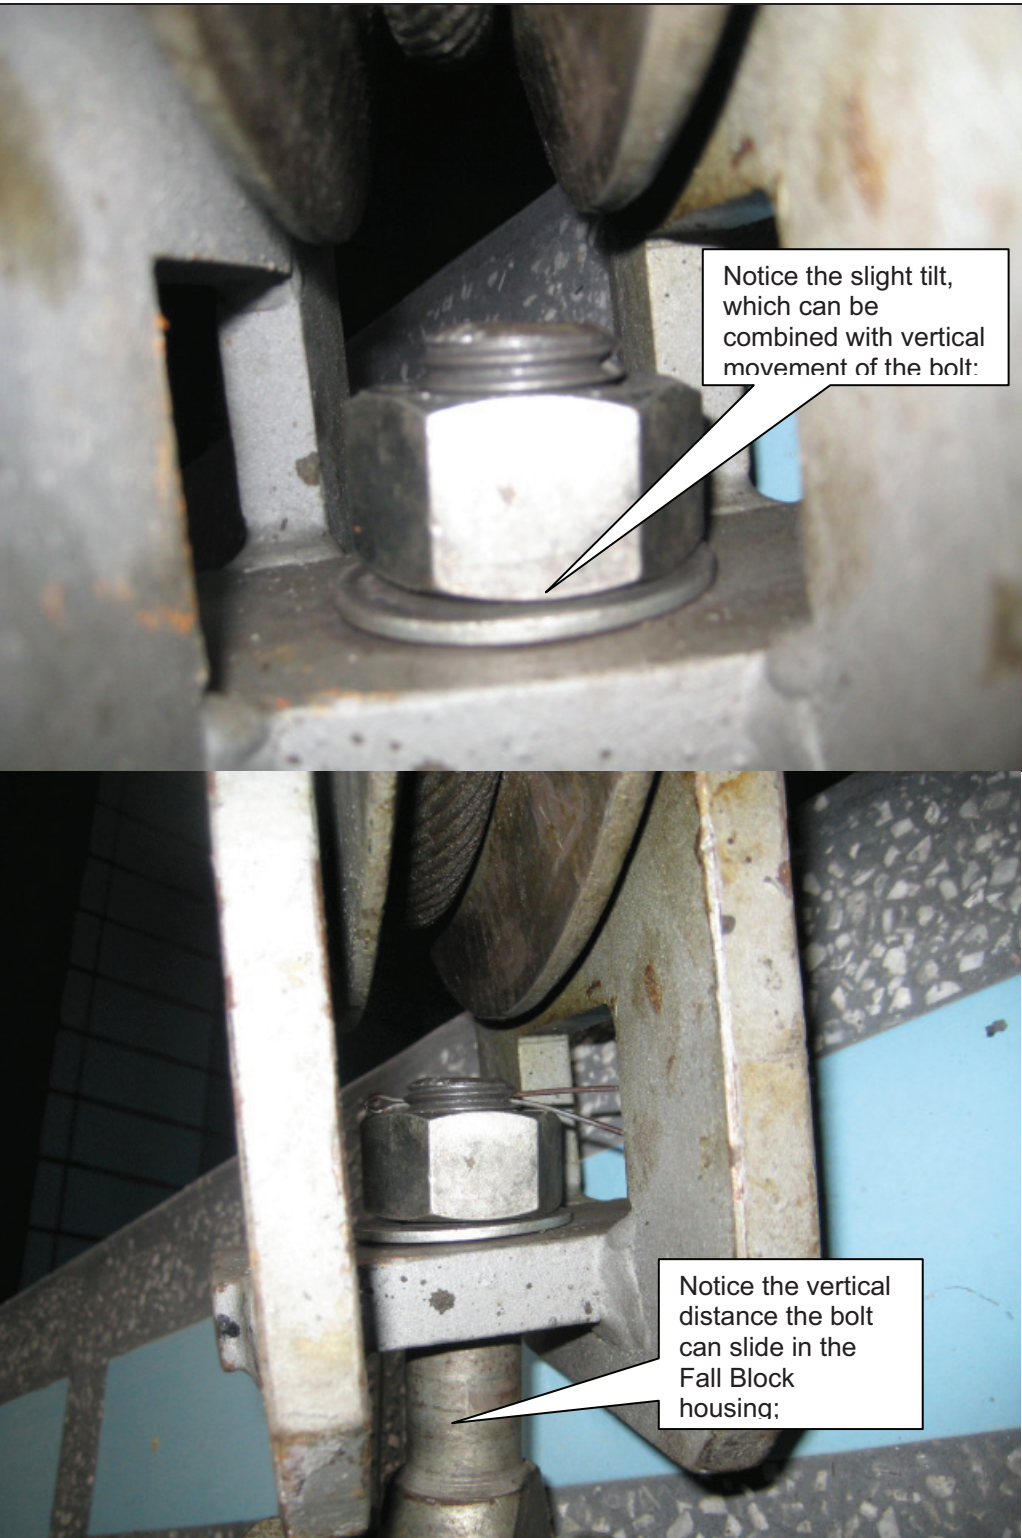
The bolt can slide vertically in the Fall Block, as well as rotate freely. Investigative team also established that bolt can tilt slightly in the housing, and it is possible that the combination of vertical/rotational tilting motion during this vigorous handling caused the split pin ends to make contact with the pulley in the Fall Block housing and disintegrate.

3	<p>It was also observed that during testing of the aft Fall Block and washer/bolt combination, that the washer is very loose and can rotate independent of the bolt. This could have resulted in the SPLIT PIN being damaged.</p>
4	<p>Whatever the cause, this is a NEAR MISS that could have caused serious injury/material damage, and/or loss of reputation/income. Its reoccurrence can be prevented by increasing inspection routines.</p>
5
