SAFETY ALERT

Brushing crystallised product from pipework results in release

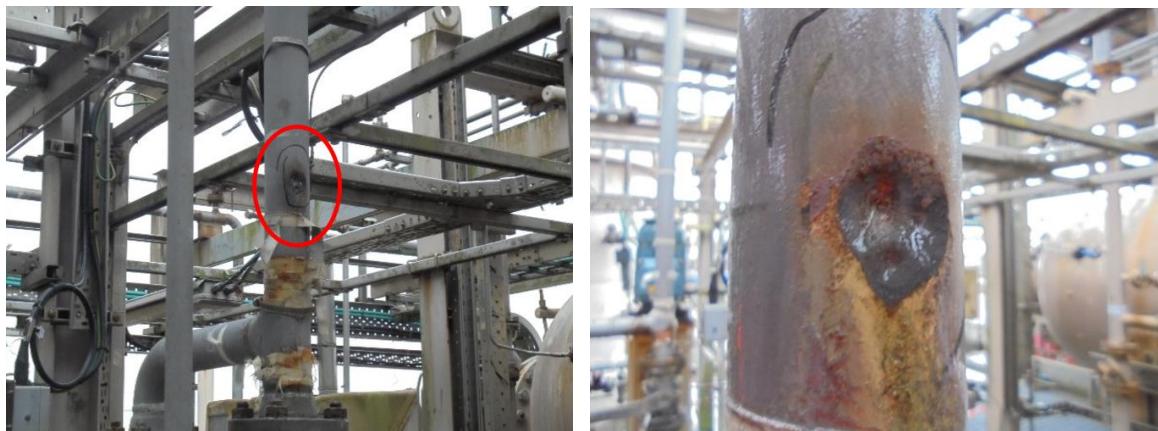
An inspector was conducting visual inspection of pipework within the condensate sweetening unit of an onshore gas terminal, during this inspection an area of external pitting was identified on a caustic line, the area of pitting had a white crystallised substance on the surface which was wiped from the area resulting in a fine spray of liquid emitting from the pitted area, no contact between the individual and the released liquid occurred.

Due to the system being shut-down but not drained down the leak was projected at head pressure from adjacent pipework and vessels.

The area was vacated immediately and made safe by erecting barriers. The line was isolated to stop the emission of liquid and remedial work was undertaken.

- The prevention and control of this type of incident centres around timely inspection and anomaly rectification. Failures of this type will be revalidated using RBI process for piping.

- Personnel must take care whenever any contact is made with pipework that is suspected of having surface corrosion, and specifically if any material is to be removed in order to facilitate inspection.
