SAFETY ALERT

Gas leak from a manual ball valve (adjacent to a grease injection channel)

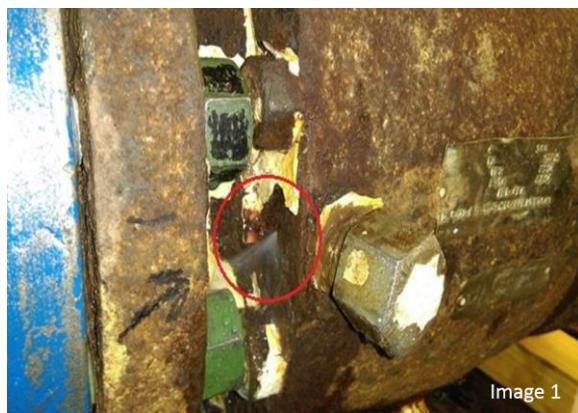
During normal operations, a gas leak was detected and traced to the failed valve. The plant was shut down and the valve was removed for further investigation.

Image 1: the failed valve during onshore hydraulic test, to show the leak location.

It is recommended that this alert is used to review inspection and fabric maintenance procedures for valves, highlighting the possible risk of areas of low wall thickness by design and therefore potential additional hazards during mechanical preparation for painting.

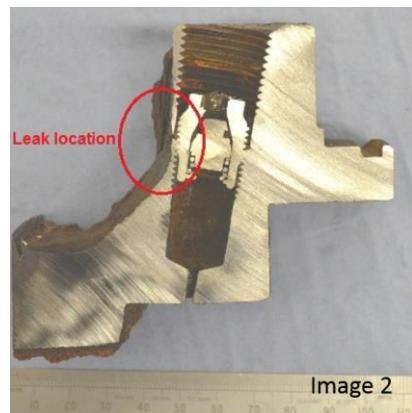
The investigation revealed that a leak had occurred on the flange adapter (see Image 2). The leak site was adjacent to a grease injection channel drilled into the flange adapter. The investigation revealed that the grease injection channel was drilled at an angle to the flange adapter, and not orthogonal as shown in the original general arrangement drawing for the valve.

It was confirmed that the angled drilling was as per original supplier design, and the original wall thickness at the location of the leak was estimated (by the operator) as 1.5-2.0 mm only. The wall loss from the valve, due

to external corrosion, was estimated at 0.5-1.0 mm overall. The angled grease channel was confirmed to be standard detail for full bore valves up to 12".

It was identified during the investigation that this arrangement presents an inherent area of low wall thickness on the valve (by design). This threat had not been identified in the maintenance or inspection programme.

Image 2: a section cut through the valve at the leak location, showing the orientation of the grease channel and the low wall thickness of the flange adapter local to the grease channel. Note that the grease injector shown in Image 1 has been removed in this photo.
