SAFETY ALERT

Gas release due to failure of incorrect seal ring material installed on clamp connector resulting in galvanic corrosion

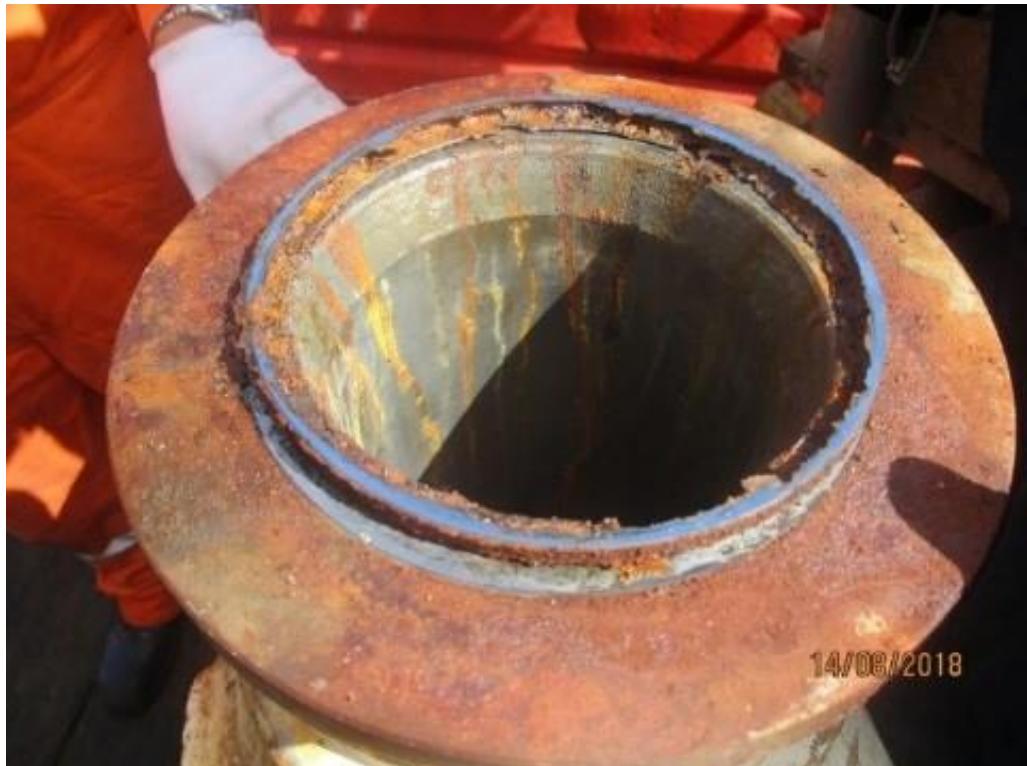
It is believed the seal ring was installed as a carbon steel material specification approximately 15 years previously during a well work-over program in 2002. The seal ring lost a significant amount of material thickness due to internal CO₂ and galvanic corrosion at the carbon steel to stainless steel interfaces, resulting in a perforation of the ring and gas release from the Christmas tree.

The potential consequences of installing an incorrect material specification seal ring gasket can lead to catastrophic in-service failure and operators should ensure proactive projects are in place to identify all clamp connectors, ensure that associated seal rings are to correct specification and remain fit for continued service.
