# SAFETY ALERT

## Gas Release from HP Compressor Valve

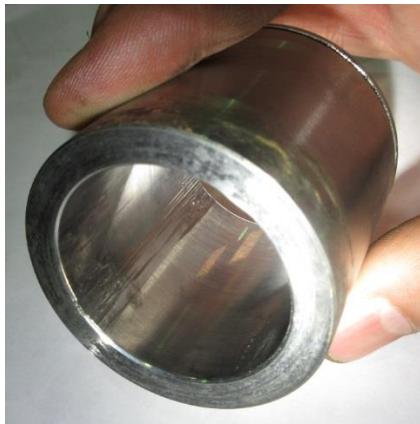
The valve stem and the gland follower (photo above) were found to have been damaged. Packing damage and ejection was noted at the time of the release.

The valve stem surface was scored/galled longitudinally in an area consistent with gland follower contact. The follower was also found to have deep scoring. As the valve moved through its stroke this area of roughness contacts the packing resulting in packing damage and opening a gas path resulting in leakage. The cause of the failure was found to be from the misalignment of the gland flange, verified by a series of tests.

It was concluded that the gland nut was adjusted unevenly resulting in misalignment. The current gland area design has little tolerance for gland follower misalignment and does not have any means of visually identifying lack or uneven pre-load on the gland follower.

Root causes of gland follower not tightened evenly:

- This is a manual task, completed without reference to manufacturer guidance or local procedure
- Gland follower position tolerance was not known, and was lower than new valves due to the follower design
- Personnel competence to perform this task was based on trade skills, rather than specific valve packing adjustment training
