## Lifeboat launch capability compromised

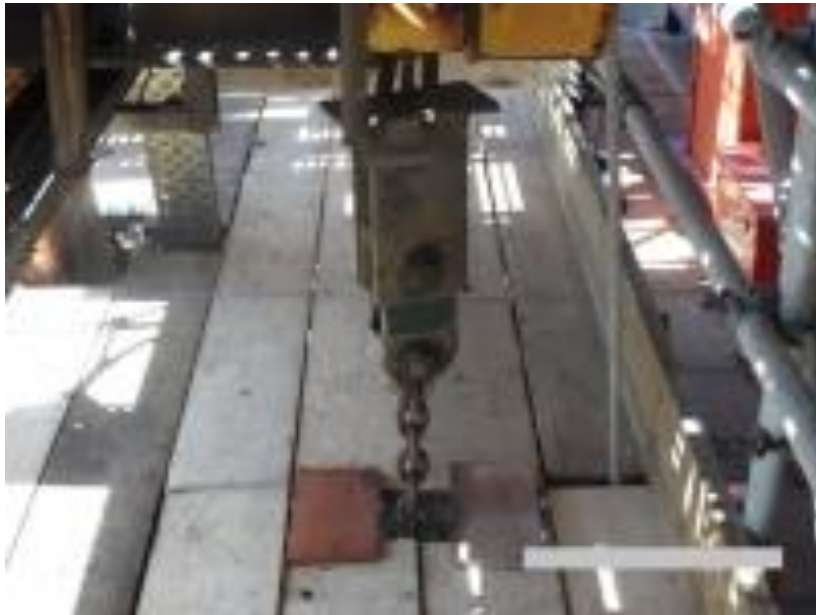
Inadequate implementation of **hazard identification** process

Scaffolding had been erected to allow safe access for vendor personnel access to surrounding structure. This involved **erecting scaffold in close proximity to the lifeboat**. During a worksite visit it was noted that the scaffold had been erected around the winch chain on the aft end of the lifeboat.

It was identified that **the opening left to allow the winch chain and winch block to pass through was significantly smaller than the winch block itself**, thus compromising the launching capability of the lifeboat. On the underside of the scaffold boards there was a scaffold pole support that would also have impaired the descent of the lifeboat.

During work preparation it is good practice to consider Major Accident Hazard implications and change management. In this case, **impairing the functionality of the lifeboat had not been fully considered** by those involved in the preparation for work risk assessment.
