# SAFETY ALERT

## Lifeboat manual winch crank handle

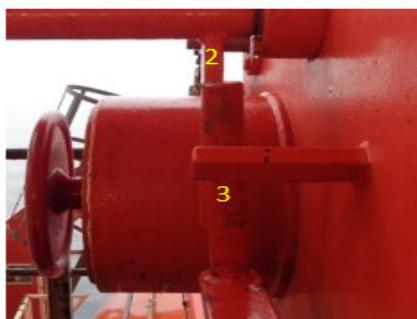
During routine maintenance, it was found that the manual winch crank handle of the lifeboat was misaligned due to a bent stowage bracket which prevented full rotation of the handle. This would have prevented the remote launching of the lifeboat by the Coxwain.

- Misaligned manual winch crank handle (3) due to bent stowage bracket preventing full rotation of (2) and remote lifeboat release
- Correctly aligned manual winch crank handle (3) allowing full rotation of the remote lifeboat release (2)
