# SAFETY ALERT

## Release of compressive load in volute spring resulting in injury

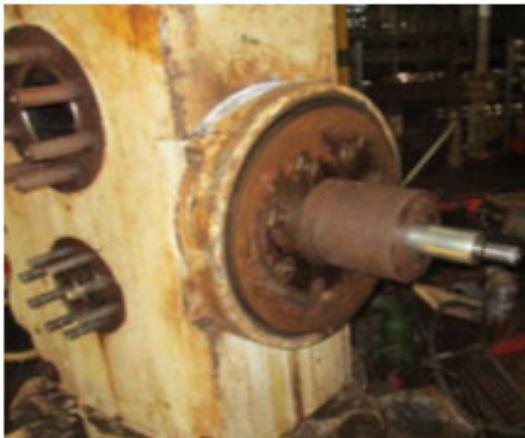
*Photograph of tree without volute spring, cover and retaining nut offshore post incident.*

During the use of an air driven impact wrench to remove the valves stem nut, the nut released after shearing off the last two threads, thereby releasing the stored compressed energy of the volute spring. This resulted in the technician who was standing directly in front of the spring, to be thrust backwards thereby sustaining injuries.

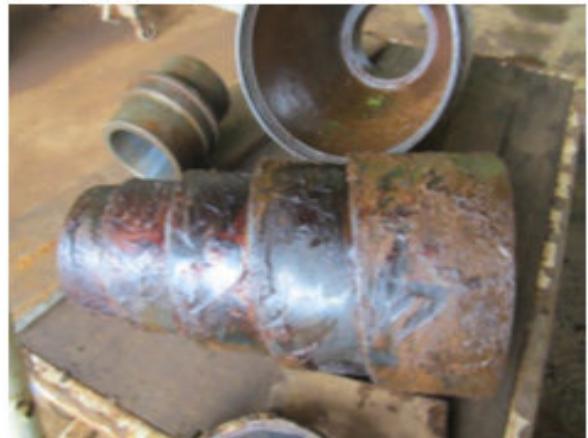
*Photograph of Volute Spring and Housing (right rear) offshore post incident.*

This actuators assembly is a discrete unit which contains a pre-compressed volute spring which enables the valve to operate as failsafe. During the removal of the actuator, the housing became separated exposing the compressed volute spring with the load contained by the valves stem nut.
