SAFETY ALERT

Rope Access Harness Incident

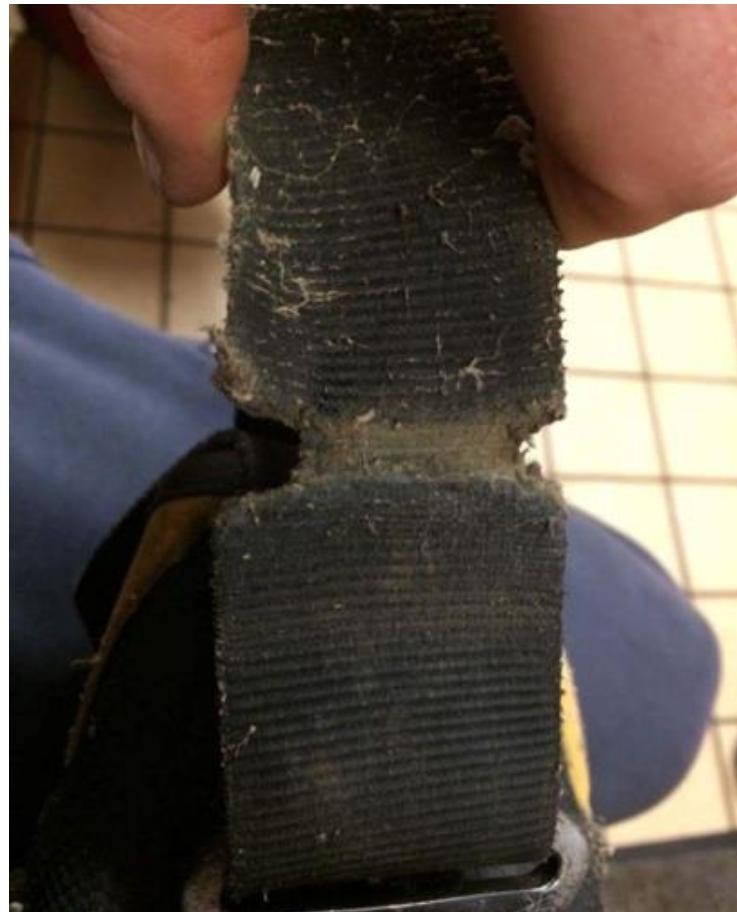
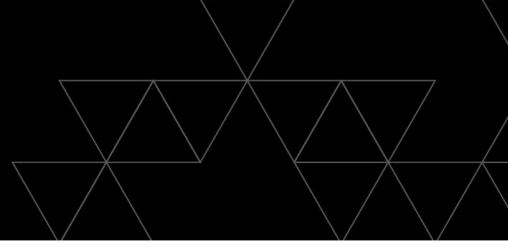
On day 14-to-15 the work party technician noticed at the end of the shift that his harness was badly damaged.

Based on witness statements, the harness became damaged by continual rubbing against the rough concrete wall of the leg.

The root cause of this incident comes down to failure to identify the hazard (tight access and abrasive concrete wall) and failure to consider that the harness may rub against the wall (job planning and risk identification).

- Recommend regular site surveys
- Better hazard awareness and understanding by all
- Pre-use equipment checks before each shift
- Regular communication with all staff involved
