SAFETY ALERT

Top Drive damage – drilling operations

Drill floor operations – Top Drive

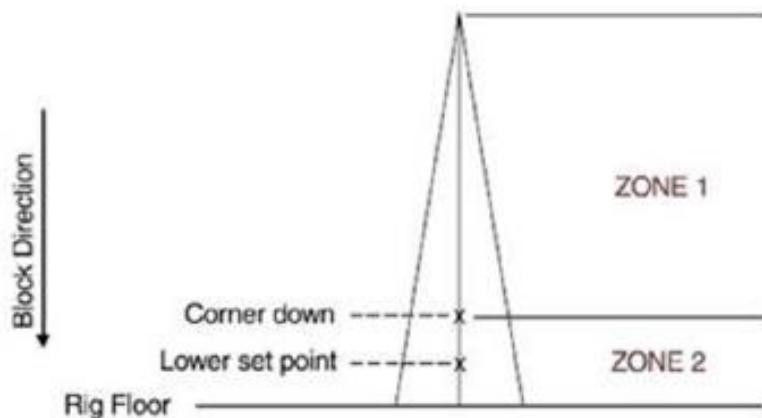
Fig. 1: Drilling down braking zones

For ongoing drilling operations the drilling control system (Electronic Drilling System - EDS) is set to drill down mode. When EDS in this mode, a Lower Set Point prevents the blocks from being lowered below a safe working height.

Due to the Lower Set Point being set incorrectly, the drill string was lowered until the elevators made contact on the drill floor. The drill string continued to move down until the rotating splines on the IBOP came into contact with the stationary splines on the torque tube of the PH85 pipe handler.

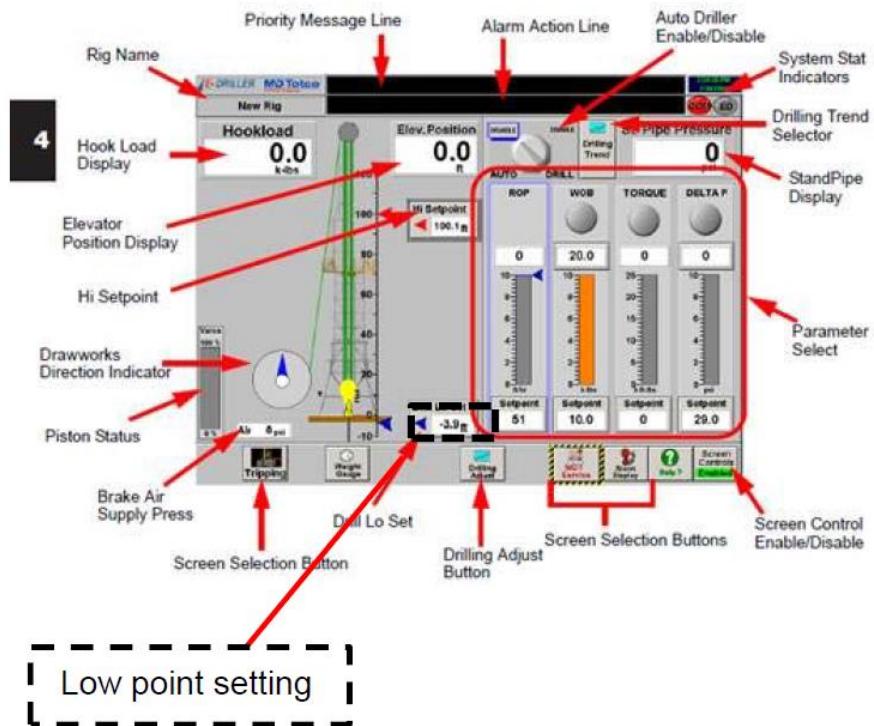
Figure 2: EDS Drill Down Screen showing low height set point

- The Lower Set Point was set incorrectly; therefore it did not prevent contact between the torque wrench and elevators
- The OEM Operating Manual and Work Guideline did not provide clear instruction on how and when to set the Lower Set Point
- The Operator failed to notice contact between the torque wrench and elevators
- The Supplementary Equipment Check sheets do not adequately address working with drilling control systems on partially mechanised rigs
- The operator on the brake at the time of incident became distracted at a critical part of the drilling operation. A lack of awareness by the operator of the risks of being distracted was evident.

Historically, low point settings in drill down mode have been left to the sole discretion of the driller to alter depending on drilling. More defined parameters and management of change (MOC) process required.

- Review and update work guidelines to provide defined and clear instruction on setting working parameters on drilling control systems
- Review and update competence system to provide robust assurance on setting working parameters on drilling control systems
