SAFETY ALERT

Potential dropped object due to unsecured door

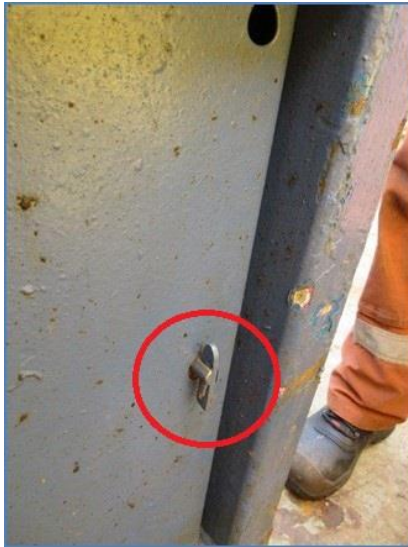
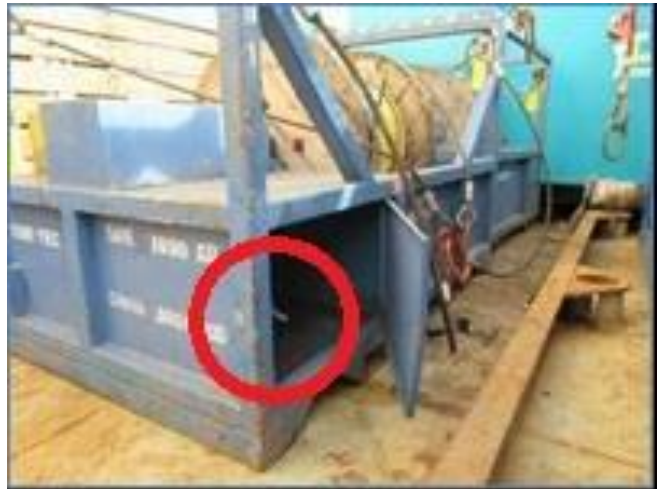
During a lift, the storage door had opened which revealed a small tool box inside which was not secured

- The Antiluce drop lock had no means of secondary retention during transportation
- Inconsistent approach to implement best practice across all workshops
- No prior industry alert sourced for similar occurrence

- Implemented secondary retention solution
- Raise awareness at morning briefings and safety meetings
- Ensure final release inspections cover all secondary retention areas on equipment
