# SAFETY ALERT

## Rope Access Team Member Inadvertently Entered Sea

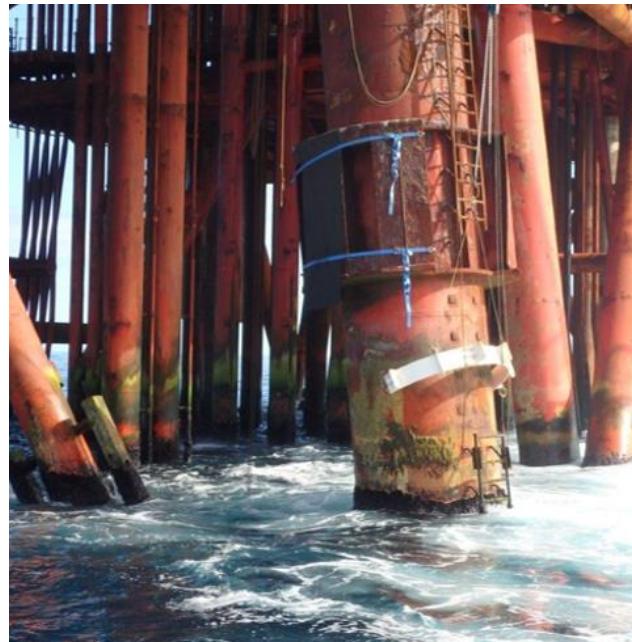
The first section of clamp had been successfully lowered into position below the leg mooring ring.

One team member ascended to the spider deck to prepare the second clamp section for lowering, leaving one over-side team member on the mooring ring.

The first team member partially rearranged one of the ropes to improve access for lowering the second clamp section.

The second team member remained on the mooring ring and positioned himself to access a chain block, changing over ropes to do this.

The second member transferred onto a rope loop, which unravelled when full weight was applied, resulting in an unplanned descent from the mooring ring onto the water surface.
