CATASTROPHIC FAILURE OF MUD CENTRIFUGE

ALERT 5-20

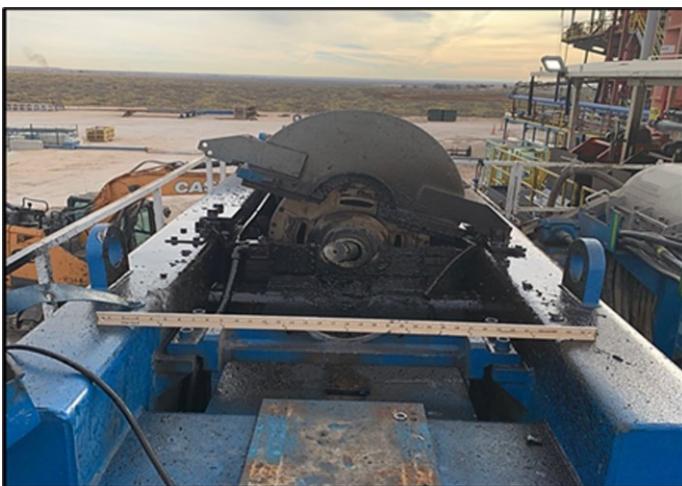
Fig. 1 - Failed Centrifuge

While processing drilling fluids, a mud centrifuge (Fig. 1) experienced a catastrophic failure resulting in the ejection of the pillow block bearing assembly. The 65 lb. assembly traveled approximately 190 ft before striking the steps of a living quarter trailer (Fig. 2). The gearbox, back drive electric motor, coupler and associated components were also dislodged from the frame but remained within the confines of the centrifuge platform.

- Inadequate maintenance at third-party facility
 - Three of twelve gearbox adaptor flange bolts installed at a third-party maintenance facility were found to be of insufficient length
 - Fit between hub and gearbox flange that had been incorporated into this machine to reduce torque on the flange bolts had been machined out, without consultation with OEM
- Vibration sensor on unit was non-operational
- Protocols for verifying and maintaining bolt torques were inadequate
- The gearbox restraint system was inadequate and did not prevent dislocation of the gearbox from the confines of the frame

- Functional verification of safety critical sensors should be conducted before utilizing any piece of machinery
- Implement torque verification protocols during routine maintenance
- Consider installation and verification of effectiveness of secondary restraints on exposed rotating components
