Safety Alert

From the International Association of Drilling Contractors

ALERT 13 – 26

FAILURE OF LIFTING EYEBOLT RESULTS IN DROPPED OBJECT

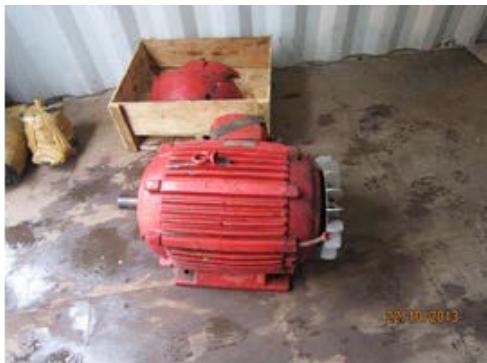
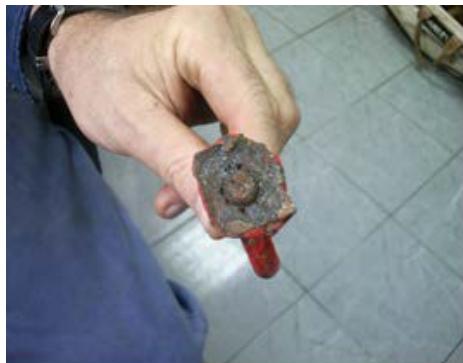
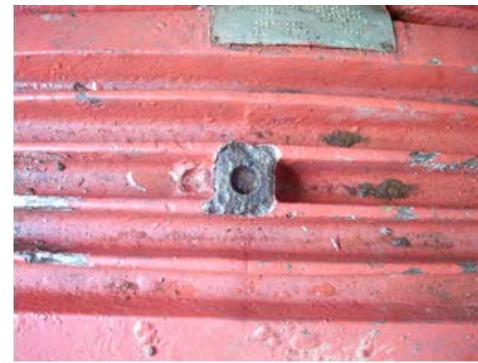
The deck crew was attempting to move an electric motor weighing approximately 200kg (440 pounds) from the shelter deck into a sea container. The motor was lifted using a crane. The banks-man signaled the crane operator to pick up the motor and lift it to the container, which was 5 meters (16 feet) away. The motor was lifted and moved to a height of approximately 2.5 meters (8 feet). When the motor approached the container at a height of about 60cm (2 feet), two roustabouts entered the container to position the motor from inside using taglines. As the motor was being pulled into the sea container it tapped the wall of the container. The motor casing parted at the eyebolt anchor mount allowing the motor to fall to the floor. The crane operator stopped the job and informed the Supervisor. No personnel were injured.

- Failure of the lifting eye.
- The motor had been in storage for a period of approximately 5 years. It was identified during the investigation the lifting eye had previously parted and had been welded to the frame of the motor at an earlier time by persons unknown. The implications of this were not realized by the crew and they thought that they could safely complete the task. The eyebolt had not been included in the lifting gear inspection routine.
- The motor had been painted and the lifting eye looked to be in good condition.
- Lack of knowledge by the deck crew to identify the hazards associated with previous failures of lifting eyes, and the fact they should never be welded.

- Rig crews were instructed to remove all lifting eyes from motors in storage and on location and replace the eyelet with a suitable bolt that conforms to the thread pattern of the motor.
- If eye bolts are to be utilized, rig crews were instructed to include the lifting eye bolts on the lifting inspection registers and routine maintenance inspections.
- All crews were advised of the previous alerts on lifting eye failures and inspection requirements.
- All personnel were reminded that lifting eyes are to be utilized for final positioning only. Electric motors are to be placed inside a designated basket for movement around the rig or they are to be slung by deck crew.
- Rig crews were reminded that lifting eyebolts are designed for final positioning on mounting brackets/foundation only and should not be utilized for overhead lifting and transport.
