# Flange failure due to incorrect tool used to set flange

**SAFETY ALERT**

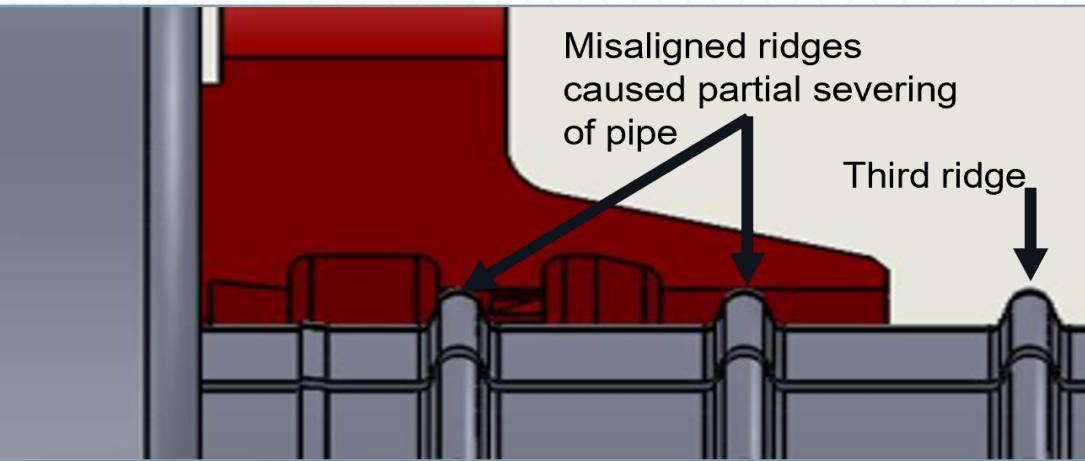
- Incorrect tool had been used to set the flange.
- Incorrect tooling alignment created stress raisers in the pipe and within the weld-neck area, out of the supported area of the flange.
- Incorrect pressure was applied during the installation, causing partial severing of the pipe - 700 bar pressure used for the tool, correct for tool but well above the pressure for the flange type (460 bar).
- Large dilation of the flange and pipe, plasticity deformed due to over pressurisation of the joint.

Above: close-up of incorrect tool and groove alignment, third ridge on tool outside the flange. NB. Pipe removed for clarity.

- Ensure the correct tool is selected for the job.
- Understand the operating limits of plant and equipment and stay within them.

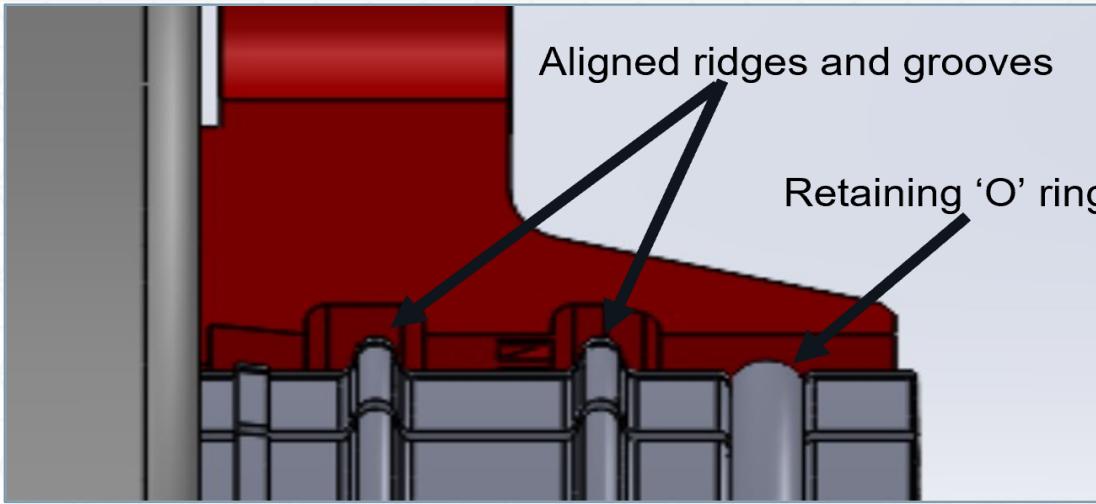
Above: close up of correct tool and groove alignment, note no ridges outside the flange. NB. Pipe removed for clarity.
