**High Value Learning****Gas leak from perforated closed drains line due to simultaneous operations****Who could be interested in this?**

# HIGH VALUE LEARNING

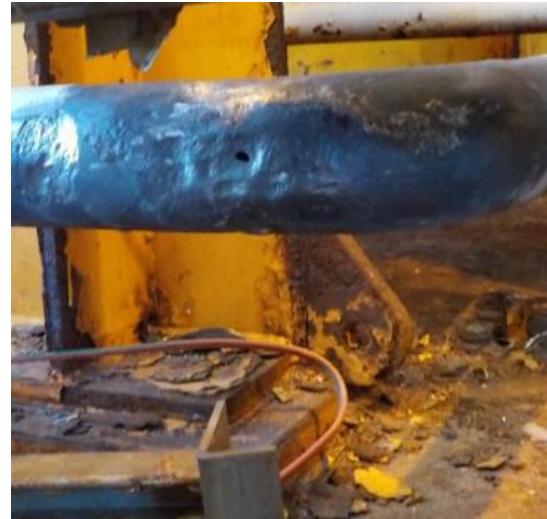
A 2" closed drain line was subject to bristle blasting in order to allow further inspection & fabric maintenance.

Before work commenced the line was subject to an assessment by the onshore Technical Authority and it was confirmed as safe to bristle blast. However, the assessment was undermined as the corrosion scab height had been constrained by an adjacent unistrut, which also introduced a galvanic corrosion mechanism.

The line had been previously isolated from the upstream production separator, but it was not possible to apply an isolation downstream toward the flare header. The work permit however did not identify the potential risk of backflow to this section of line or consider the 'what if' scenario if the line was holed during the work. When the line was subsequently perforated, it was then ineffectively reported to the site management team thus preventing a timely response and assessment of the risk to take place.

As a result, a well was lined up to the flare knockout drum in order to stimulate production. The resultant gas flow into the flare header raised the back pressure resulting in a gas release from the hole created by the bristle blasting.

- Consider whether your live blasting assessment would have highlighted the above issues which compromised the onshore evaluation.
- Consider whether adequate consideration is given to simultaneous operations and system backflow in permit development and review.
- Consider whether permits clearly communicate the actions to be taken to cover the 'what if' and that work parties are clear on the importance of clear, effective communication should a line be perforated during surface preparation operations.
