**High Value Learning****Gas release from a newly completed well****Who could be interested in this?**

# HIGH VALUE LEARNING

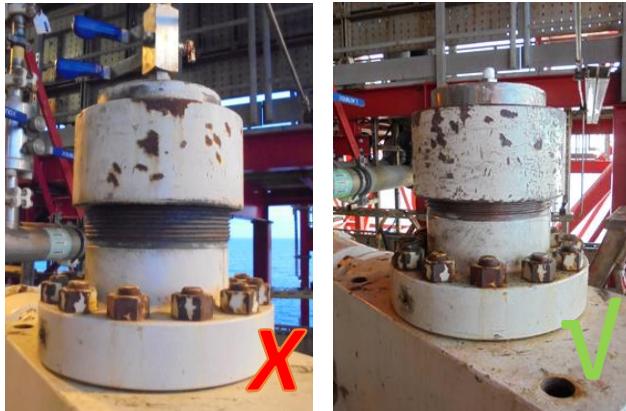
The investigation found that the incorrect assembly of the tree cap resulted in damage to the O-ring and led to its failing to seal as intended. Up to the point of the gas release the incorrect assembly had not been correctly recognised due to the successful pressure test.

When the tree cap is correctly assembled the cap's plug is fully engaged, the collar is screwed on with only 1-2 threads left exposed, and the O-ring is correctly placed in the tree cap's seal-bore.

If it doesn't look right, it probably isn't right. If you see something, say something. If you are not sure, ask for advice.
