High Value Learning

Hydrocarbon release and spill to sea from a newly installed control valve stem packing after a very short operation life

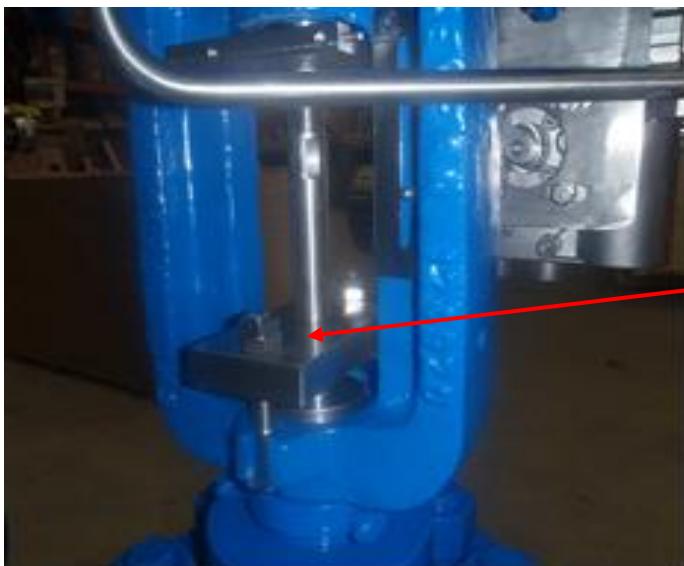
Valve stem packing assembly

The control valve gland plate loading bolts and nuts became detached from the valve, leading to a loss of containment at the valve stem packing gland. The evidence suggests that the lock nuts were not tightened when the valve was brought into service and there was no record of any checks being carried out.

As the valve had been tested at high pressure onshore as part of the procurement process, the technicians who installed and stroke tested the valve were not aware of the requirement to check the adjustment of the packing assembly. Hence, the gland packing retaining bolts/nuts were not tightened prior to putting the valve into service.

The net effect was that the actual flow rate through the combined pump recycle pipework was excessive which led to flow-induced vibration in the export recycle pipework. The vibration was then transferred to the recycle valves which led to the packing assembly nuts unscrewing on the new control valve and the subsequent loss of containment.

- Consider if your processes for installation, testing and recommissioning of control valves ensures that gland packing assemblies (including lock nuts) are checked by competent technicians at the appropriate time throughout the reinstatement process and during early service life. The relaxation of gland packing material following valve hydro testing is not uncommon and can result in gland fasteners becoming loose. For the gland packing to work effectively it must be kept under an appropriate compressive load and for this reason, regular inspection of the gland locking nuts is recommended, especially post installation.
