SAFETY ALERT

Helicopter fuel cap damage

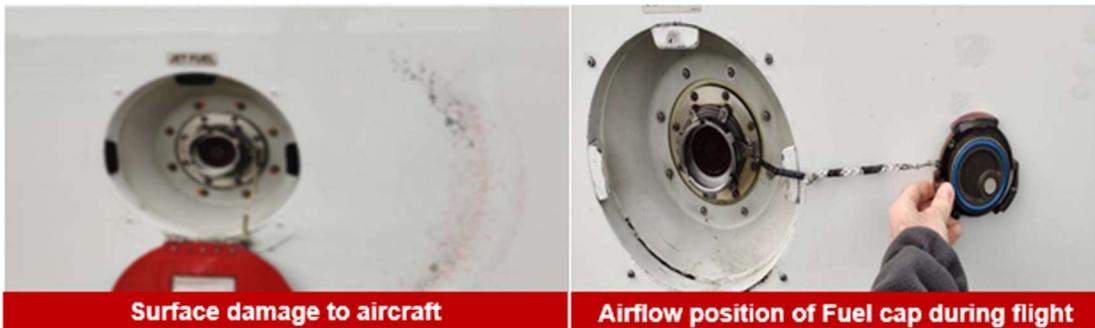
On returning from offshore, a helicopter was to be re-fuelled for overnight parking in accordance with the Aircraft Maintenance Manual. At this time, the fuel outer cap was found to be open and had caused significant surface damage to the left-hand fuel tank side panel aft of the pressure refuel connection by the way of surface pitting and scratches.

The fuel cap had been free to float in the airflow during the flight while remaining connected via the chain/lanyard. The damage created, whilst significant, would not have been sufficient to cause any flight threatening hazard.

The most probable cause being the cap was not secured properly on refuelling completion, resulting in detachment mid-flight from vibration. The detached cap then dislodged the cover plate resulting in the fuel cap dangling in airflow with the chain lanyard remaining intact. Under normal circumstances, pre-flight checks by flight crew should have identified this potential problem, however, such checks did not take place due to temporary restrictions relating to Covid-19.

- Deck Operations Procedure revised and an additional, physical check of the fuel cap prior to the fuel panel being secured
- Enforce message of following procedures
