Pryor Trust Blowout

DATE OF EVENT: 22nd Jan 2018

OUTCOME: 5 Fatalities

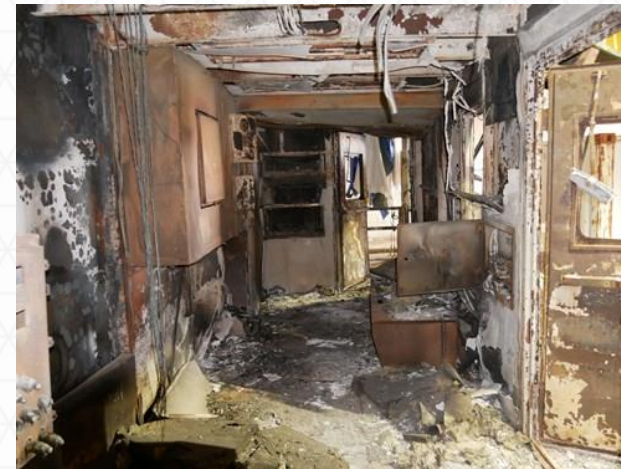
- The alarm system was deactivated for the 14 hours prior to the blowout because irrelevant nuisance alarms flooded the driller.

- The drillers were using new electronic logging system they were not trained in how to use.

Photo showing inside the Drillers Cabin located on the drill floor →
