SAFETY ALERT

PULSATION DAMPENER FAILURE

ALERT 5-19

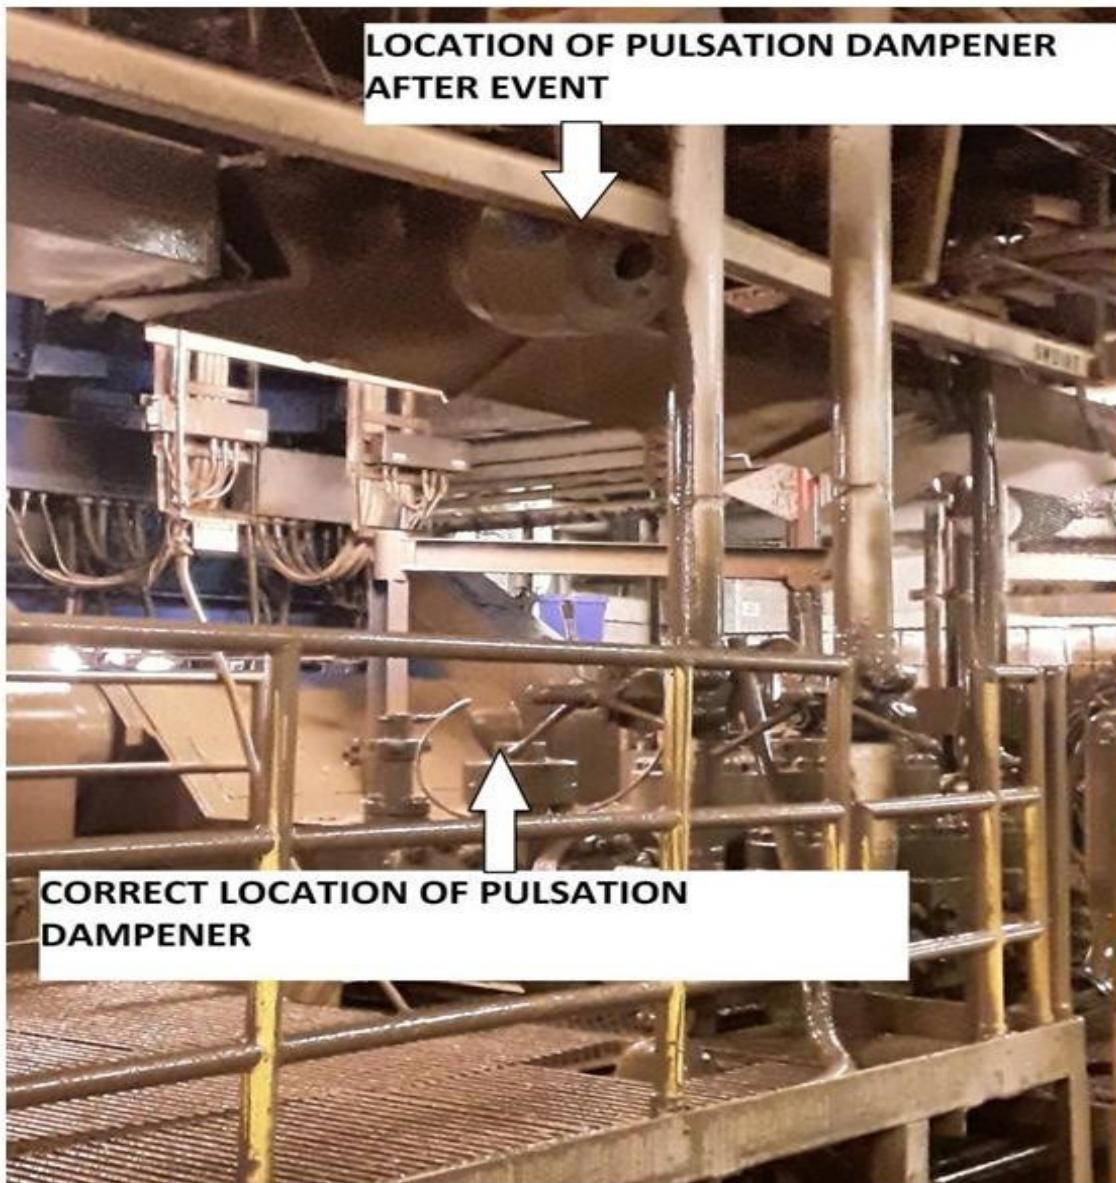
During well displacement, a sudden loss in standpipe pressure was observed. (Max circulation pressure at time of the incident was 1750psi). The Driller immediately shut down all mud pumps. The Derrickman confirmed that the discharge dampener on Mud Pump # 3, had separated from the flange area and was wedged in the overhead ducting/pipework above the pump. *Note: No personnel were in the pump-room area at the time.*

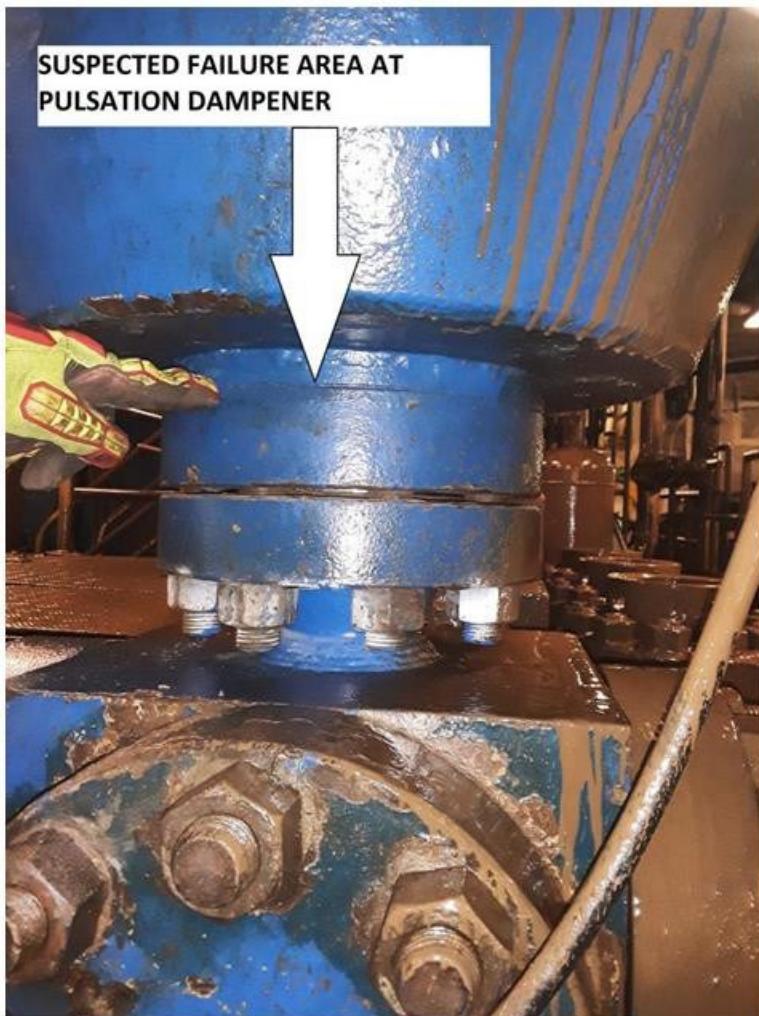
The # 3 Mud Pump Pulsation Dampener separated from its flange and was lodged in the ducting/ beam structure 1.6m above its flanged connection. Operations were immediately suspended. Displacement operations were shut down and the well confirmed secure. Relevant offshore and onshore persons were notified of the incident. Barriers were established around # 3 Mud Pump to prevent access to the area.

- **RC1:** The threaded hole in the dampener body was insufficient for the length of the cap screws used. This allowed corrosive fluid to enter the sump/void surrounding the cap screws providing a hydrogen embrittling environment which lead directly to the cap screw failure.
- **RC2:** The maintenance/Inspection regime for the dampener securing cap screws was insufficient. There was no recommendation from the OEM as to when the failed cap screws should be inspected or replaced.
