High Potential Incident - Collapsed Winch Drum

Replacement of crane winch barrel boss.

SAFETY ALERT

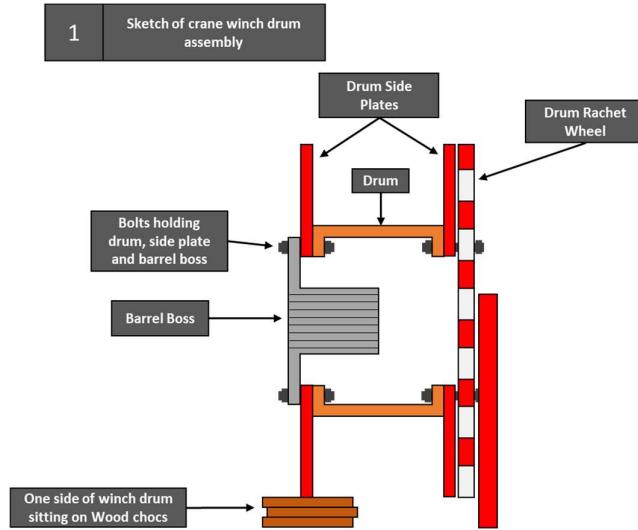
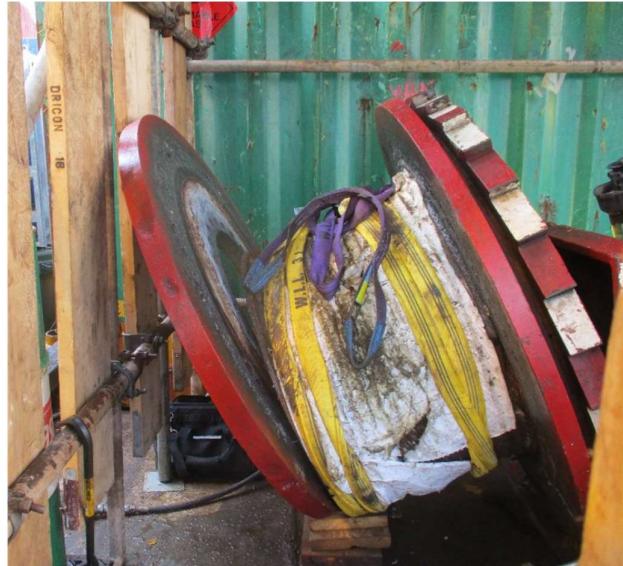
1: Overview of crane winch drum arrangement:

The winch drum had been removed from the boom hoist winch and positioned on the deck.

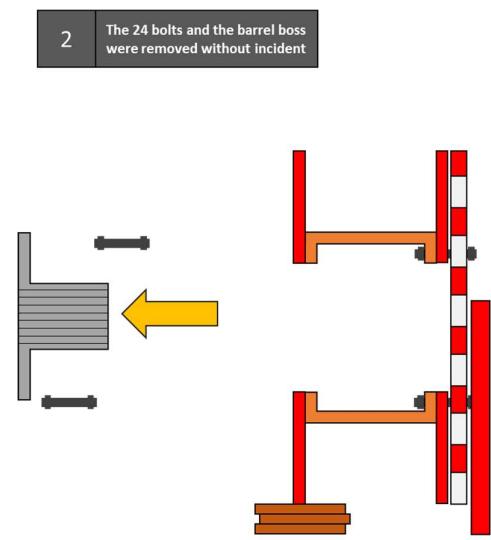
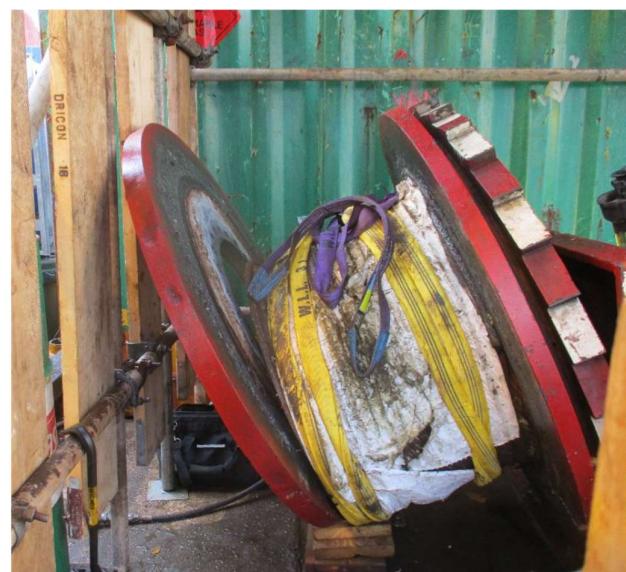
2: Barrel Boss Removed:

The team removed the 24 bolts securing the barrel boss in position and removed it, leaving the winch drum resting in position.

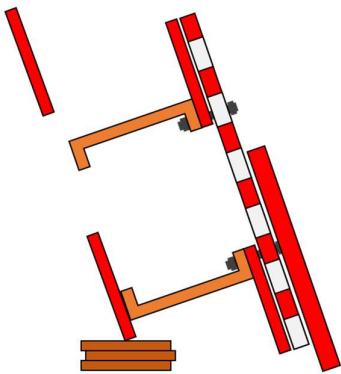
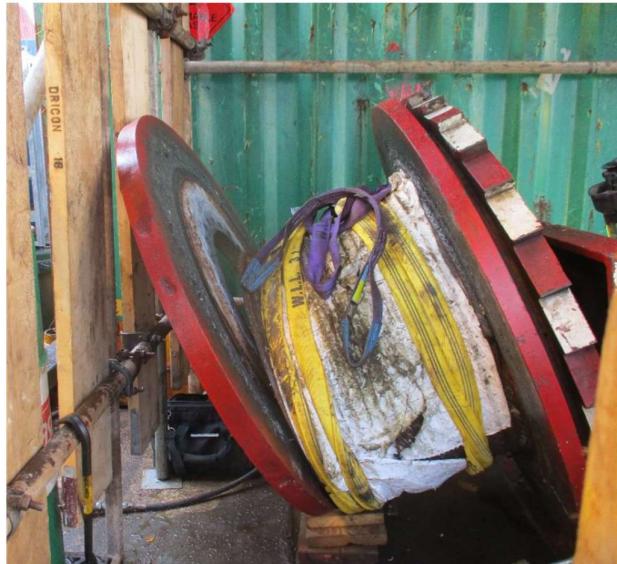
3: The Collapse:

Approximately 15 minutes later with two personnel still working in the area, the winch drum collapsed trapping the IP against the wall by his chest. The IP managed to call out as the winch rested on his chest alerting the other members of the team. The IP was struggling to breathe and was unable to speak, due to the pressure being exerted on his chest. 2 people managed to take enough weight off the IP's chest to allow him to slide out from the trapped position.

15m later, the winch drum assembly collapsed as the drum and side plate separated

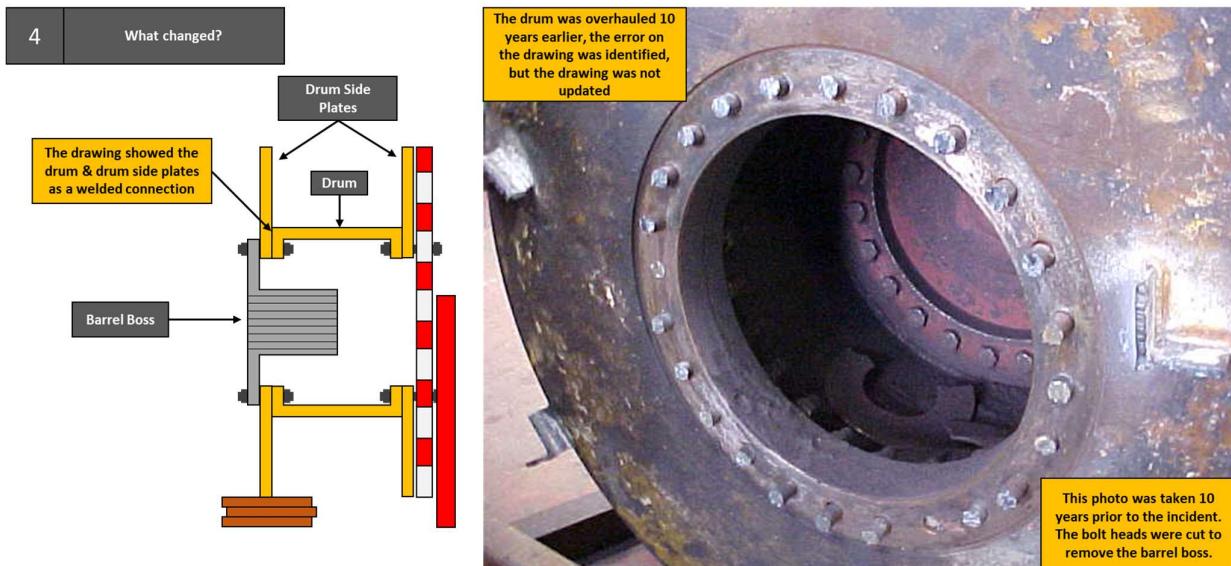
4: What Changed?

The work-pack drawings showed the drum and side plates were a single welded assembly, but this was not the case. The discrepancy was suspected by one of the team, but they did not raise this concern at the TBT.

The drawings showed the barrel boss was held in place by 8 off M24 X100mm bolts, the crew discovered that 24 off M24 X 170MM bolts were present, but this did not prompt a review.

This job had been completed before, the drawing discrepancies had been identified, but they had not been updated.

- If you identify an issue, raise your concern
- Ensure drawings are reviewed and revised to reflect known discrepancies
- Ensure processes are in place to; identify, assess, record and communicate change
