Safety Alert

From the International Association of Drilling Contractors

ALERT 13 – 28

SUDDEN ICE PLUG RELEASE RESULTS IN STRUCK-BY INJURY

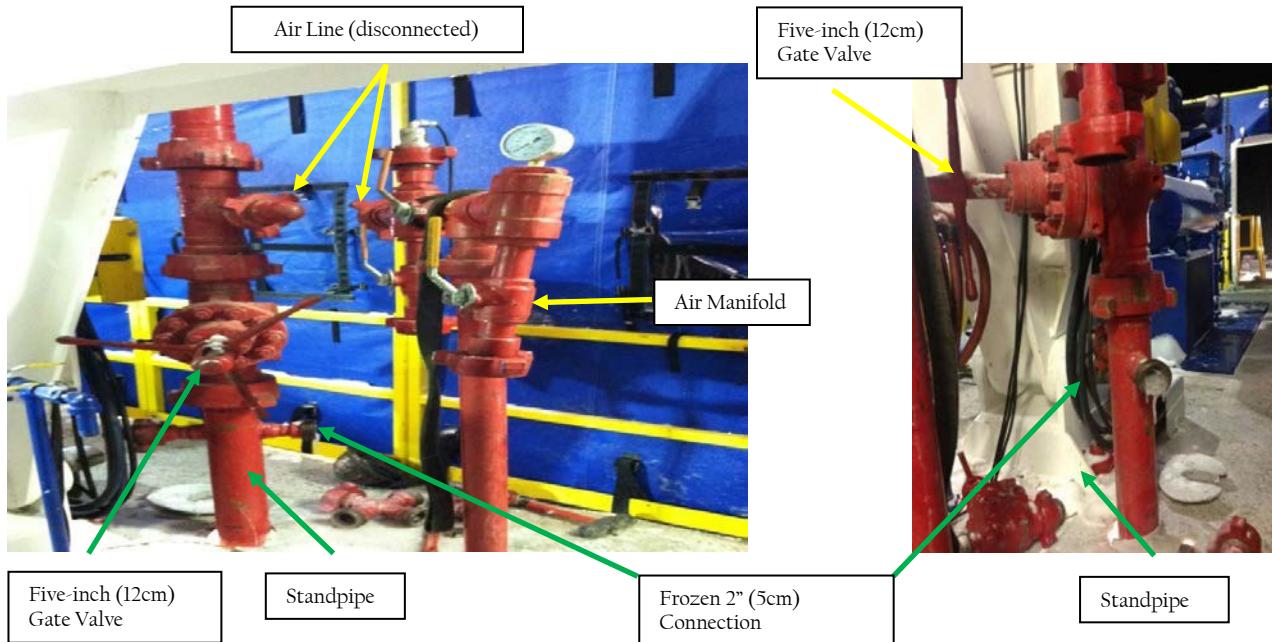
While converting from air to mud, the employee was attempting to reinstall the pressure gauge on the standpipe manifold. When he removed the bull plug from the manifold, he noticed ice had accumulated inside the two-inch (5cm) line. He notified the Driller and then attempted to remove the ice using a hand tool. Trapped pressure existed inside the lower section of the standpipe. As the ice dislodged from the line, it struck the employee in the ribs on the right side, causing internal injuries. He sustained further injuries when he fell back into the handrail striking his shoulder.

- Trapped pressure contained in the section of the standpipe below the five-inch (12cm) gate valve was not recognized and released prior to removing the two-inch (5cm) bull plug from the lower section of the standpipe.

- The crew assumed that the standpipe below the five-inch (12cm) gate valve did not have pressure since they were drilling with air, which was supplied and tied in above the five-inch (12cm) gate valve.

- Air pressure was contained in the standpipe below the five-inch (12cm) valve either from a leaking valve or from releasing pressure into the standpipe through the valve to make a connection while air drilling.

- Pressure reading devices (gauge or transducer) had been removed from the lower section of the standpipe for the air drilling.
- The crew did not understand the manifold configuration and did not realize that up-line approval was required for in order for changes to be made to the manifold.

- The crew did not expect icing on the inside of the standpipe.

- Crewmembers were reminded to discuss the potential for “trapped pressure” and the importance of NEVER ASSUMING that pressure does not exist in a line.
- Employees were reminded to be aware of and to stay out of the potential “line of fire”.
- All crew members were made aware that extra effort must be taken to prevent pressurizing the lower section of the standpipe during air drilling operations.
- Crews were instructed that pressure reading devices are not to be removed from any isolated line unless other measures are taken to verify the presence of trapped pressure.
- Effort shall be made to assist crews, new to a rig/rig type, in order to develop a rig specific JSA (with appropriate detail) to familiarize them with any new aspects of a rig or rig type.

Crewmembers must be reminded of the potential for icing inside of any line and are to discuss (during JSA and periodically during cold weather operations) the hazards and steps to prevent an incident from occurring during any operation requiring separation/disconnection of lines/connections.
