### • What Happened?

**Location:** EnSCO 100 at Huntington

**Description:** Whilst helicopter was lifting off an unsecured fibre glass lid was blown off the top of accommodation block. The lid fell approximately 50 feet to the main deck below. Tool pusher was on main deck approx 15 feet away. No other personnel were near.

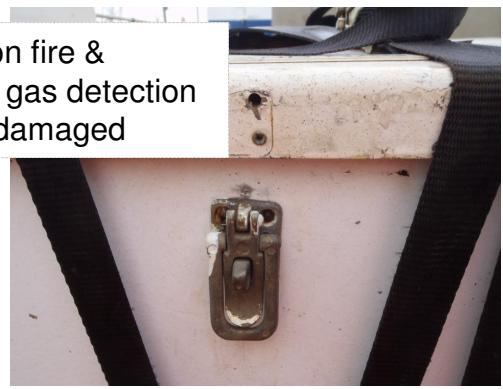
Latch on fire & battery gas detection box is damaged

1. Increase vigilance/inspection criteria on storage boxes/containers

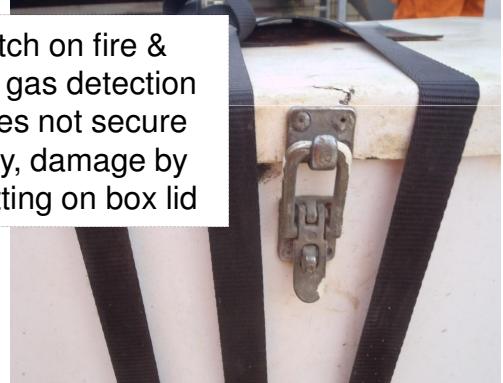
2nd Latch on fire & battery gas detection box does not secure properly, damage by latch fitting on box lid
