# TAQA Bratani Ltd - HSSE ALERT

**Location:** North Cormorant

**Description:** Unexpected movement of crane

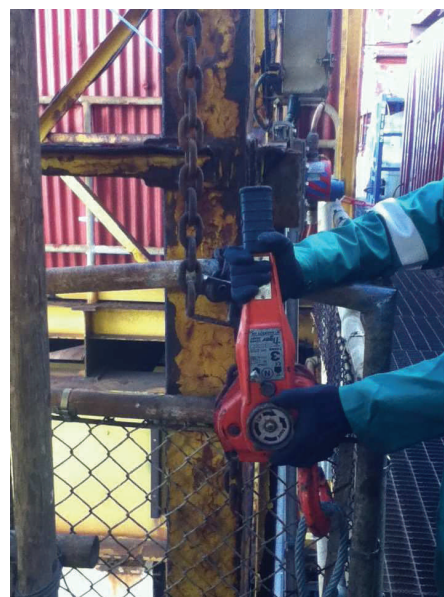
Due to a crane engine failure and being unable to lower the crane boom into the rest safely, the headache ball had been anchored to the boom structure using a chain block to prevent it moving in high winds.

The crane was felt to shudder; Occupant immediately returned to the crane cab to turn off the high revs and shutdown the engine. It was noticed at this point that the headache ball had moved up several feet and the chain block had snapped.

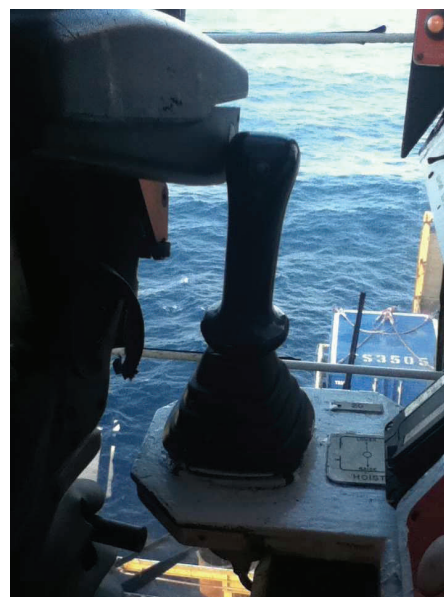
1. The crane would not have activated had the boom been in the rest
2. The crane cab chair arm inadvertently activated the main hoist joystick, whilst the engine was being commissioned at high revs.
3. The work party, toolbox talk, WCC & risk assessment all failed to identify any concerns with the “crane controls” being live and the crane boom not in the rest.

1. There was an ergonomics design flaw with the cab, the chair could physically activate one of the controls. This went unreported for many years - perhaps because people believed it couldn't cause a problem
2. The change of conditions associated with the crane not being in the rest was not recognised. This meant that the risk of inadvertent activation of the crane was completely missed.

1. Consider the potential for hidden hazards
2. Be vigilant and aware of any changes imposed by your actions (e.g. moving a chair) and confirm that no hazards have been introduced as a result
3. Challenge the norm – don't accept “it's always been like that”
