IP injured left thumb using torque equipment

IP sustained a severe laceration to the tip of left thumb whilst using torque equipment

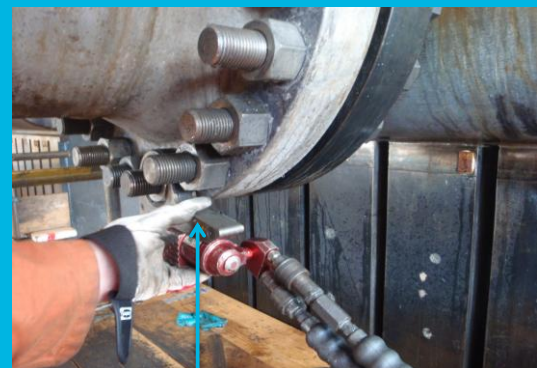
Thumb position as per injury.
NB Thumb should never be on locking mechanism

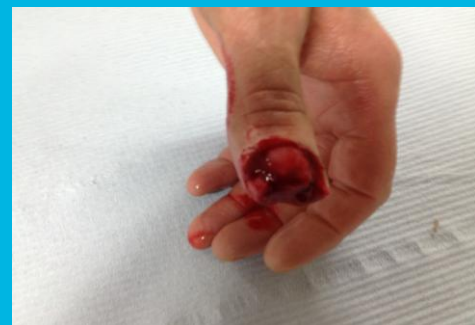
Severe laceration of the top of the injured party's left thumb

IP Thumb Injury
