Safety Alert

ALERT 08 – 26

FALL FROM HEIGHT RESULTS IN DOUBLE MTO

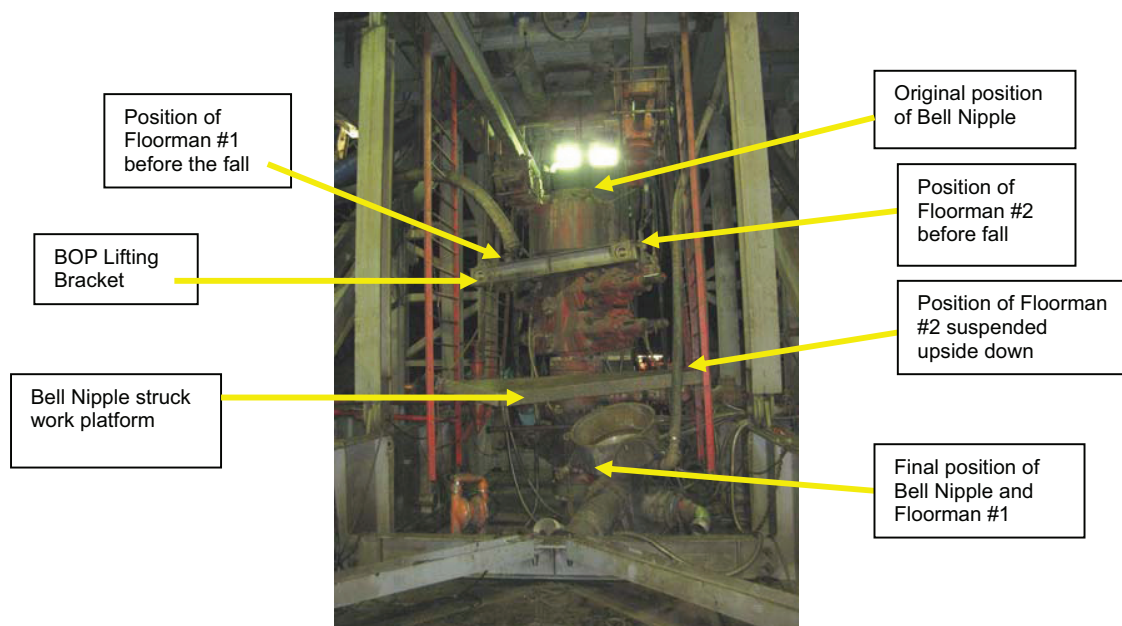
Two Floormen were working in the substructure approximately 4 metres (13.4 feet) above the ground and removing the bell nipple from the top of the blowout preventer (BOP). The flow line had been disconnected from the bell nipple but was still attached to the winch on the drill floor when it was raised unexpectedly. The flow line flange knocked the bell nipple from the BOP seating and it fell to the ground. The Floormen had moved from one side of the Bell Nipple (v-door side) to the other side (draw works side) where they had just connected a soft sling to secure the Bell Nipple. One Floorman (#1 in picture below) had attached his shock absorbing lanyard to the Bell Nipple (approx 300 kg) and he was pulled down and fell to the ground. The other Floorman (#2 in picture below) was knocked off balance and fell backwards to the extent of his shock absorber lanyard before coming to rest suspended upside down with the unused work platform stopping his fall any further. His lanyard did not extend far enough to activate the shock absorber. Both workers were standing on the BOP lifting bracket. Both workers received soft tissue injuries and returned to work the next day.

- The winch line connected to the flow line was supposed to have been disconnected.
- The original plan was to use two winch lines to remove the bell nipple, one through the mouse-hole and one through the rotary table. One line was ready and passed through the mouse hole, but not connected. The Driller changed the plan to use only one winch.
- Neither worker was connected to the Safety Retracting Life (SRL) line fall arrestors which were attached to the underside of the rig floor on each side of the sub base.
- Lanyards used were not secured above head height and in one case the lanyard was connected to an unsecured anchor point (bell nipple).

- All four studs that attach the bell nipple to the BOP annular had been removed before it had been secured with a hoist line.
- No procedure was available for this job.
- No JSA/JHA was used for this task.
- Brief pre-job discussion was inadequate for the task being undertaken and potential risk
- Lack of adequate and / or specific instructions during the task, particularly just before the incident.

- Procedure to be developed with sequential steps particularly the restraining of all equipment before unbolting or removing it.
- Ensure all provided safety devices are used (in this case fall arrestors)
- Processes to be put in place to ensure adequate and thorough Pre Job meetings are planned as part of the job, including the communication of hazards and why controls are necessary to prevent an accident.
- Ensure all instructions given during a job are specific, understood and recorded.
- Outline Supervisor expectations to ensure that jobs are undertaken safely
- Reinforce to the work force that they are empowered to **STOP THE JOB** when safety controls or precautions are bypassed.
- Ensure fall protection lanyard is secured to a suitable (stable) anchor point.
- To reduce fall distance, lanyards are to be secured to anchor points that are above head height.
