# Safety Alert

From the International Association of Drilling Contractors

**ALERT 10 - 01**

## DROPPED OBJECT – GUIDE COLLAR SEGMENT SEPARATES FROM WINCH LINE AND FALLS INTO THE WATER

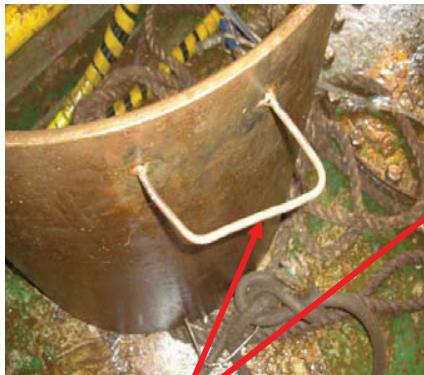
Lifting handle that the cable was attached to.

- There was no proper lifting eye (or manufactured lifting hole) on the collar guide segment.
- The handle was too weak to sustain a snag and easily broke off.
- Rig motion was also a likely contributing factor. (Since master bushings were removed, it would not be safe for anyone to attempt to center the tool as it passed through the table).

- Client and Third-Party Contractor changed procedures for transporting the collar guide segments to the rig floor. The segments would no longer be lifted through the rotary table.
- The OIM must approve anything lifted through the rotary table with his senior-level supervisor supervising the lift.
- Procurement policies should be revised to require that third party companies should provide equipment with built-in suitable lifting points that will not break off while being lifted even if it snags on something.

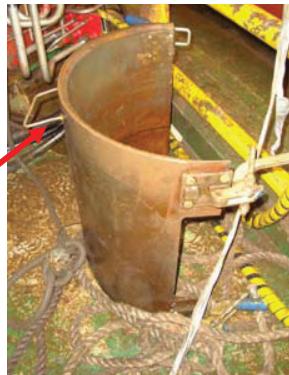
Although there was a spotter with UHF radio in the moon pool area and a spotter at the rotary table to signal the winch operator, as the guide collar segment entered the rotary table, it caught on the diverter housing. The handle broke off and the 25 kilogram guide collar fell and struck the moon pool equipment support beams then fell into the water. Since personnel had been evacuated from the drop zone, there were no injuries.

Area where the busing fell to in moon pool
