# Safety Alert – Corroded Deck Gratings: Unable to Determine Condition from Visual Inspection

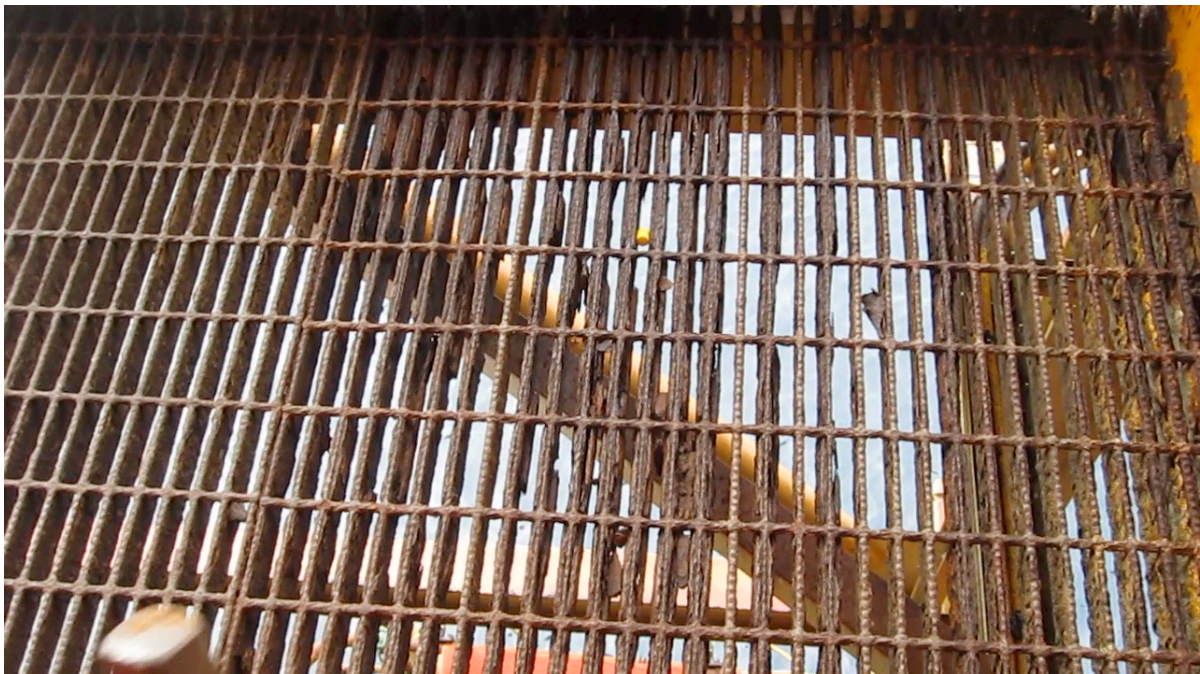
During inspection of gratings on a fixed jacket offshore installation, it was identified that where gratings have suffered significant corrosion, the build up of corrosion product remained in place and masked the true extent of the loss of metal.

Without removal of the corrosion product, gratings which had unacceptable corrosion damage could not readily be differentiated from gratings which had less severe underlying corrosion. This resulted in misleading results from simple visual inspections.

Picture 1: Corroded gratings prior to removal of corrosion product build up

Where inspection is carried out of gratings which have a build up of corrosion product on the load bars, the corrosion product should be removed in order to allow the amount of metal remaining to be accurately assessed.

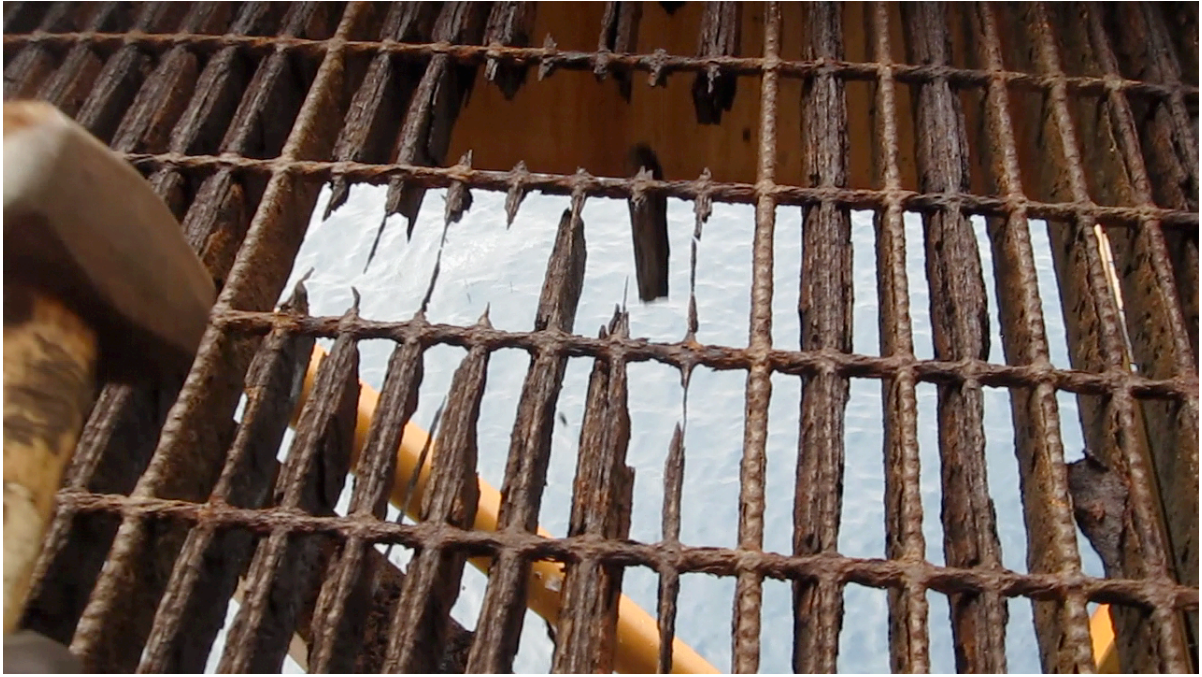
Impacting corroded gratings with a hammer, to remove corrosion product, identified gratings where there was an unacceptable loss of metal once the corrosion had been removed.

Picture 2: By removing the corrosion product, the severity of metal loss can be seen
