Marine Safety Forum – Safety Flash 11-16

Issued: 25th May 2011

Subject: Limitations of Equipment

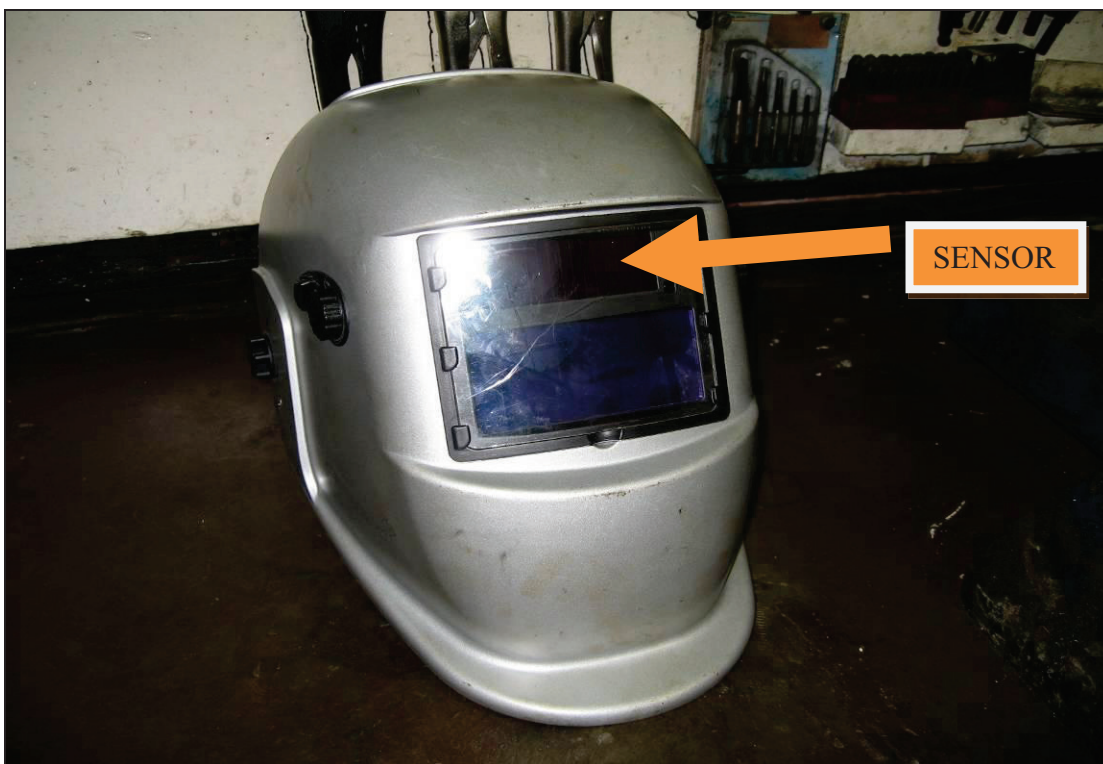
A recent Near Miss on a vessel highlighted the limitations of Auto Darkening Welding Helmets. The Chief Engineer was welding a small crack in the bulkhead of the Aft Peak tank where it meets the shell plating, the access to which was awkward due to thruster cable trays etc.

He was using a recently supplied auto-darkening welding helmet which was operating correctly until he got to a point where the weld bead was starting to pass under a cable tray which resulted in the sensor on the helmet becoming obscured by the cable tray, causing the screen to become instantaneously clear while the arc was still lit.

Luckily there was no eye damage done on this occasion and this incident highlights the fact that these helmets have limitations and should be used with caution. Vessels that have this type of Welding Helmet are advised to consider a more conventional welding mask.

All personnel are reminded to assess the risks prior to using any equipment and take into account the limitations which might be encountered.
