Gas bottle rack door swings open during back-loading operation

Details of near miss:

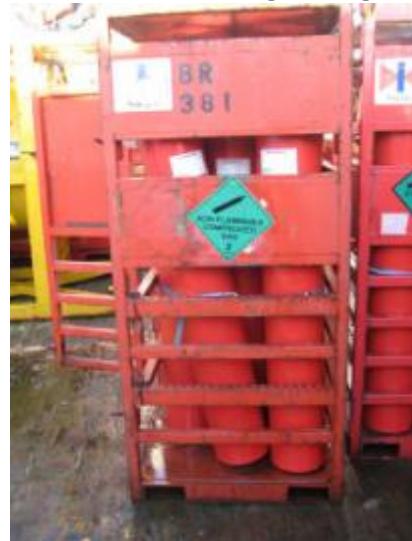
The locking pins on the gas rack door were both subsequently found to be in the open position and have now been secured. One of the bottles inside the unit was found to be loose and able to tip backwards and forwards despite there being a ratchet strap around them.

View of bottle rack showing dislodged bottle

2. The internal retaining bar and application of an additional fabric ratchet strap clearly prevented the bottles falling when the door opening and it is recommended that bottles racks are not moved without these additional precautions being used.
3. Ratchet straps should be fitted in a position which takes into account the likely centre of gravity of the bottles.
4. Suppliers of bottle racks of similar design should be contacted to make them aware of the need to provide clear indication and instruction as to how doors should be locked.

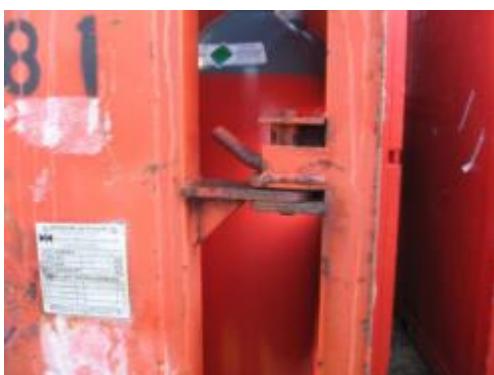
On checking the bottle rack, it was not immediately apparent that the locks were open as there is no clear indication of the open and locked positions; there were no stickers or other form of markings to show the position the handle should be in. The door looked secure, but on physically checking, it could still be opened.

Pin in correct closed position

1. Banks-man's checks should include not only visual, but a physical check of security of any opening doors or panels, not only on gas bottle racks, but any back-loaded cargo.

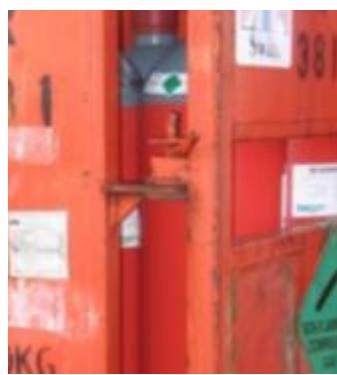
Pin in open position – door can swing open
