SAFETY ALERT

Product Safety Notice: Crosby Shur-Lock Hook

IMPORTANT SAFETY NOTICE**USERS OF THE BELOW CROSBY PRODUCT:****S-1326 18/20 mm Shur-Loc Hook with 16t WLL, PN 1004349****With Production Identification Codes (PIC) of 9SB, 9SC, and 9SD as located on the latch****PLEASE CAREFULLY REVIEW AND ACT UPON THE FOLLOWING INSTRUCTIONS.**

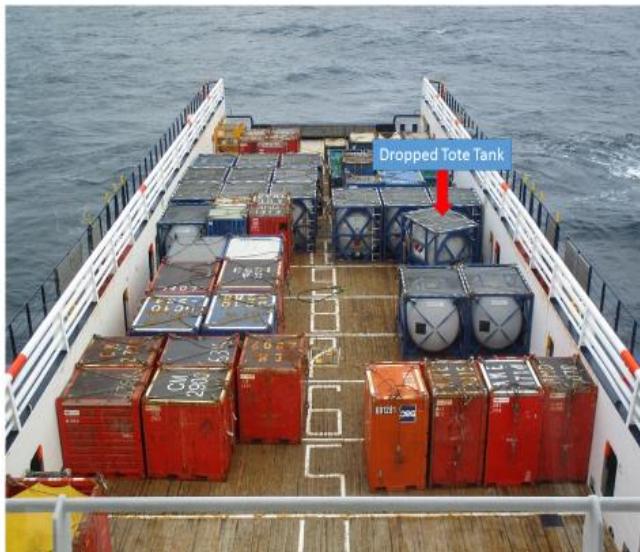
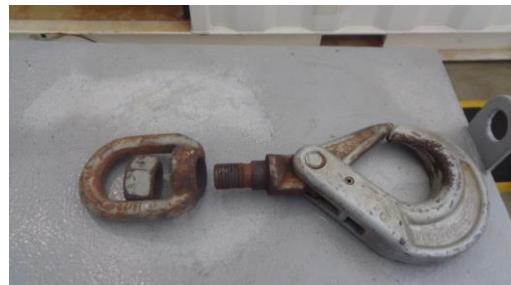
During the backload of tote tanks from the rig to the supply vessel, a 16mt Crosby hook that was part of the lifting arrangement failed, causing the tote tank that was being lowered onto the deck of the vessel to drop approximately 3ft (1metre), coming to rest on the vessel's deck in an upright orientation.

The crane's MIPEG (crane monitoring system) was checked and the recorded load at the time of the incident was 12mt with a max dynamic weight recorded at 13mt.

The hook and swivel were supplied and certified as a composite unit.

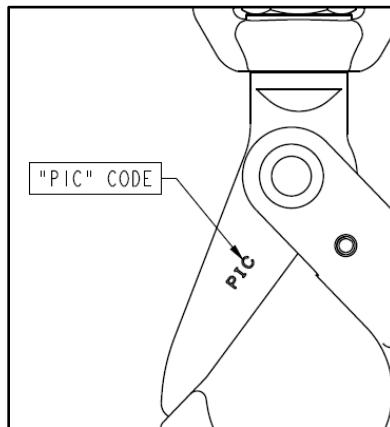
Figure 1 - PIC Location

By use of the Production Identification Code (PIC) symbols appearing on the product, we have determined the 18/20mm size of S-1326 Shur-Loc Hooks with PICs 9SB, 9SC, and 9SD shown on the latch may have this condition. See Figure 1 below indicating the position of the PIC on the hook latch. No other PICs are part of this Important Safety Notice.

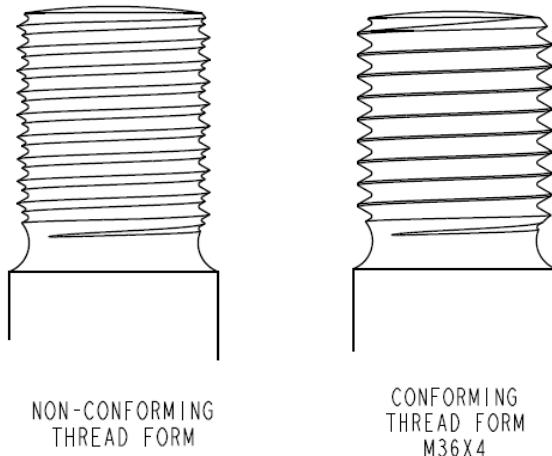
1. Inspect the shank thread for non-conforming thread form. The thread form is to be checked by a competent person, and is to conform to M36x4. See images below. Hooks found with non-conforming threads are to be immediately removed from service.
2. Reinstall the coiled spring pin. If the coiled spring pin requires replacement, contact Crosby for a replacement or replace with a 6mm diameter by 50mm long heavy duty coiled steel spring pin per ISO 8748 (Spring pin ISO 8748 – 6 x 50 St).

If it is determined during inspection that the hook threads are non-conforming, please make arrangements to return the hook for replacement. To return these products, please contact your Crosby Distributor. For more information concerning this Important Safety Notice, contact Technical Support at 1-800-772-1500.
