SAFETY ALERT

Lithium ion battery overheated following exposure to water

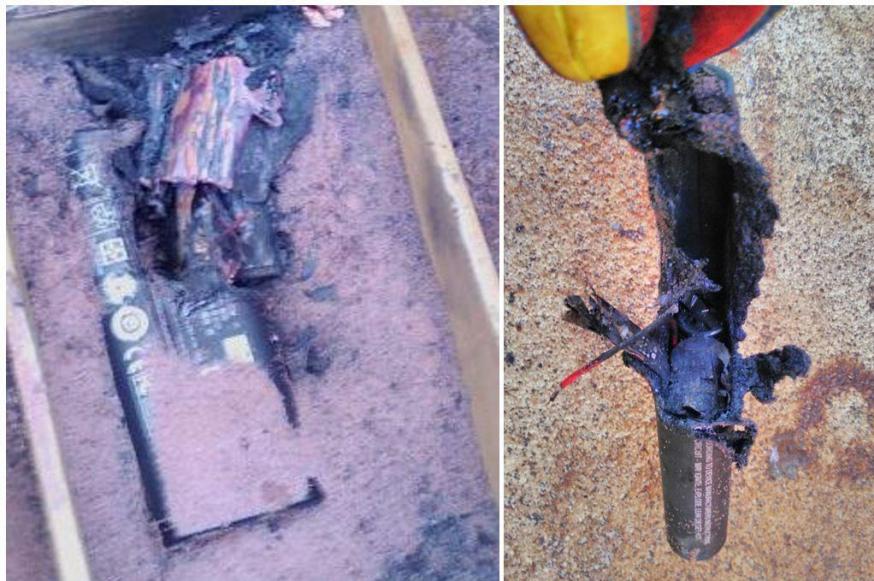
As a result of a general platform alarm (GPA) and deluge, a piece of inspection equipment was exposed to significant amounts of water, causing the internals to become saturated and short circuit.

Following the event, the lithium ion battery was removed and found to be overheating. Shortly thereafter the battery started to smoke then catch fire. Fortunately, the fire was controlled and extinguished immediately however the outcome could have been much worse.

The importance of protecting equipment from water ingress is highlighted, along with the importance of ensuring that care is taken whenever equipment is being dried out following exposure to water.
