SAFETY ALERT

Teflon pad dropped from crane

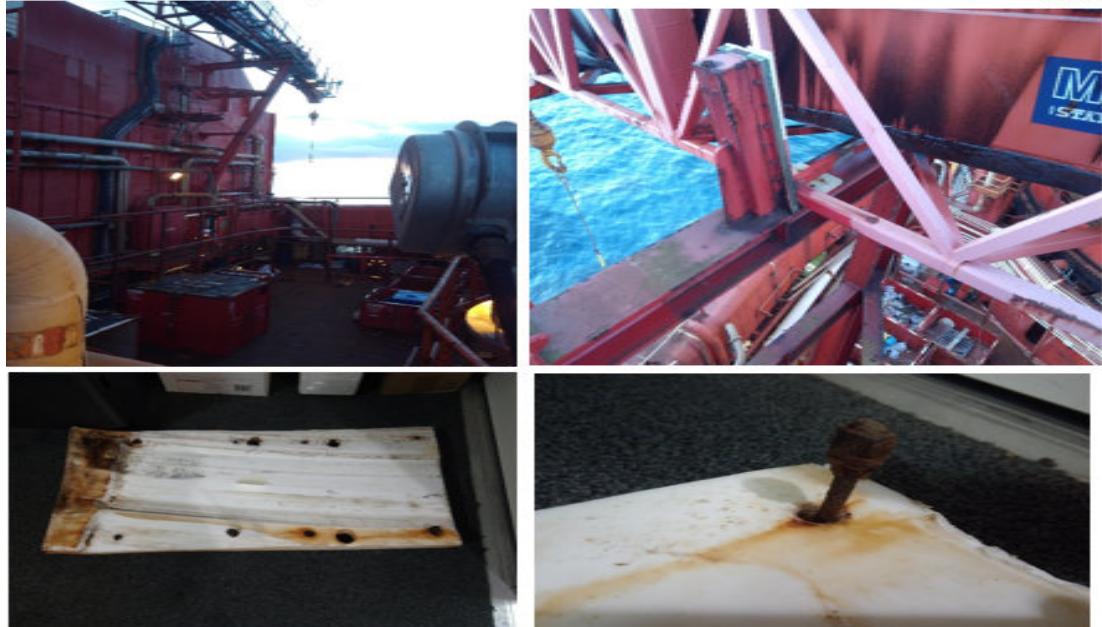
After completing lifts with the forward crane, the crane operator stowed the crane boom in its cradle. The crane operator observed one of the Teflon pads dislodge and fall from the cradle. The pad initially fell onto the handrail around the tunnel air lock roof before falling further into the main deck forward landing area.

- Ensure planned maintenance is carried out
- Carry out inspections on the crane rest for Potential Dropped Objects
