SAFETY ALERT

Crane block sheave guard dropped from 25 metres

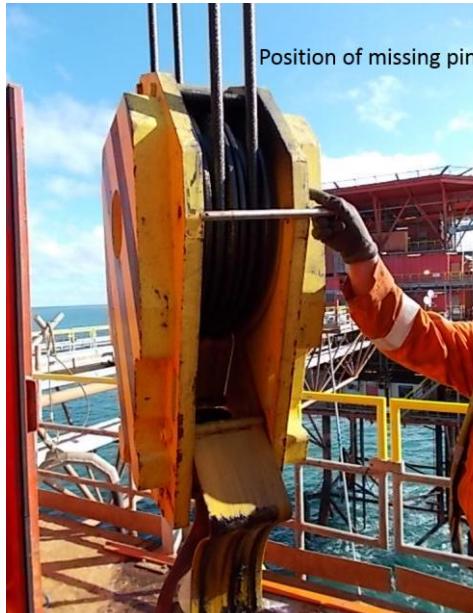
During the lift, a member of the deck crew heard a loud noise. On investigation, he found that the securing pin for the main block sheave guard had detached from the main crane block and fallen approximately 25 metres to the deck below.

Crane operations were immediately halted and the crane main block was brought to deck level for inspection. The fallen sheave guard weighed 0.8 kg and landed 2 metres from a member of the deck crew. This is a potential fatality on the DROPs calculator.

The sheave guide was secured by a spring clip. The crane block was supplied with this spring clip configuration. It cannot be determined if the clip had failed or was not installed correctly.

The spring clip on the sheave guide was removed and replaced by a bolted configuration.

All cranes in the fleet were inspected to ensure the same configuration was not present.

Suppliers were informed of incident to ensure they no longer supply blocks with this configuration.

Planned maintenance tasks amended to ensure checks are carried out on condition of sheave guards.
