SAFETY ALERT

Partial load lost during road transit

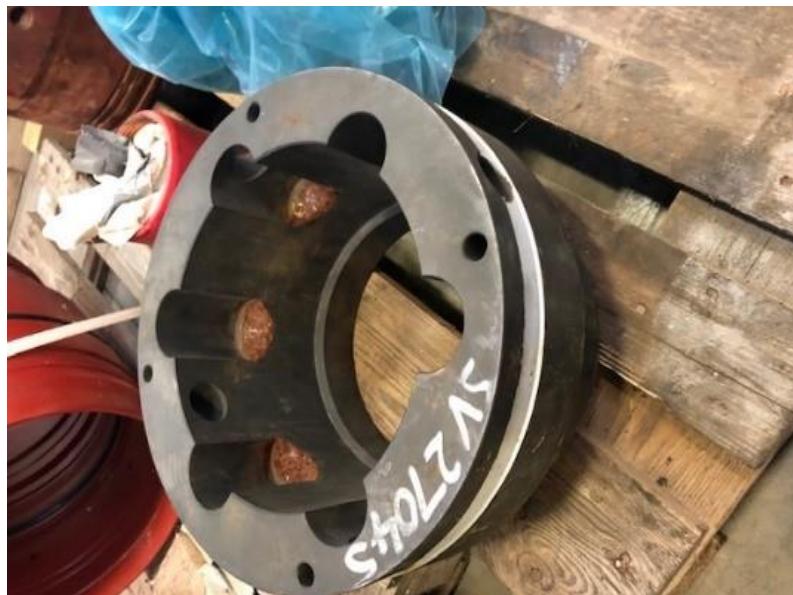
The missing piece of equipment was described as a tubing hanger load ring weighing approximately 43kg and 13" diameter.

Following an investigation, it was concluded that the banding securing the tubing hanger load ring had failed.

The load ring had been banded to the pallet using polypropylene type banding. The single piece of banding had been fixed across several unprotected sharp edges.

Tension had then been applied to the banding to secure the load ring to the pallet.

- Banding must be certified and fit for purpose
- Materials stored on pallets should have secondary retention in place
- Drivers to ensure that items are 'fit for journey' before commencing journey
- Drivers to ensure that any required paperwork is checked, signed and dated, providing an auditable trail
- The hierarchy of controls should be considered at all time to eliminate hazards e.g. alternative storing options such as a crate
