SAFETY ALERT

Blind Shear Door Blown Off BOP Body

Alert 7-21

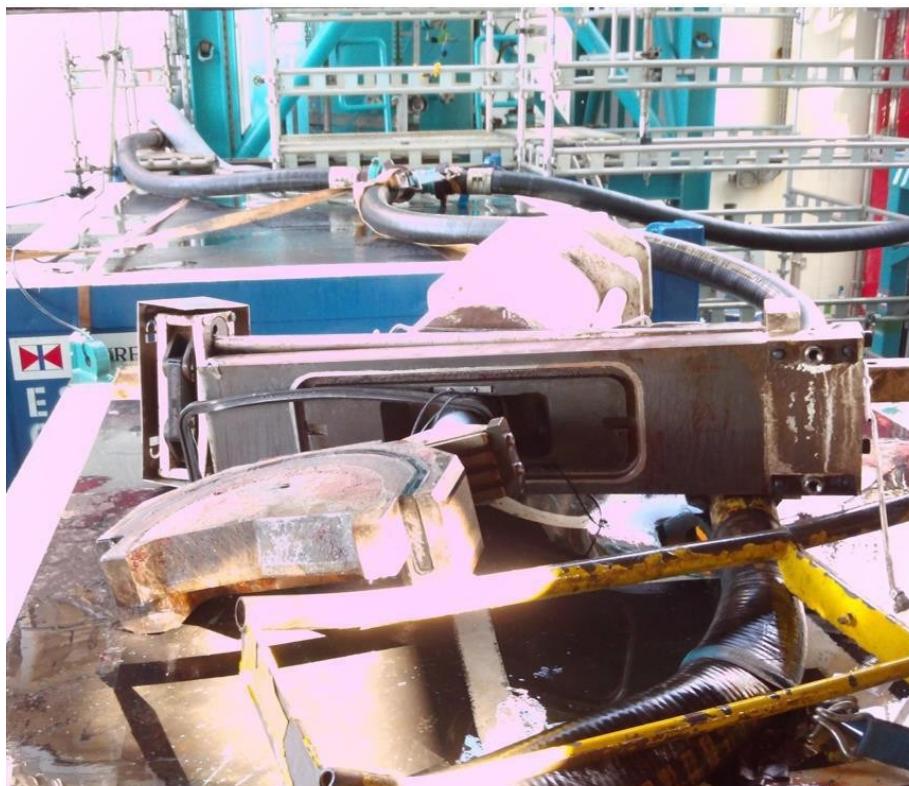
During a high-pressure test of the Blow Out Preventer (BOP), one of the Blind Shear Ram (BSR) doors blew off the BOP body. The door was found resting on top of an adjacent equipment container, approximately 5 meters (16 feet) to the port side of the BOP.

Picture 1: BOP Door and Ram on Top of Container

- Ensure BOP maintenance personnel are knowledgeable of BOP door locking mechanism.
- Ensure BOP maintenance and testing procedures mandate second verifier for BOP door secondary lock activation.
- Work with manufacturer and human factor specialist to enhance the secondary lock design and mitigate the risk of human error.

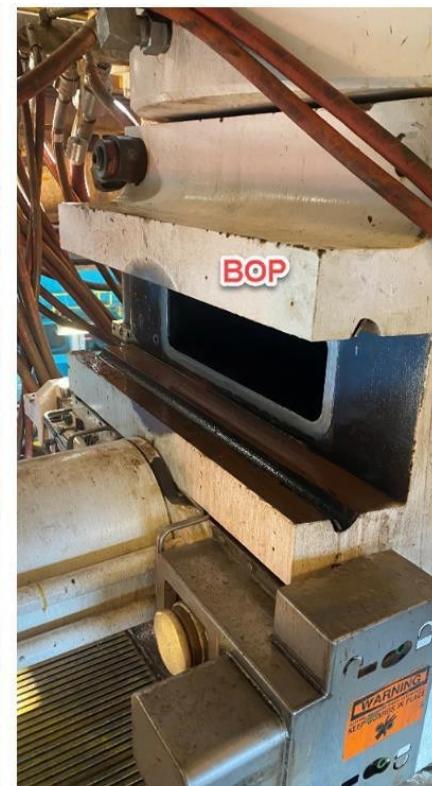
The pressure test took place using the cement unit after nipple up of the BOP. The test started with a low-pressure test to 20 bars (290 psi) and held for 5 minutes. While increasing the pressure to a planned 570 bars (8,267 psi), the BSR door blew off when the pressure reached 109 bars (1,580 psi).

Picture 2: BOP Body Where Door Separated

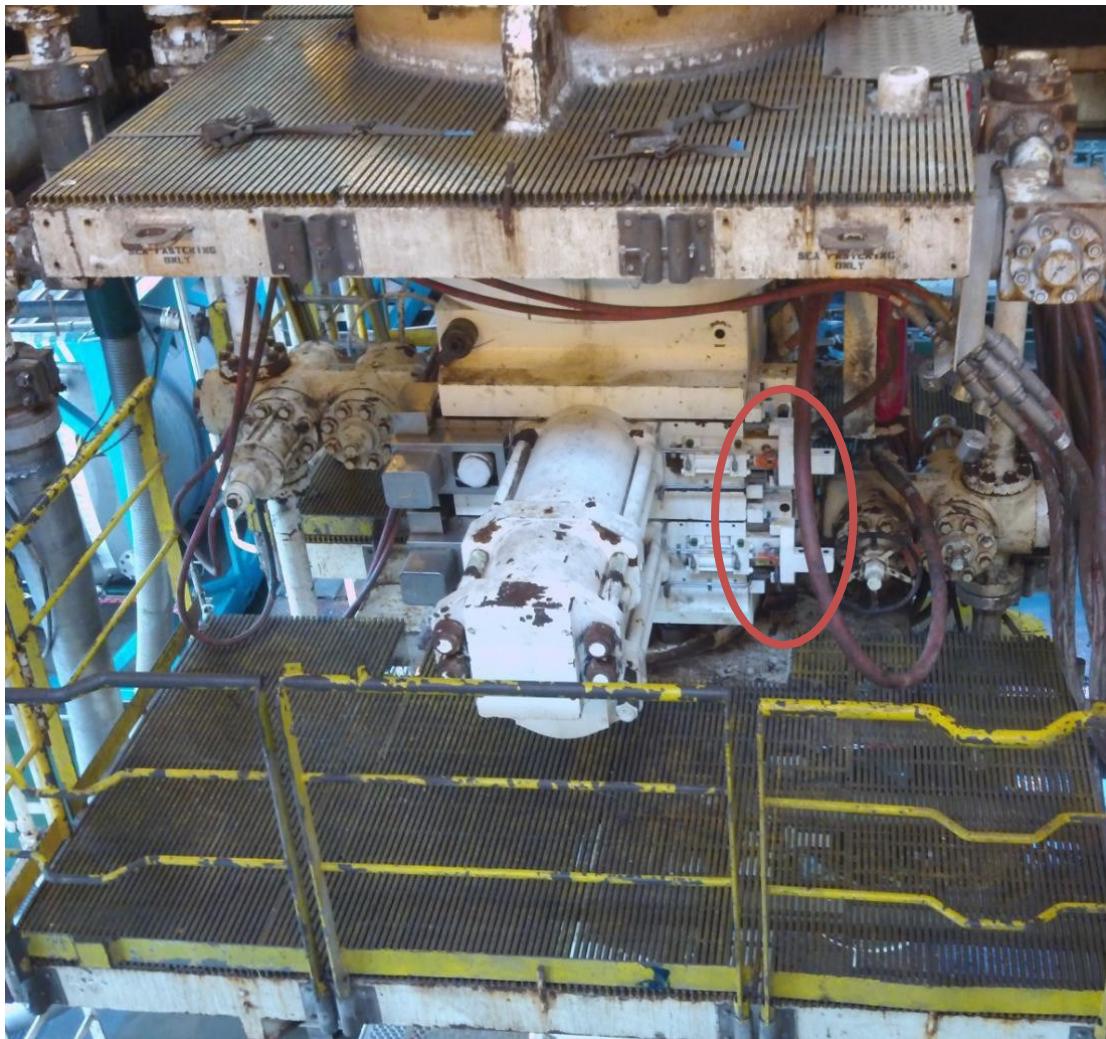
Before the pressure test, the BOP doors were opened for inspection and replacement of the middle pipe RAMS was carried out. During the reassembly of the BOP doors, the anti-rotation bars were not engaged.

Picture 3: BOP with Anti-Rotation Bar Disengaged

- Incorrect use of locking system – Maintenance personnel did not engage the anti-rotation bar after reassembling BOP as described in the work instruction.
- No independent verification of correct locking – Drill crew did not conduct second verification of BOP before the pressure test as required by the work instruction.

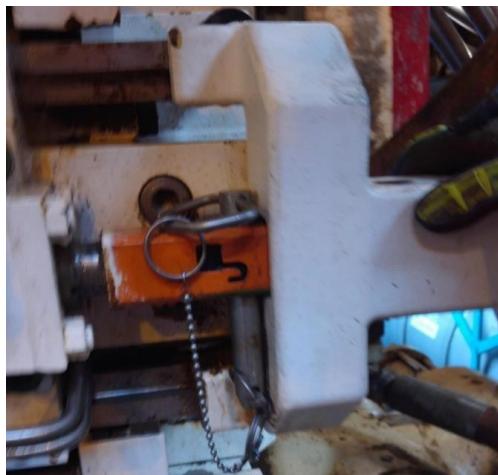
Picture 4: Anti-Rotation Bar in Unlocked Position

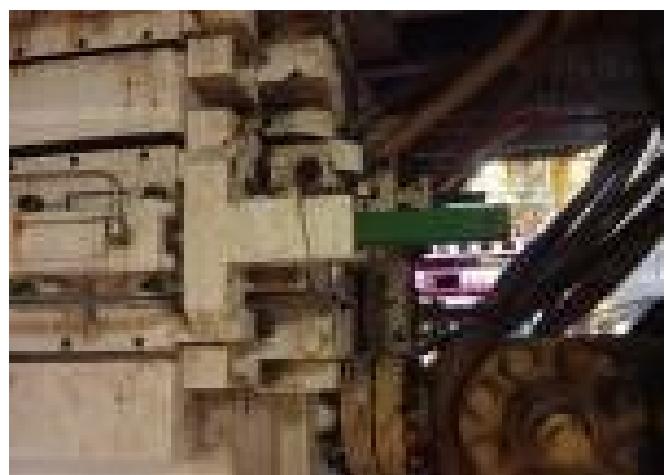
Picture 5: Anti-Rotation Bar in Locked Position
